**VAN DORN
REDEVELOPMENT AREA
Lincoln, Nebraska**

**BLIGHT AND SUBSTANDARD
DETERMINATION STUDY**

October, 2006

Prepared By:
HANNA:KEELAN ASSOCIATES, P.C.
Community Planning and Research
Lincoln, Nebraska
www.hannakeelan.com

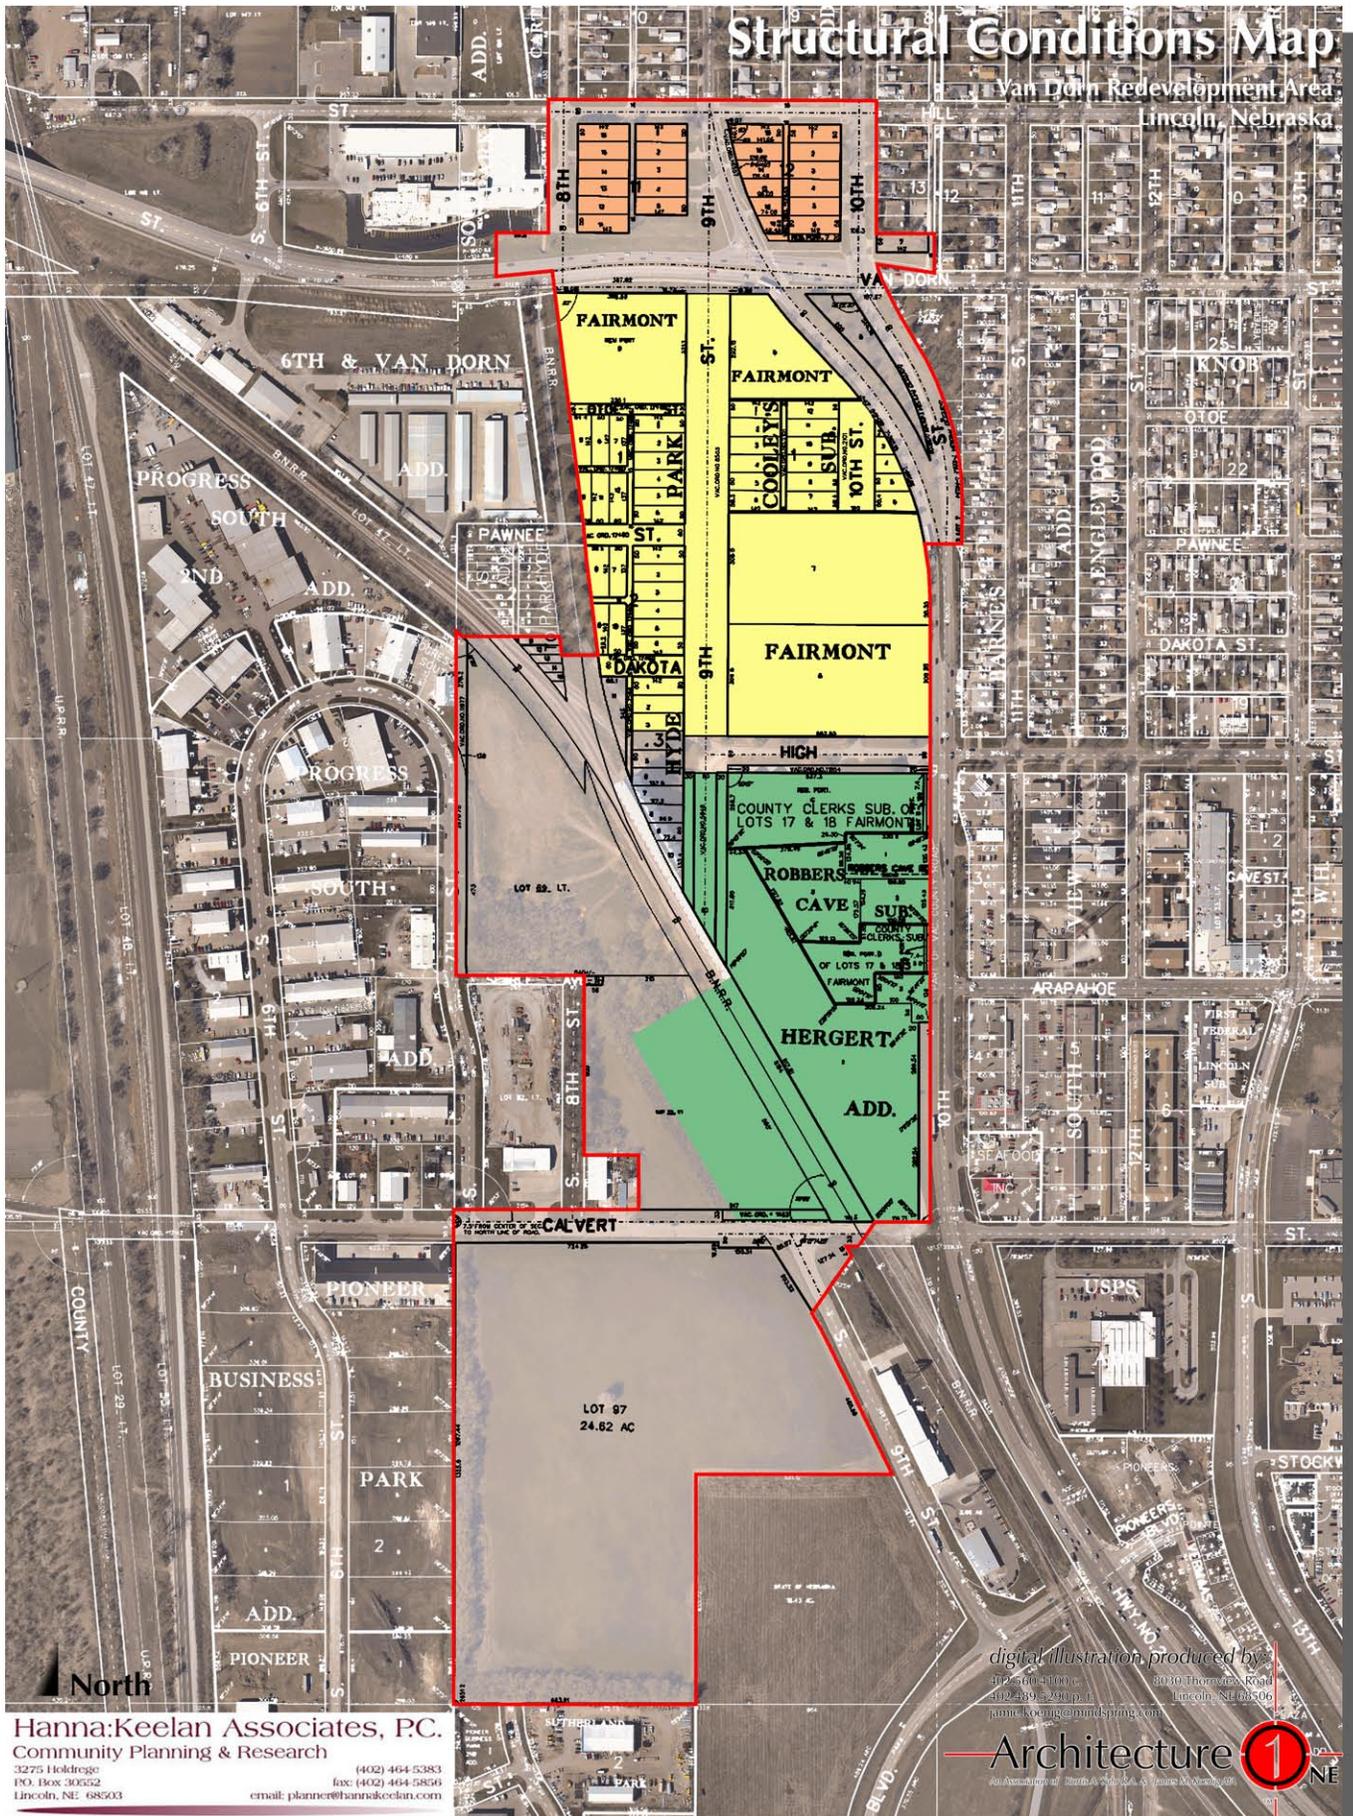
Structural Conditions Map

The building condition analysis was based on an exterior inspection of all **28** existing structures, within the Redevelopment Area, to note structural deficiencies in individual buildings and to identify related environmental deficiencies for individual sites or parcels within the area. Building conditions are identified in **Illustration 4**.

- Nineteen (19) structures were classified as structurally sound;
- Three (3) structures were classified as deteriorating minor defects,
- Three (3) structures were classified as deteriorating major defects; and
- Three (3) structures were classified as dilapidated.

The results of the exterior structural survey identified the conditions of the structures, throughout the Redevelopment Area. A total of six (21.4 percent) of the total 28 structures, within the Area, are either deteriorating or dilapidated to a substandard condition. (See **Illustration 4**)

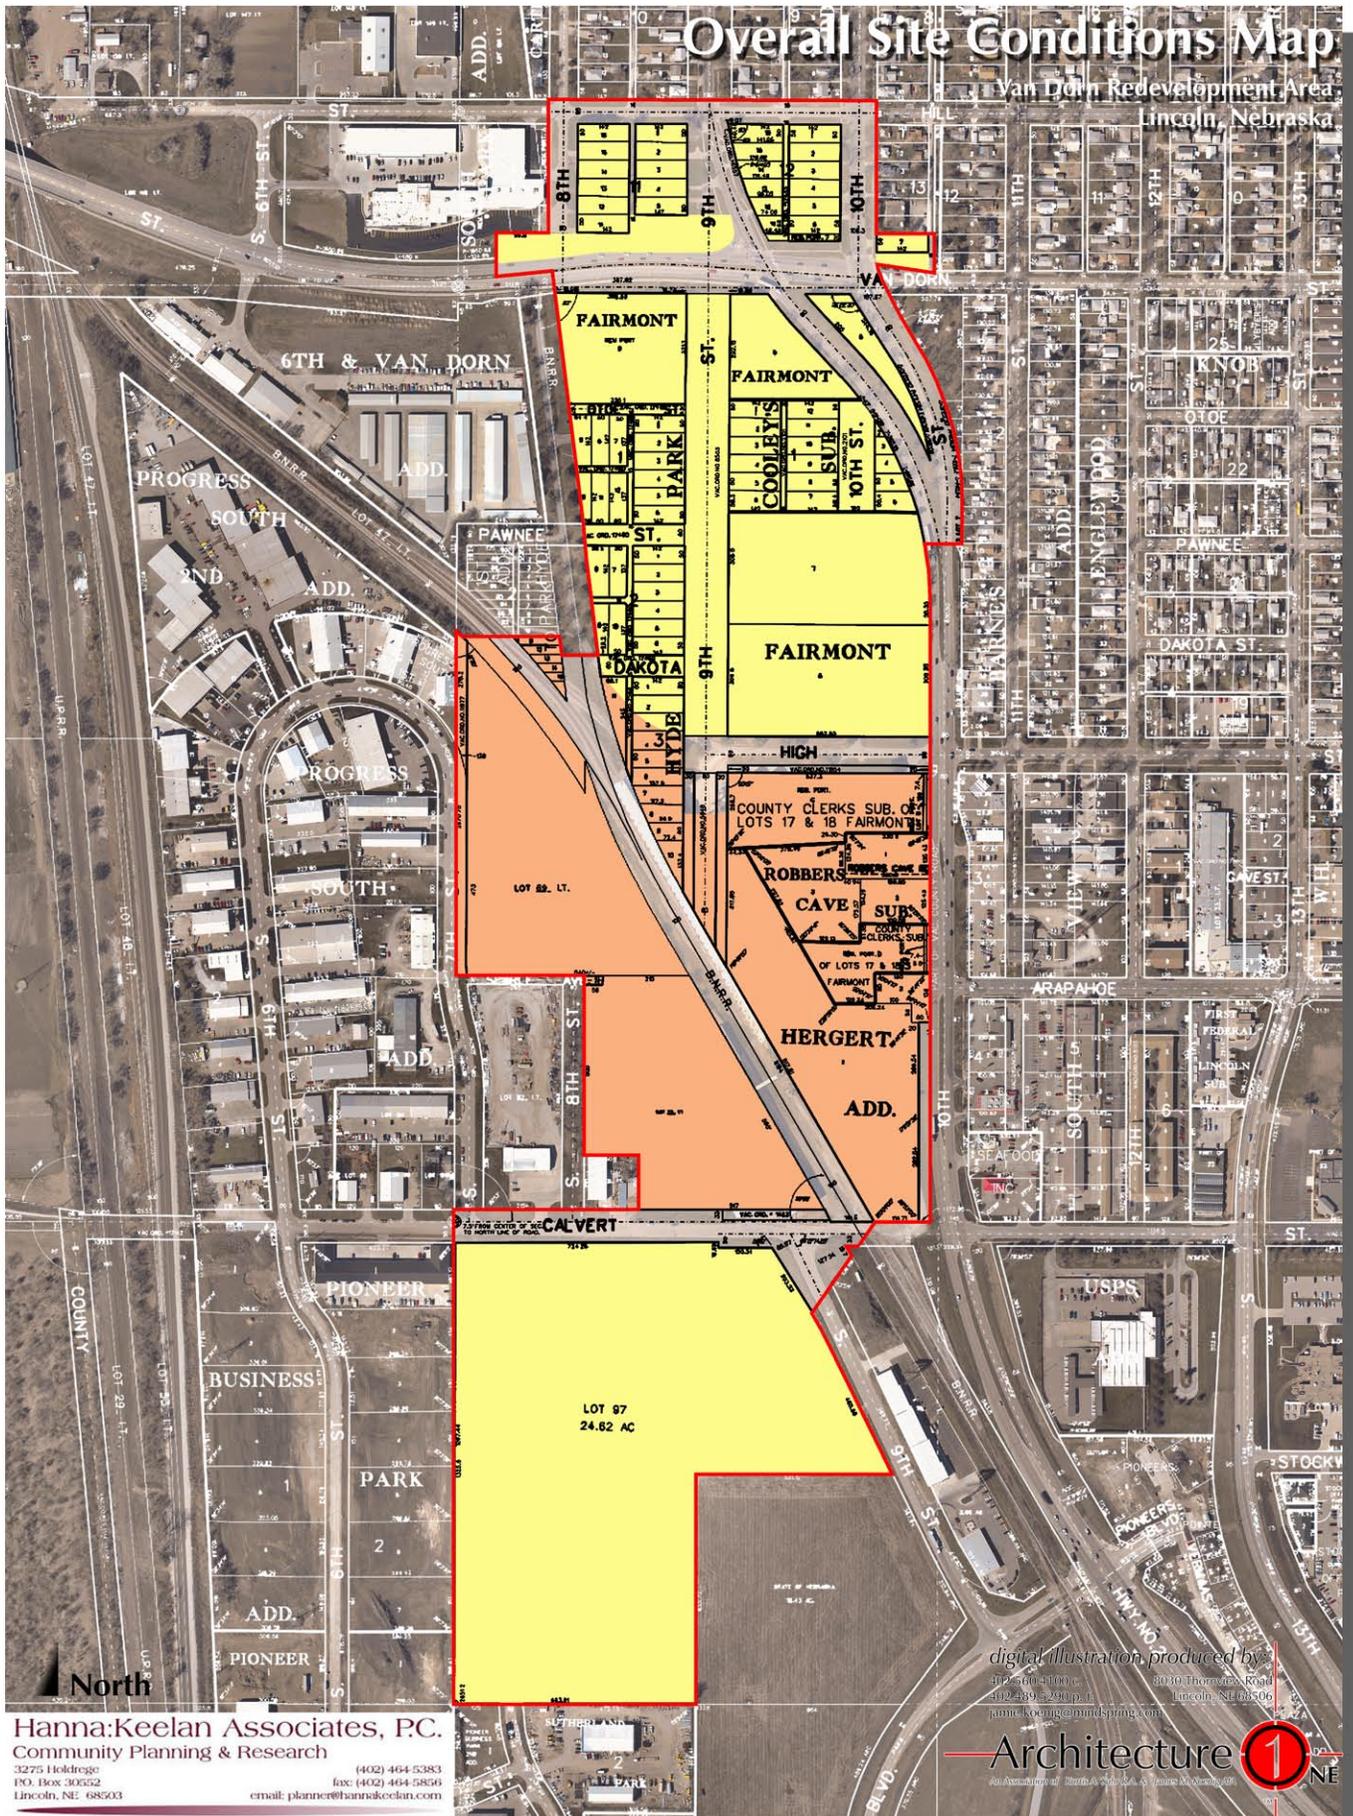
Overall Site Conditions Map

Insanitary or unsafe conditions are strongly present throughout the Redevelopment Area. Contributing Factors include 35 percent of the total 37 parcels having “fair” to “poor” overall site condition and the advanced age of utility mains.

Deterioration of site or other improvements is a reasonable presence throughout the Redevelopment Area. A notable number and percentage of parcels in the Area have “fair” to “poor” overall site conditions. Deteriorating public infrastructure and gravel-surfaced driveways and access roads are also reasonably present in the Area.
