**LINCOLN, NEBRASKA
NORTH 27TH CORRIDOR/
ENTERPRISE COMMUNITY
TARGET NEIGHBORHOOD
STUDY AREA**

**BLIGHT AND SUBSTANDARD
DETERMINATION STUDY
APRIL, 1996**

**PREPARED FOR:
CITY OF LINCOLN**

**PREPARED BY:
HANNA:KEELAN ASSOCIATES,
P.C.**

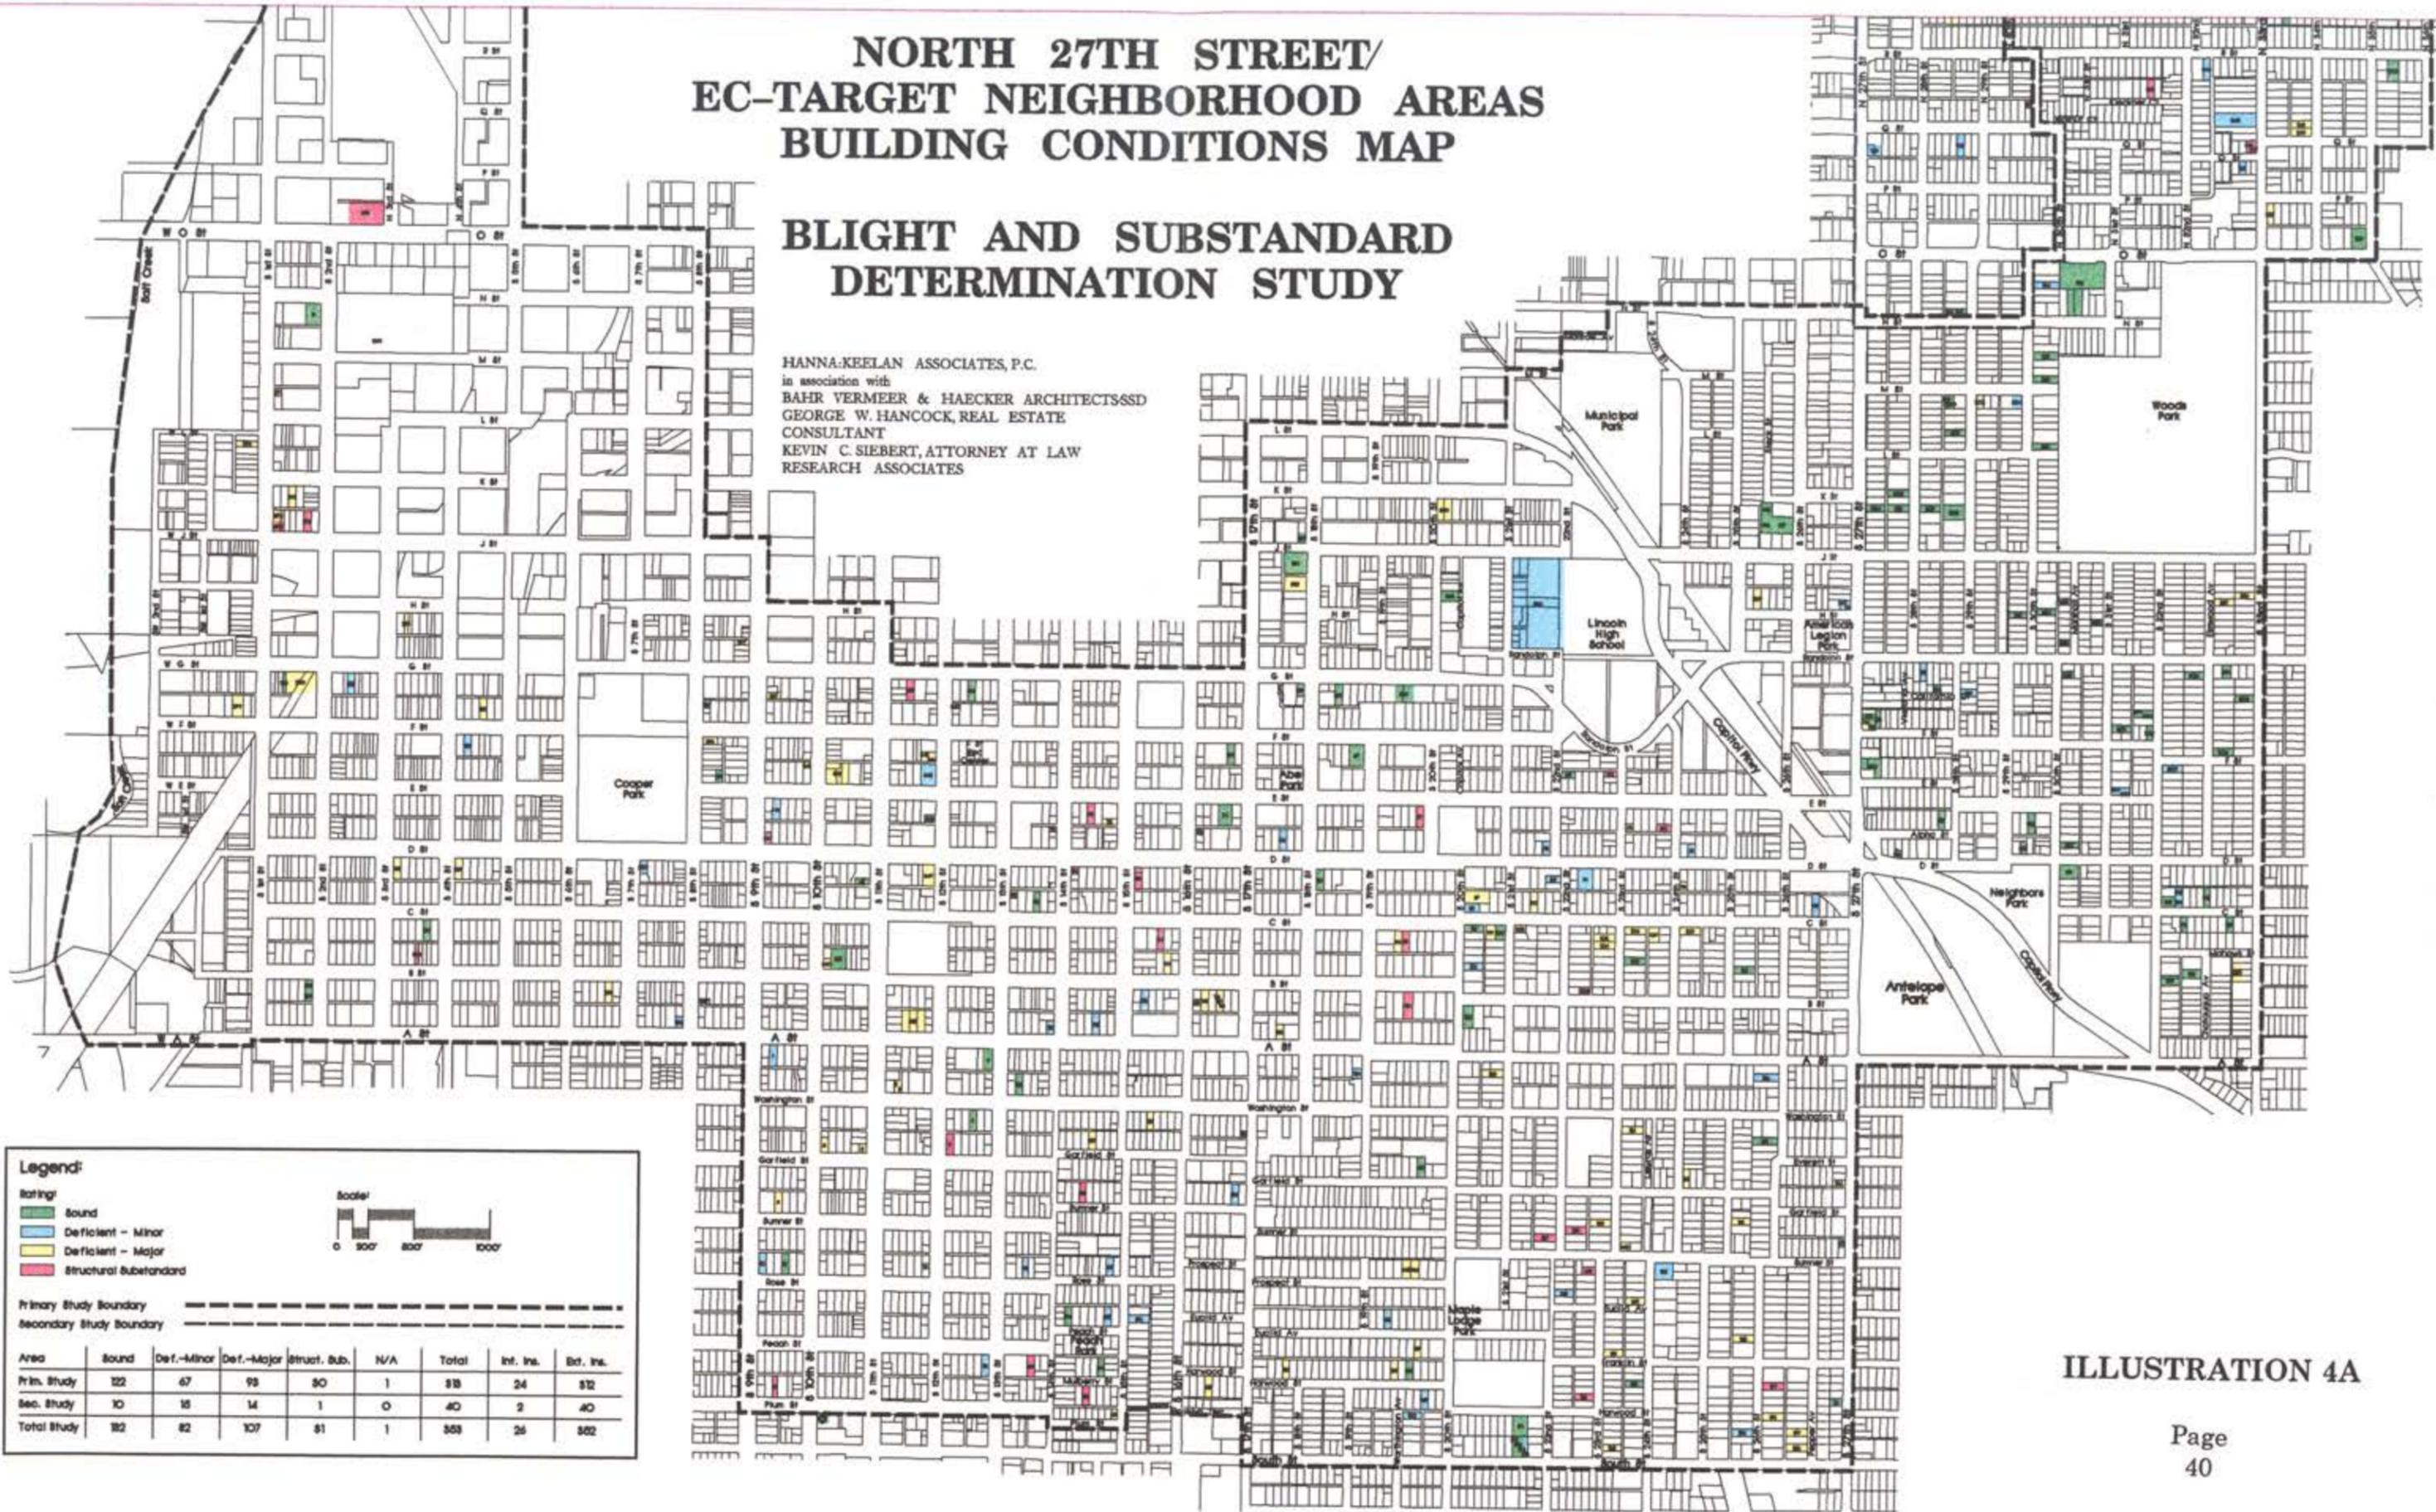
The building condition analysis was based on exterior inspections of 39 existing structures within Study Area #1, 289 existing structures within Study Area #2, and 328 existing structures within the Overall Study Area, to note structural deficiencies in individual buildings and to identify related environmental deficiencies for individual sites or parcels within the Study Areas.

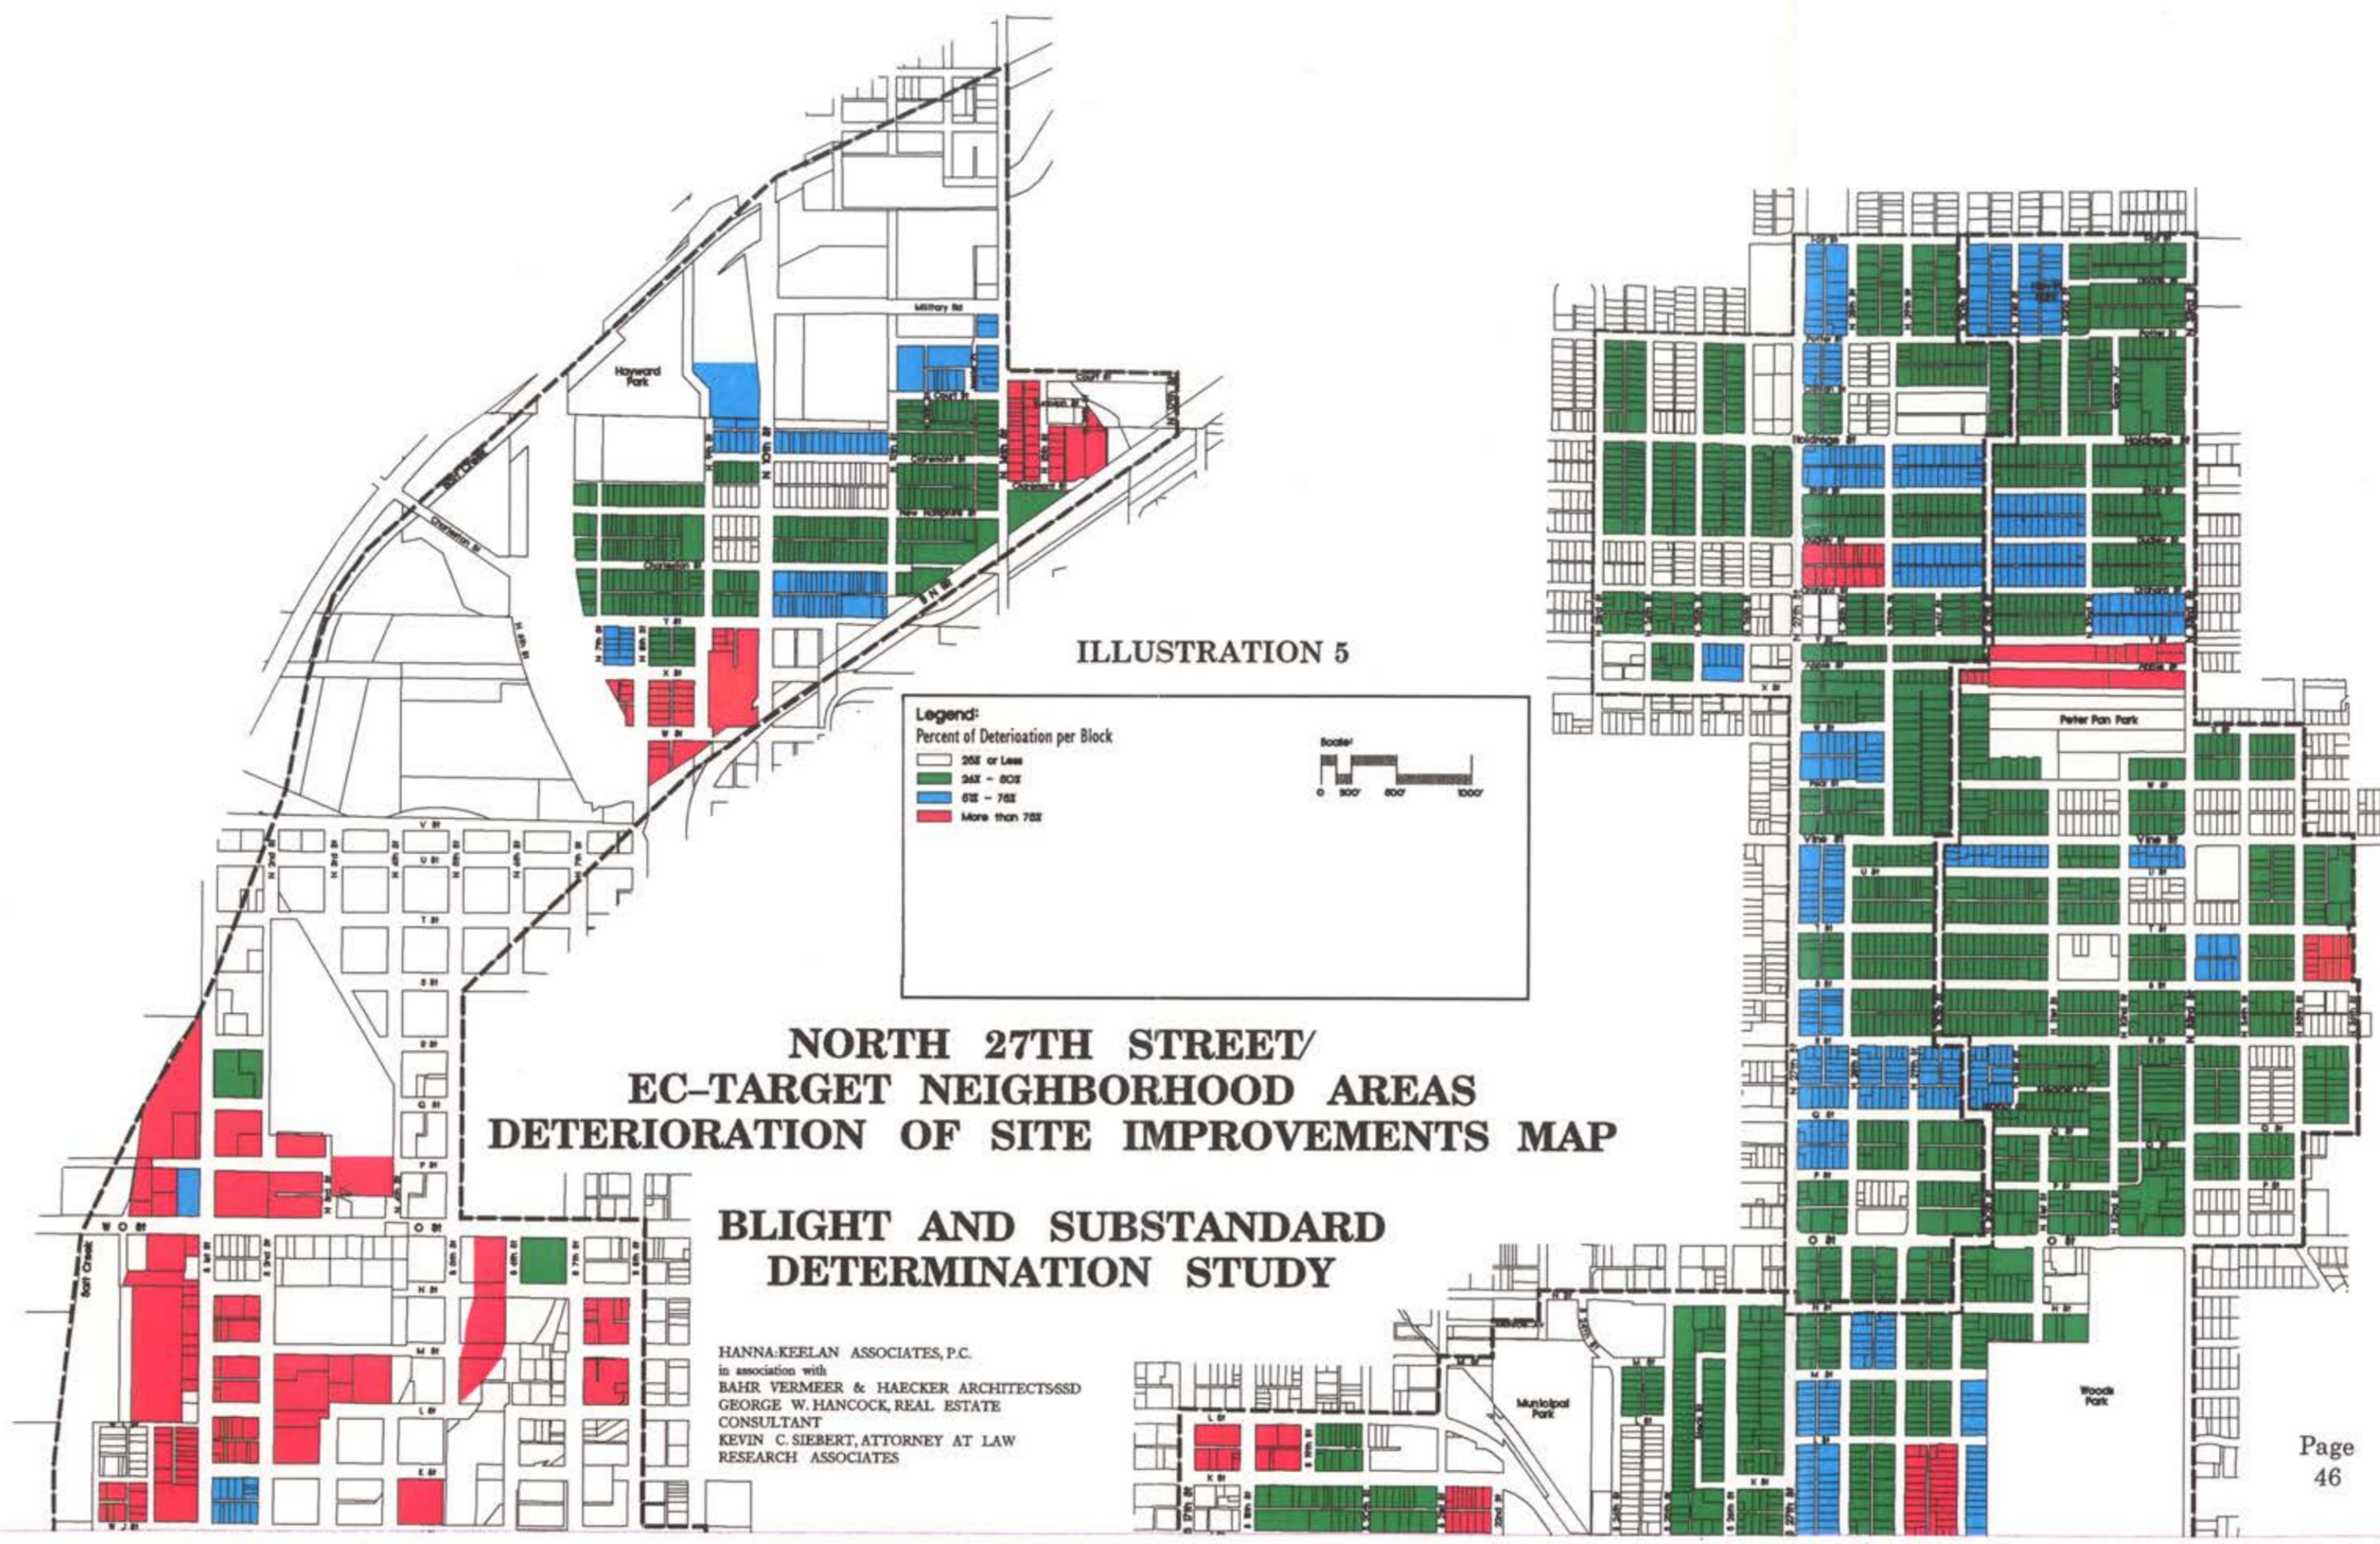
ILLUSTRATION 5

Deterioration of site improvements are strongly present throughout Study Area #2. Significant percentages of parcels in the Area have excessive debris, inadequate overall site maintenance, and unimproved sidewalks and surface parking. Deteriorating infrastructure and inadequate improvements also contribute to the strong presence of this factor.

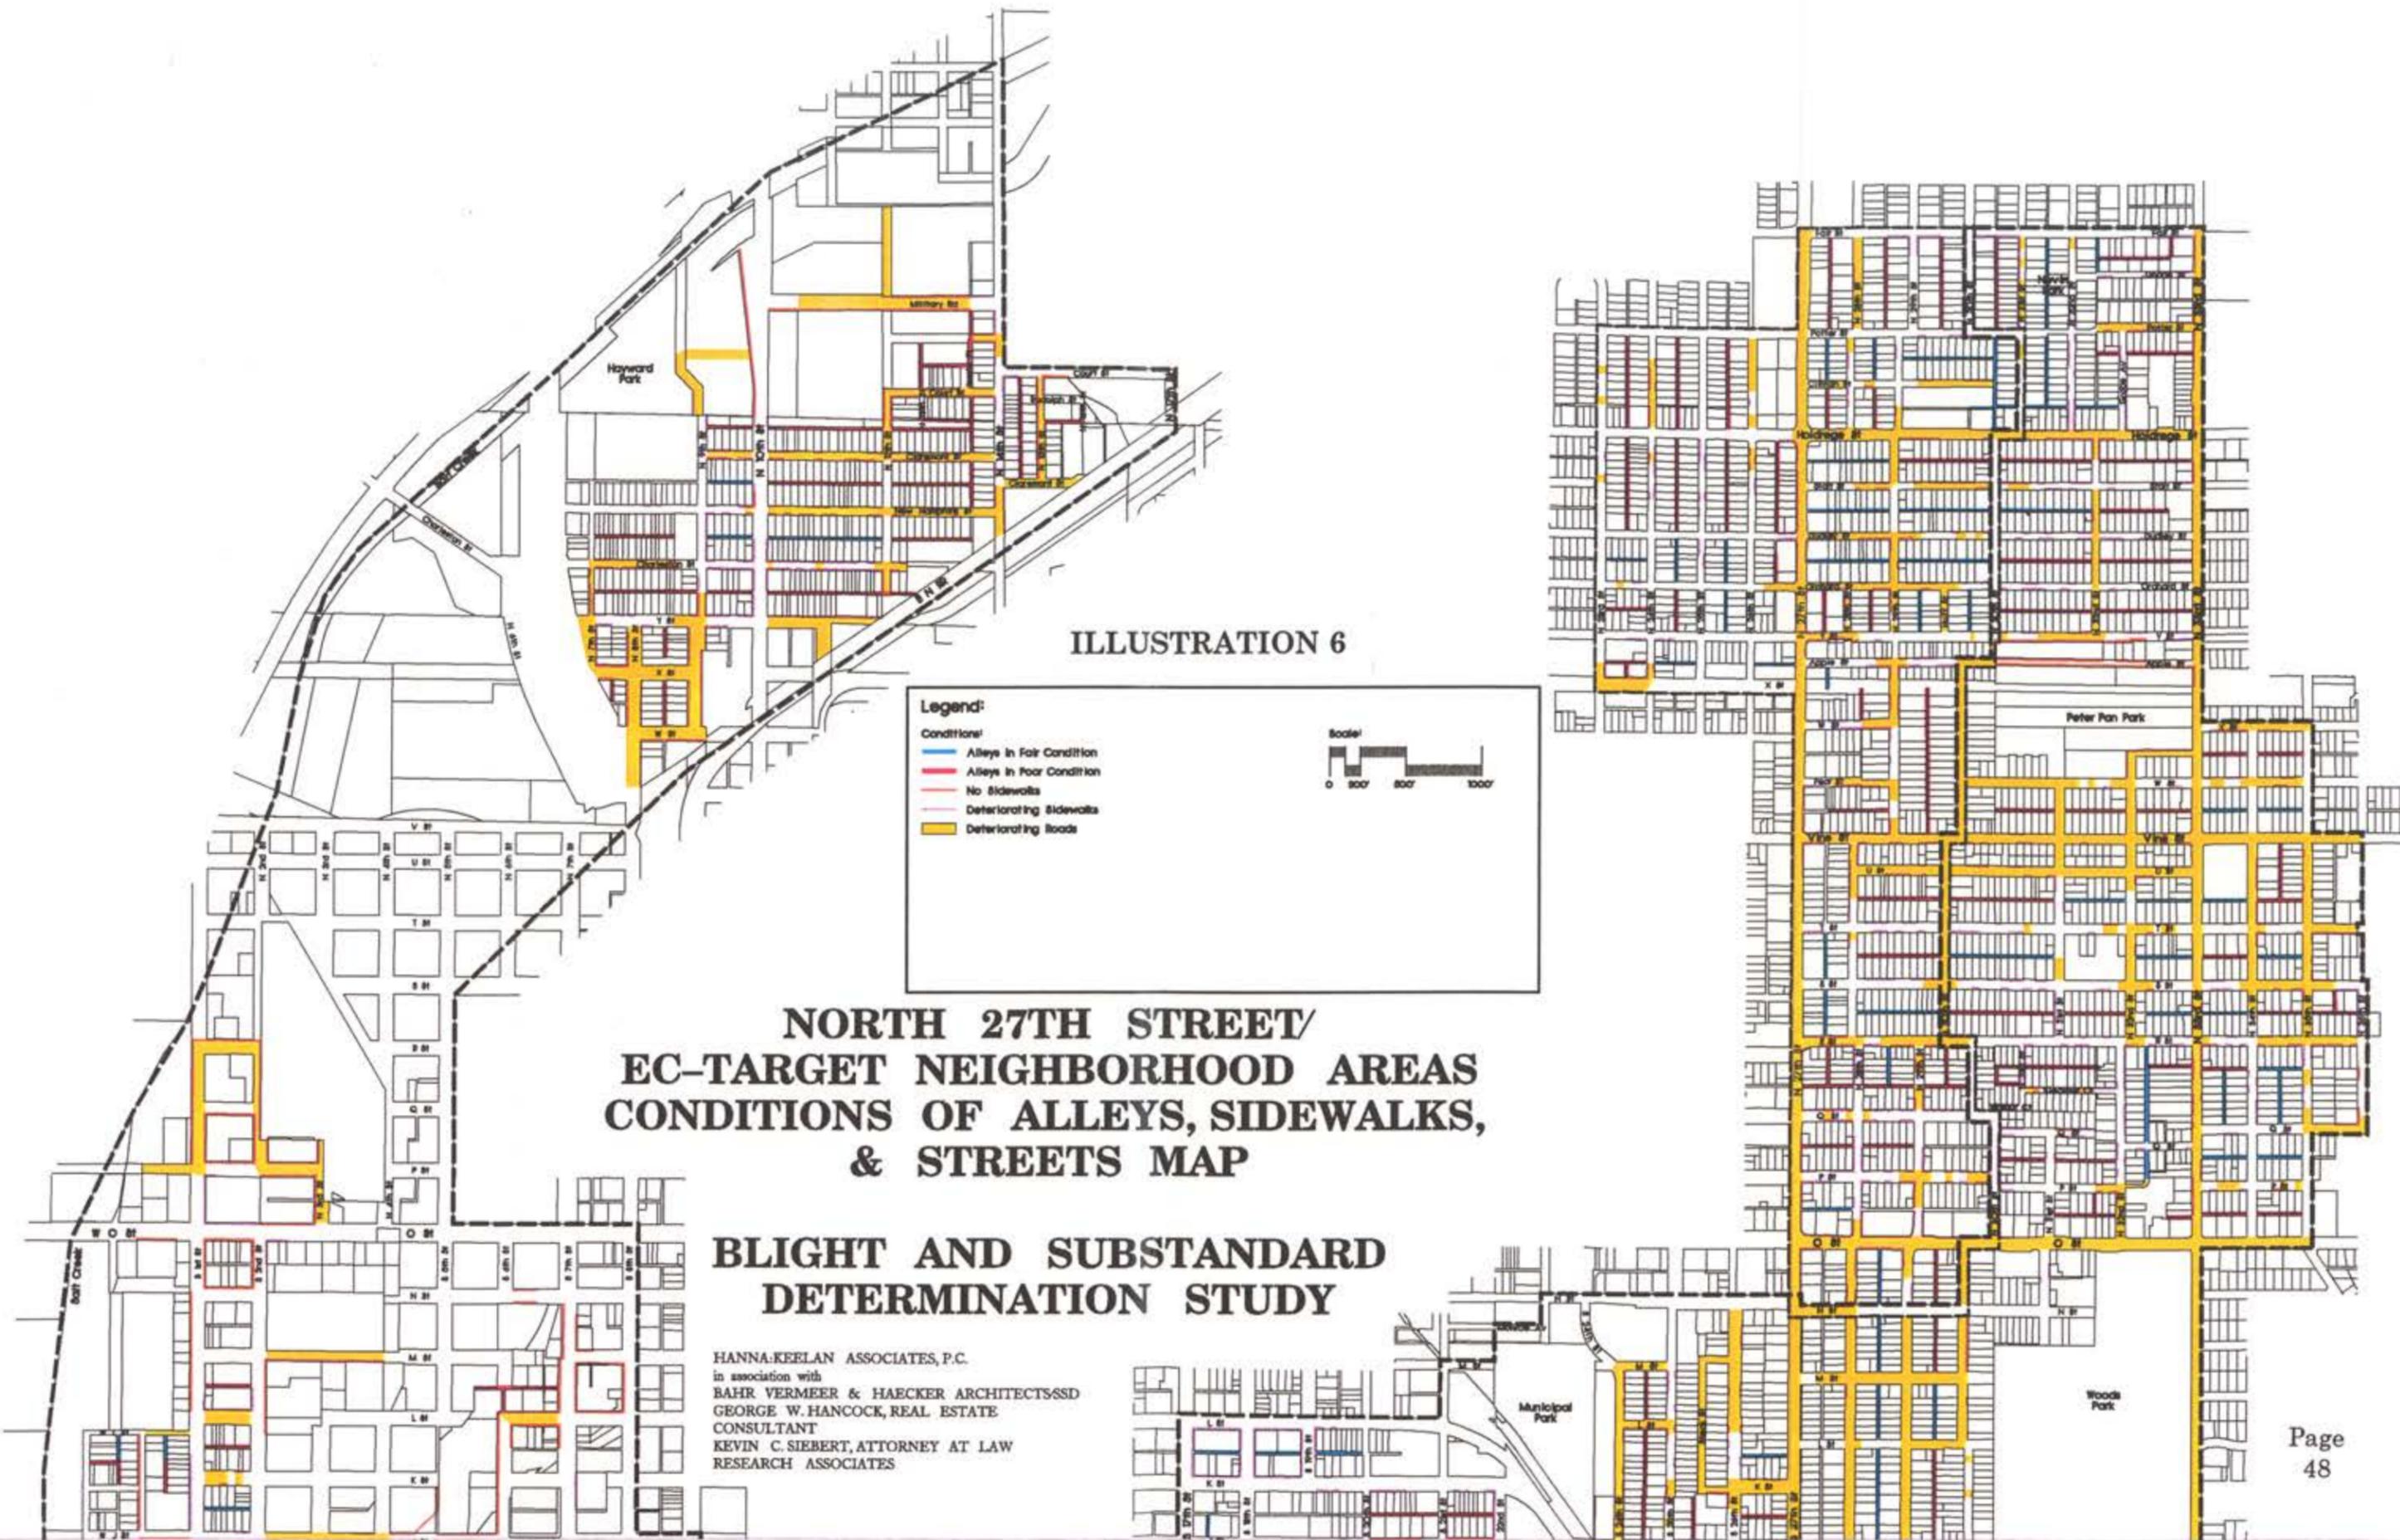
ILLUSTRATION 6

The existence of defective or inadequate street layout is present to a reasonable extent. Contributing factors include unimproved streets, sidewalks, and alleys.

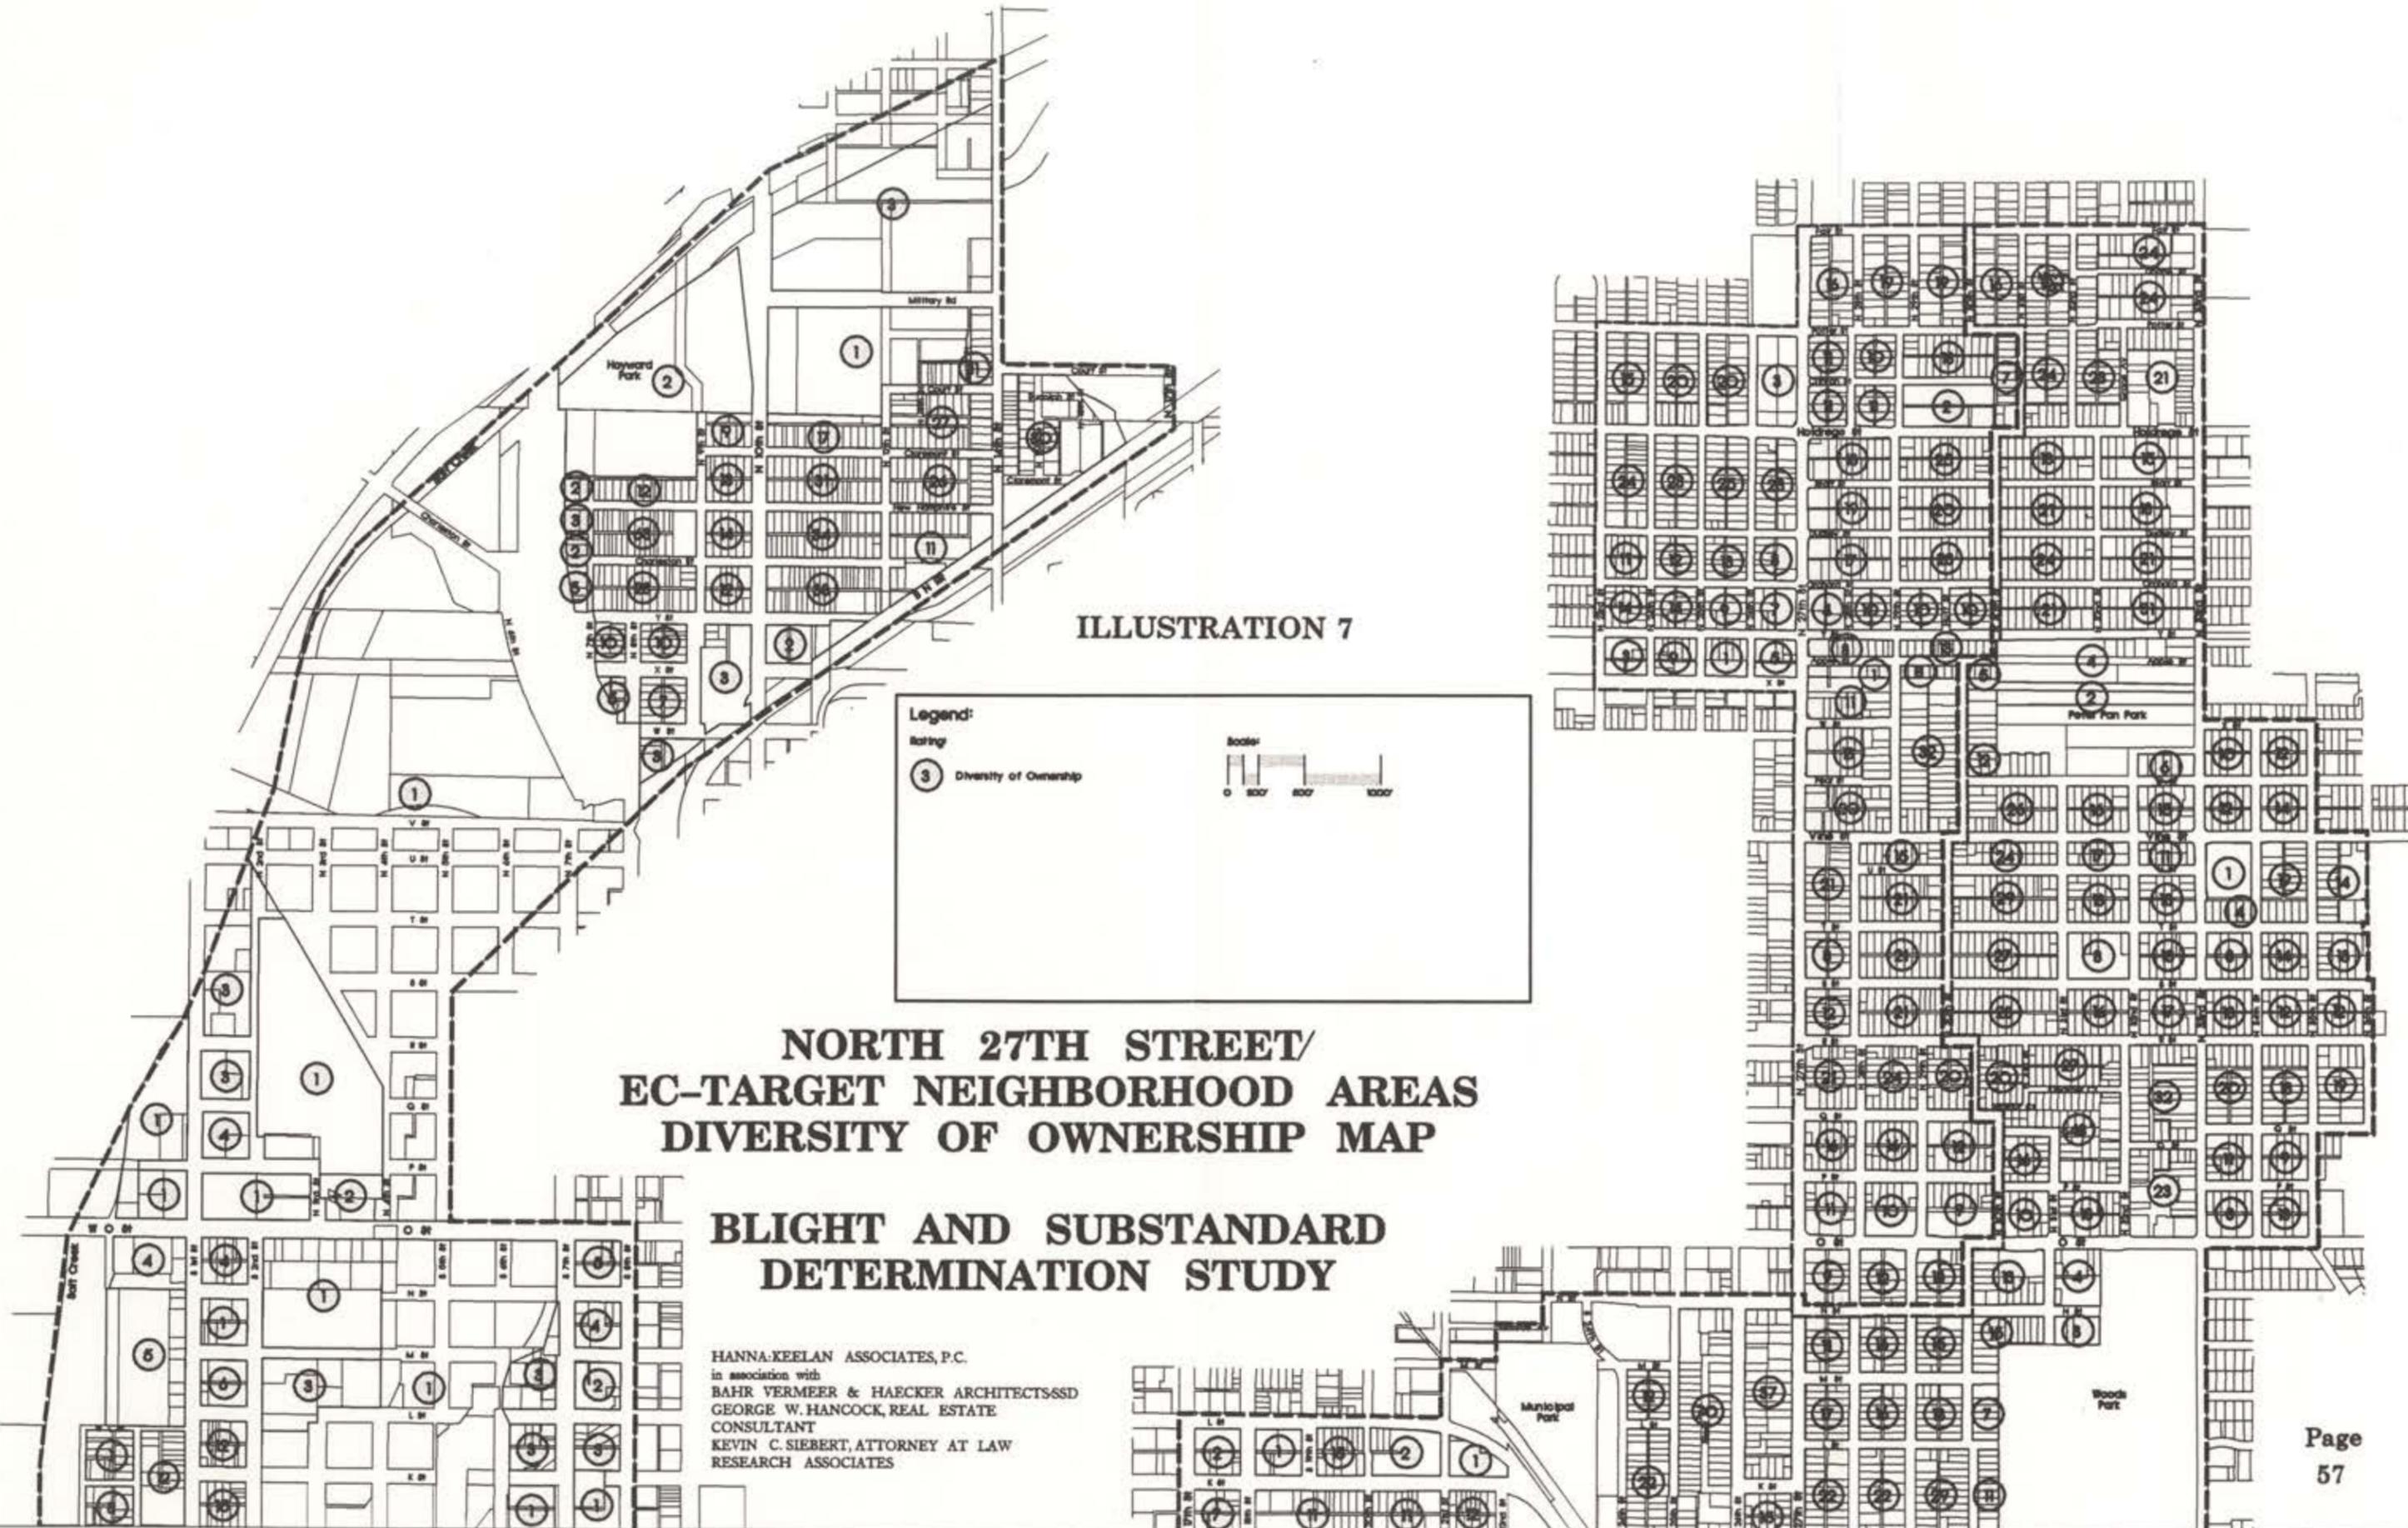
ILLUSTRATION 7

Diversity of Ownership is a strongly present Blight Factor in each Study Area.
