Section 7

Capital Improvement Projects

7.4.1 Project SSC-1: Grade Control Tributary SC005R005

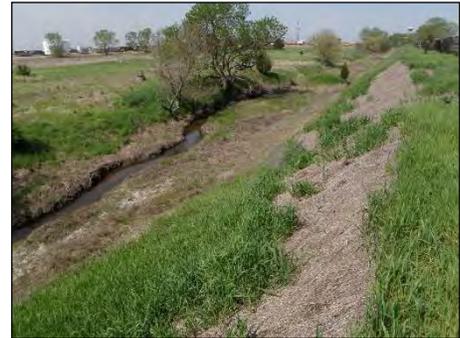
Figure 7-5: Incision in channel

Recommendation: Recommend constructing grade controls along the upper reach at existing knickpoint locations and installing outlet protection below culvert outfalls to maintain the profile grade along this reach and protect the outfall structures.

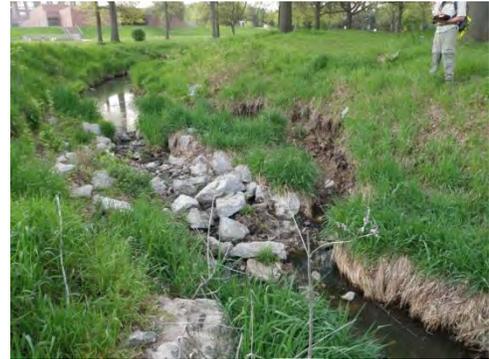
Problem description: Stream incising and plan form adjustment on tributary SC015R015 is threatening Irvingdale Park infrastructure and one residential parcel. An existing rock grade control is failing upstream of the park pedestrian bridge over the tributary and bank erosion is threatening the park trail, one resident and a storm water outfall downstream of the pedestrian bridge.

Figure 7-7: Failing Grade Control

Recommendation: Recommend removing the failed grade control and replacing it with a new rock grade control structure and associated bank stabilization to stop incision and protect the parking lot and the project reach upstream of the pedestrian bridge. Recommend installation of grade controls and bank stabilization measures to protect the residential parcel, park infrastructure and storm water outfall along the project reach downstream of the pedestrian bridge.

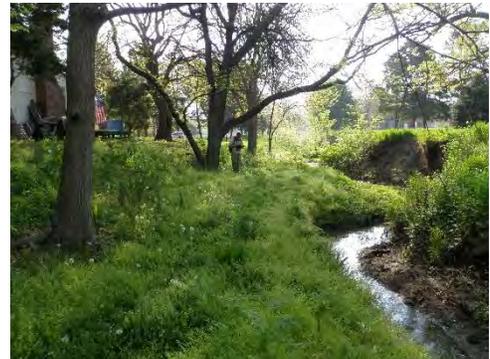
Figure 7-8: Incising channel north of Irvingdale Park

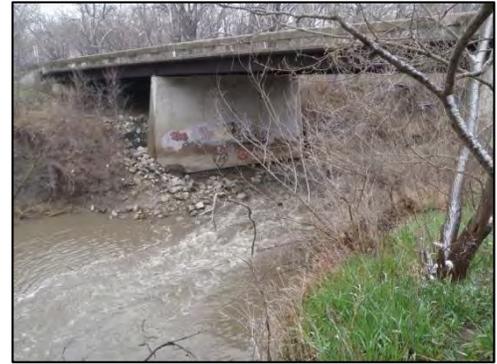
Problem description: An existing rock armored knickpoint in the channel main stem SCR010 at W Pioneers Blvd Bridge (County Structure O-175) over the main stem (Located east of W Pioneer Blvd and S 1st St) is failing. Past incision has exposed the bridge pier foundation and the stream banks downstream of the bridge are eroding.

Figure 7-10: Knickpoint and Exposed Bridge Piers

Recommendation: Recommend constructing a rock grade control and stilling basin with associated bank revetment to protect the bridge piers and channel by preventing the knickpoint from propagating upstream. A USGS stream gauge is installed on the bridge at this location. The designed revetment must not interfere with the operation of the gauge. City GIS contour data indicates the channel flowline at elevation immediately upstream of the knickpoint at the W Pioneers Blvd Bridge is 1,136 feet AMSL.

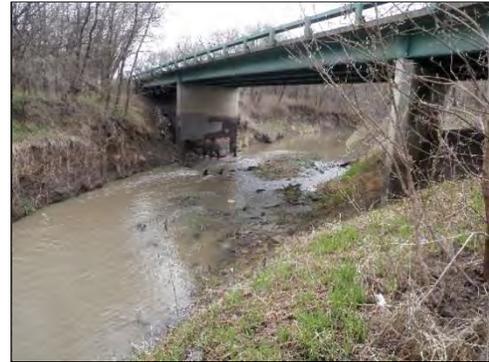
Problem description: A knickpoint on the main stem SCR020 is located at the Old Cheney Rd Bridge (County Structure O-37) west of the Old Cheney Rd and Hunts intersection. Past incision has exposed Old Cheney Rd Bridge piers and the stream banks downstream of the bridge are eroding.

Figure 7-12: Old Cheney Rd Bridge Piers Exposed

Recommendation: Recommend constructing a grade control and stilling basin with associated bank stabilization immediately downstream of the bridge to protect the bridge piers by preventing the knickpoint from propagating upstream. An evaluation of the bridge piers stability and any subsequent structure rehabilitation or replacement necessary to stabilize the structure is also included in this recommendation. City GIS contour data indicates the channel flowline at elevation immediately upstream of the knickpoint at the bridge is 1,146 feet AMSL.

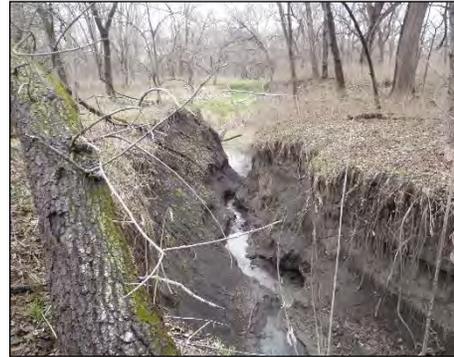
Problem description: Incision and a deep knickzone is actively eroding into the stable upper reach of tributary SC040R005 located approximately 600 feet south of the Old Cheney Rd Bridge over the main stem. The erosion is threatening walking trails in Wilderness Park at this location.

Figure 7-14: Headcut and Knickzone associated with Channel Incision

Recommendation: Recommend constructing a series of grade controls and associated bank stabilization to stop the incision, protect the existing pedestrian trails and upstream reach from erosion, and preserve the upstream natural resources. This project includes construction access from Old Cheney Rd along the park trail and crossing tributary SC035R005. The existing rock grade control at this location on tributary SC035R005 is failing and a new grade control at this location to protect the tributary and facilitate construction access is included in this project. In addition, the access route through wooded areas should vary to avoid a straight clear cut path and to minimize tree removal.

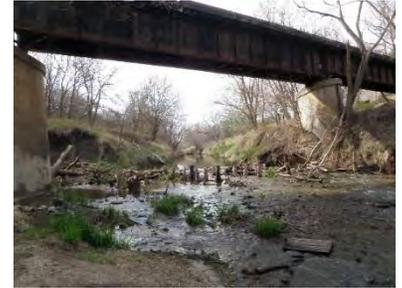
Problem description: There is an existing rock rubble knickzone on the main stem SCR030 at the old railroad bridge located approximately 2,500 feet south of W Denton Rd and 450 feet east of Highway 77. The rubble does not appear to provide reliable stability of the knickzone. Also, incision along tributary SC050R005 is undermining the trail bridge piers and exposing a fiber optic line in channel bed. The bridge is located west of the northwest corner of Lincoln Southwest High School, about 275 feet west of the railroad tracks. MCI plans to lower the exposed cable line and the MCI construction plans are available with the City Parks Department.

Figure 7-16: Knickpoint Downstream of old Railroad Bridge Knickpoint

Recommendation: Recommend constructing a grade control and associated bank stabilization on the main stem at the old railroad bridge to stop incision from propagating upstream. Also recommend grade controls and associated bank stabilization along approximately 150 feet of the tributary at the trail bridge to stop incision and protect the bridge. The tributary project reach should beginning downstream of the bridge and extending to a point upstream of the bridge to the knickpoint in the channel bed where the exposed fiber optic line is/was located in the channel.

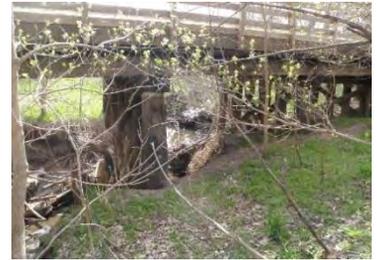
Figure 7-17: Trail Bridge with exposed footings.

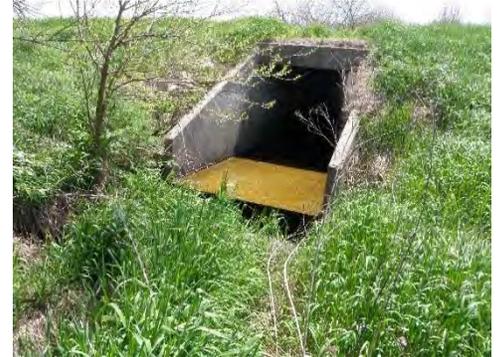
Problem description: The W Rokeby Rd culvert (County Structure O-48) outfall is perched and a debris jam in the tributary SC155R005 approximately 380 feet downstream of W Rokeby Rd is holding up a 2 foot tall knickpoint. The tributary crossing is located east of SW 12th St.

Figure 7-19: Perched Culvert at W Rokeby Rd.

Recommendation: Recommend constructing a stilling basin and grade control with associated bank stabilization at the perched culvert outfall to protect the culvert. The grade control will need to be deep enough to protect against the 2 foot knickpoint downstream of the culvert. Utility markers indicate the location of a pipeline downstream of the W Rokeby Rd crossing that will need to be considered during design and construction.

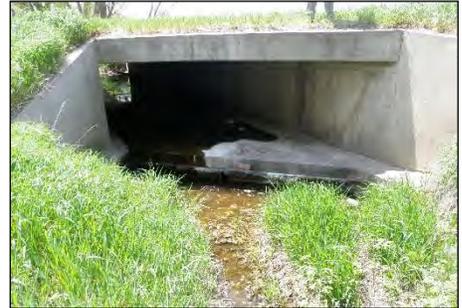
Problem description: The SW 12th St culvert (County Structure O-155) on tributary SC155R005 located 1070 feet south of W Rokeby Rd is perched.

Figure 7-21: Perched SW 12th St culvert outfall

Recommendation: Recommend constructing a stilling basin and grade control at the culvert outfall.

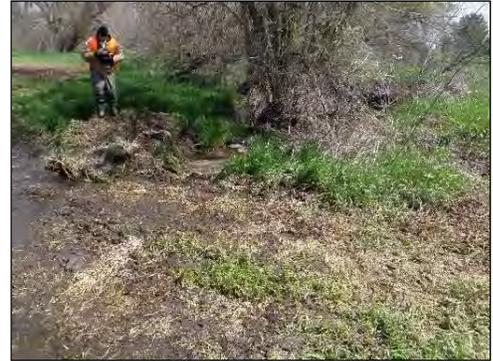
Figure 7-23: Eroding farm crossing holding up knickpoint

Recommendation: Recommend replacing or reinforcing the dirt farm crossing with engineered erosion control and rock structure/grade control to prevent erosion of the crossing and stop the knickpoint from propagating upstream.

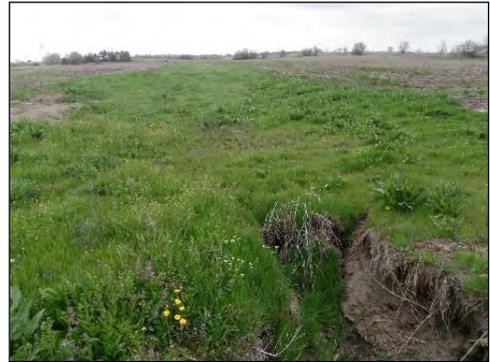
Problem description: A 4 foot tall knickpoint is moving up the tributary SC265R005 located just west of Rokeby Rd and Homestead Expressway.

Figure 7-25: Headcut propagating into field.

Recommendation: Recommend grade controlling the knickpoint and associated bank stabilization to halt propagation of the knickpoint and to protect the upstream tributary. This project is in the location of the new beltway construction, will require access across State ROW and needs to be coordinated with the future South Beltway plans anticipated in 2020

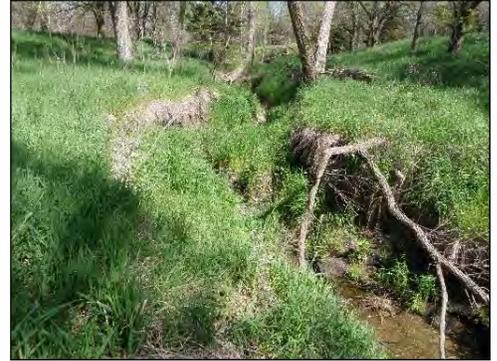
Problem description: A 4 foot tall knickzone in the tributary SC435R005 near the confluence is actively eroding into the un-incised upstream reach. The project is located approximately 1,300 feet west of Homestead Expressway and 2,300 feet north of Bennet Rd.

Figure 7-27: Knickpoint in channel

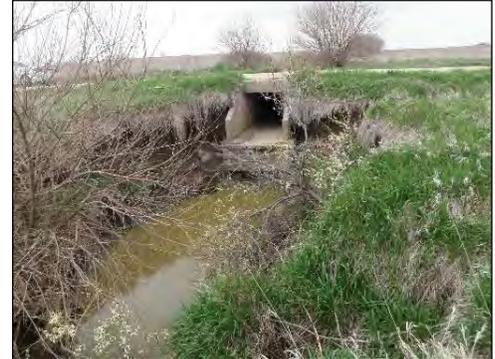
Problem description: The S 1st St culvert (County Structure O-204) is perched at the tributary SC365R005 crossing located approximately 1,150 feet south of Rokeby Rd.

Figure 7-29: Perched S 1st St Culvert

Recommendation: Recommend constructing a grade control, stilling basin and associated bank stabilization to protect the S 1st St culvert.

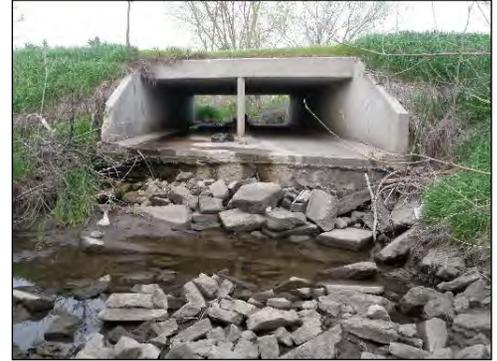
Figure 7-31: Perched S 1st St culvert

Recommendation: Recommend removing dumped rubble and constructing a grade control, stilling basin and associated bank stabilization to protect the S 1st St culvert. This project will be a joint City, NRD and State (NDOR) project and will need participation of all entities.

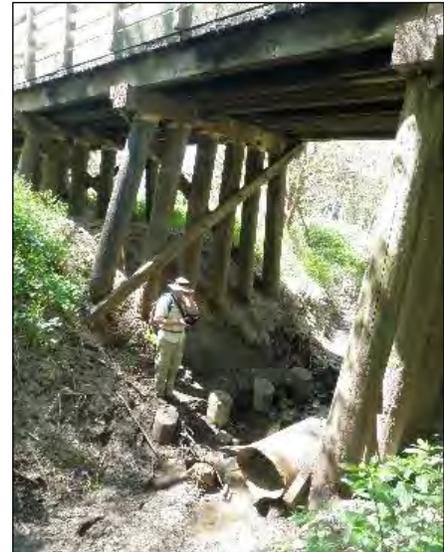
Figure 7-35: Knickpoint Beneath Trail Bridge

Recommendation: Recommend constructing grade control and associated bank stability to stop incision and protect the trail bridge.

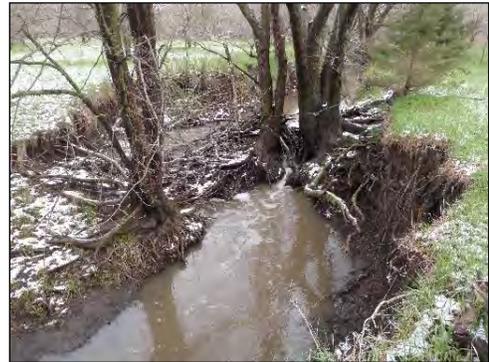
Problem description: Existing tree root mass is holding up a 3 foot knickpoint on Wagon Train main stem WTR005 approximately 1,950 feet upstream of Wittstruck Rd between S 82nd St and S 96th St. At this location, the main stem is approximately 37 feet from an adjacent tributary and this tributaries flowline is approximately a foot deeper than the flowline of the main stem. Continued incision, potential lateral migration and flowline elevations of the tributary present the potential that the main stem may erode to the tributary and subsequently flow down the tributary.

Figure 7-37: Root mass holding up 3 foot knickpoint on main stem

Recommendation: Recommend constructing a grade control and stilling basin with associated bank stabilization immediately downstream of the root mass to stop the incision and protect the channel.

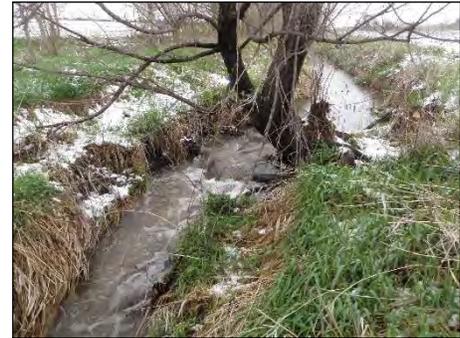
Figure 7-41: 1 foot knickpoint held up by tree roots

Recommendation: Recommend installing a grade control and associated bank stabilization immediately downstream of the tree to stop incision and protect the upstream reaches.

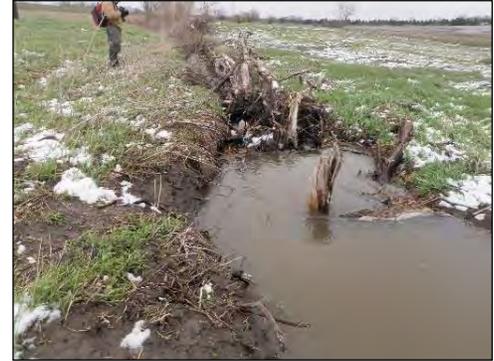
Figure 7-43: Debris jam holding up knickpoint

Recommendation: Recommend removing the debris jam and installing a grade control and associated bank stabilization to stop incision and protect the upstream reaches.

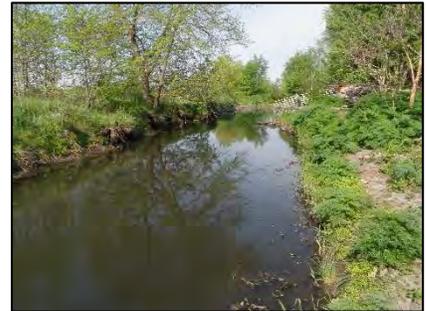
Project Description: A resident has constructed a dam across the tributary SC015R005 located 950 feet upstream of W South St and 200 feet west of S 1st St.

Figure 7-47 – SC015R005 upstream of the dam

Recommendation: Notify the appropriate agency of violation.

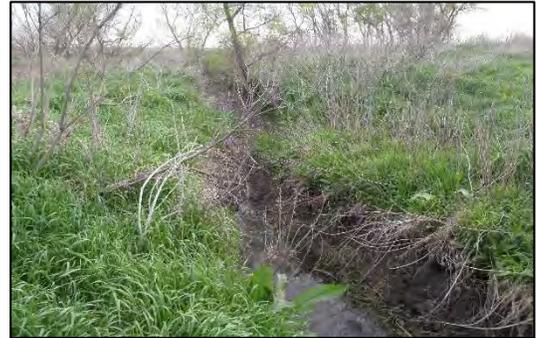
Problem description: A farm crossing is holding up a 3 foot knickpoint on the tributary SC165R005 south of Rokeby Rd approximately 1800 feet west of Homestead. There is an advancing knickzone approximately 5 feet high downstream moving toward crossing.

Figure 7-53 – incised channel reach

Recommendation: Monitor for knickpoint advancement during next CIP cycle.

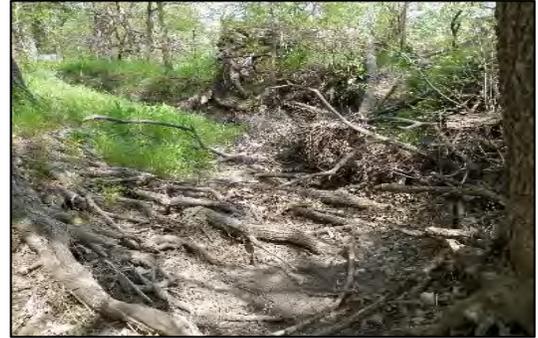
Problem description: The channel downstream of this reach is incising with an active knickpoint located at the edge of the field 50 feet to the east of the S 25th St culvert (County Structure T-22). Tributary SC080R005 is located 1,800 feet north of Bennet Rd.

Figure 7-55 – Incised channel reach

Recommendation: Monitor knickpoint advancement in future CIP.

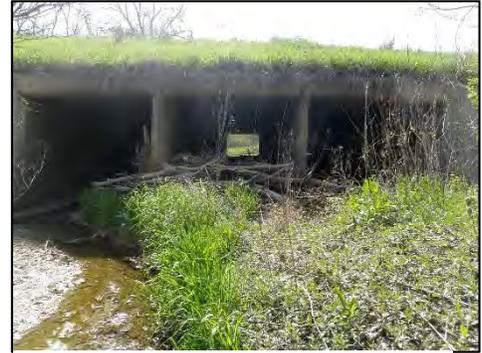
Problem description: Hydraulic analysis based on available hydrologic and as-built data, indicates that roadway overtopping will occur at the S 54th St culvert (S86) on tributary SC097R010 during a 100-year flow event. Roadway overtopping at this location could be eliminated if the culvert capacity is increased. The channel capacity at this locations is sufficient to convey flood flow without overtopping the roadway.

Figure 7-60 – S 54th St culvert

Recommendation: Conduct further evaluation of the culvert crossing to augment prioritization for culvert replacement.

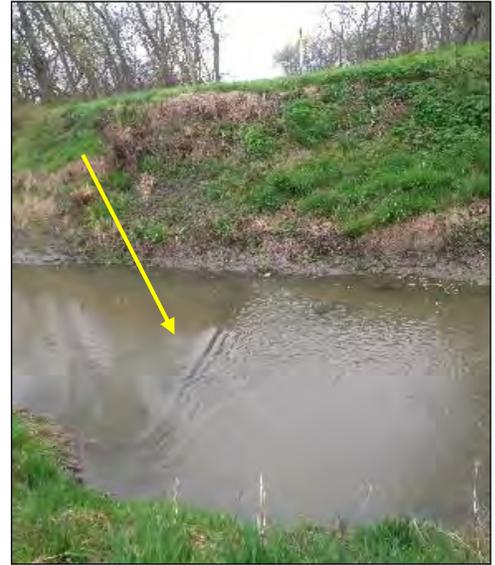
Figure 7-74: Petroleum pipe exposed in bed

Recommendation: Recommend grade control downstream of pipe crossing to raise the channel gradient and protect the pipe.

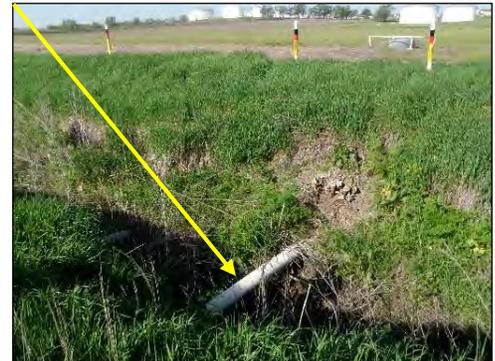
Figure 7-76: Pipe exposed in bed

Recommendation: Recommend either deepen pipes and grade control, or grade control to raise grade and protect pipes.

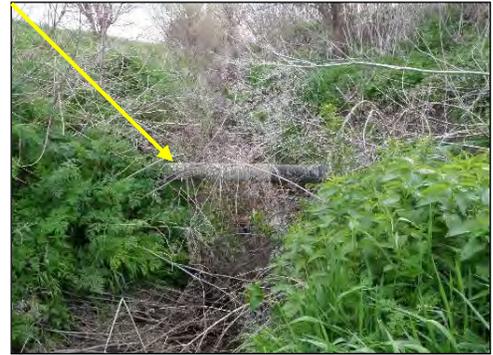
Figure 7-78: Petroleum pipe exposed in bed

Recommendation: Recommend deepen pipe and grade control or grade control to raise grade. The pipe is currently an aerial crossing 4 feet above the channel bed.

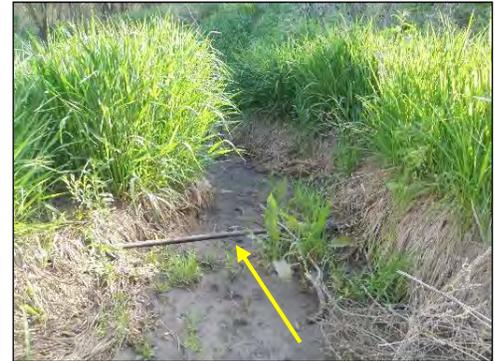
Figure 7-80: Natural gas pipe exposed in bed

Recommendation: Recommend lowering the pipe and installing a grade control or alternatively installing a grade control to raise the channel gradient and protect the pipe. Additional grade controls should also be constructed to protect the Rokeby Rd.

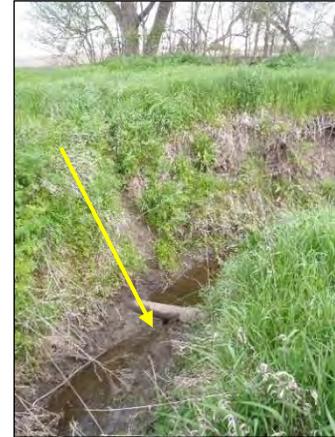
Figure 7-82: Petroleum pipe exposed in channel

Recommendation: Recommend grade control to raise grade and protect pipe or lower pipe and grade control.

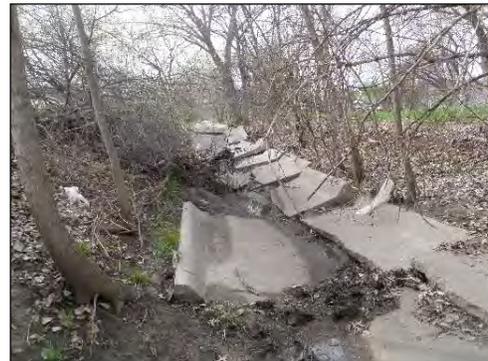
Figure 7-84: Broken up and deteriorated concrete channel

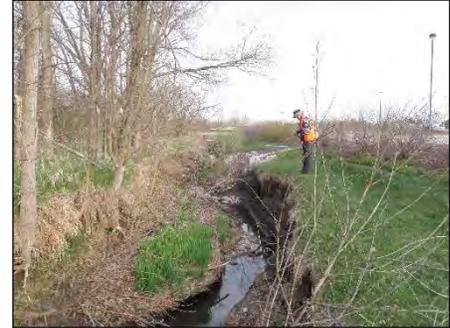
Figure 7-86: Bank Erosion and Incision Upstream of Warlick Blvd
