LINCOLN, NEBRASKA

YOLANDE AVENUE REDEVELOPMENT AREA

BLIGHT AND SUBSTANDARD DETERMINATION STUDY

MARCH, 2011

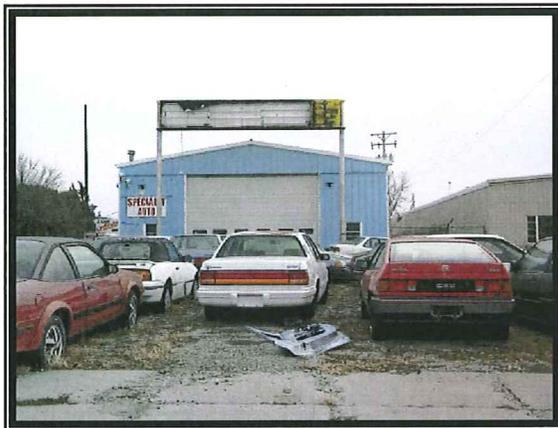
Yolande Avenue street condition.

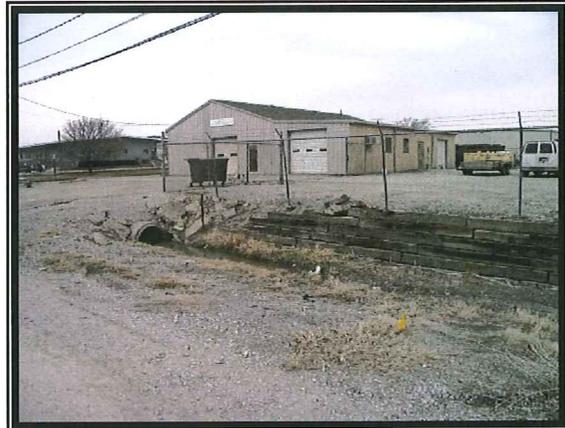
North 20th Street condition.

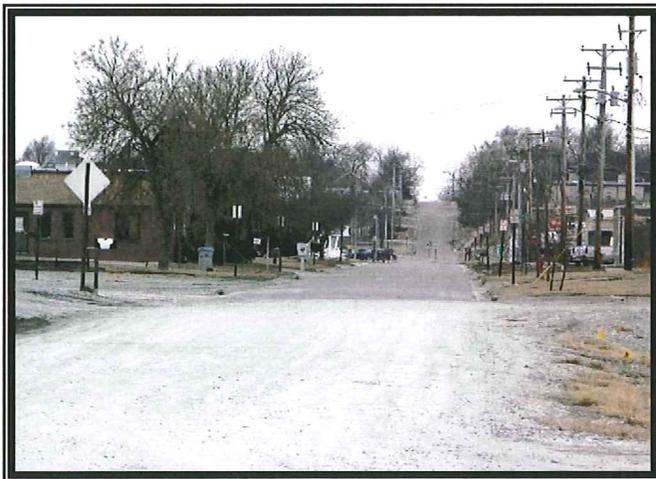
Defective or inadequate street layout was strongly present in the **Redevelopment Area**. This **Factor** relates to streets in “fair” to “poor” condition and the lack of public sidewalks.

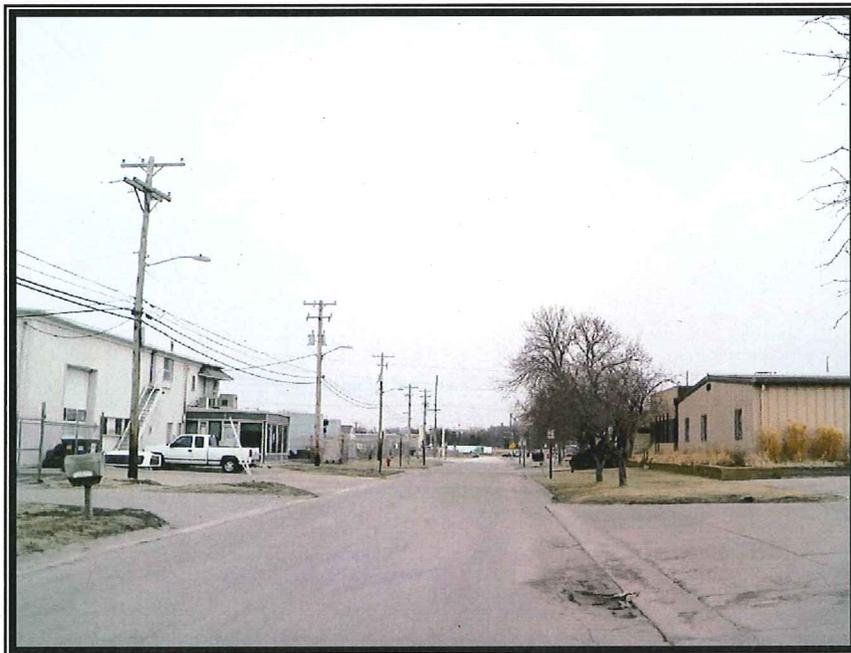
Existing land uses within the **Yolande Avenue Redevelopment Area** are identified in **Illustration 2.**

Major land uses in the **Yolande Avenue Redevelopment Area** included commercial and industrial uses. The **Redevelopment Area** contains an estimated 96.6 acres, of which approximately 75.3 acres have been developed. Concentrations of industrial uses are located either side of Yolande Avenue throughout the **Redevelopment Area**, generally between North 14th and North 24th Streets, south of Cornhusker Highway.

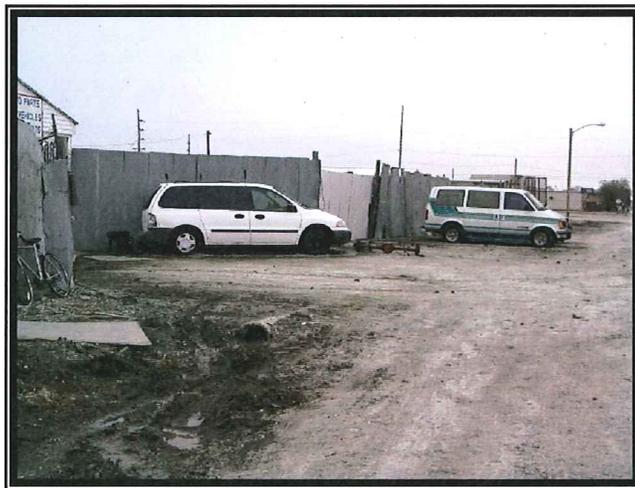
OVERALL SITE CONDITION MAP YOLANDE AVENUE REDEVELOPMENT AREA LINCOLN, NEBRASKA

Deterioration of site improvements was present to a strong extent in the Redevelopment Area.

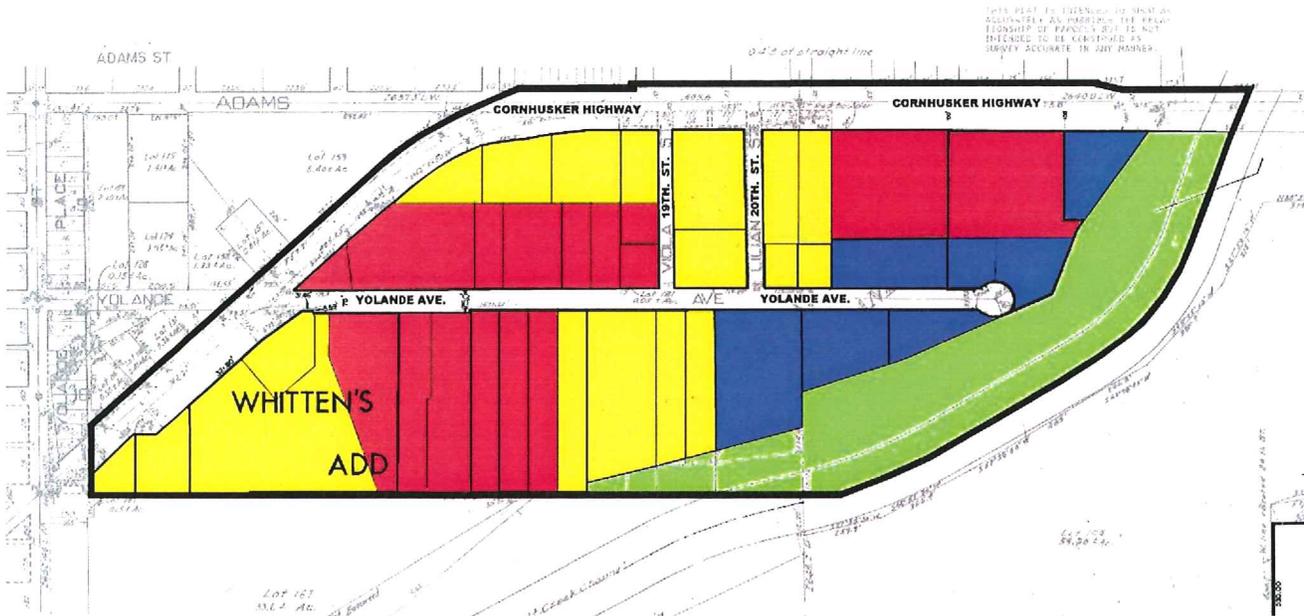
A parcel-by-parcel Field Survey was conducted in the month of March, 2011. A total of **48 separate parcels** were inspected to identify land use type, street, sidewalk, driveway and overall site conditions. **Illustration 4** depicts the results of the analysis. The Site Condition Survey Form is included in the **Appendix**, with the results also in the **Appendix**.

The parcel-by-parcel field survey identified a total of 18, or 37.5 percent of the total 48 parcels as possessing "fair" overall site conditions. Additionally, 13, or 27.1 percent of the total 48 parcels were identified as being in "poor" condition. **This represented a combined total of 64.6 percent, or 31 of the total 48 parcels as being in "fair" or "poor" condition.** The combination of overall site condition and structures that are deteriorating or dilapidated indicates that both public and private property improvements are needed throughout the **Redevelopment Area**.
