Section I
BASIN EVALUATION

Beal Slough Basin Stormwater Master Plan

BEAL SLOUGH MASTER PLAN

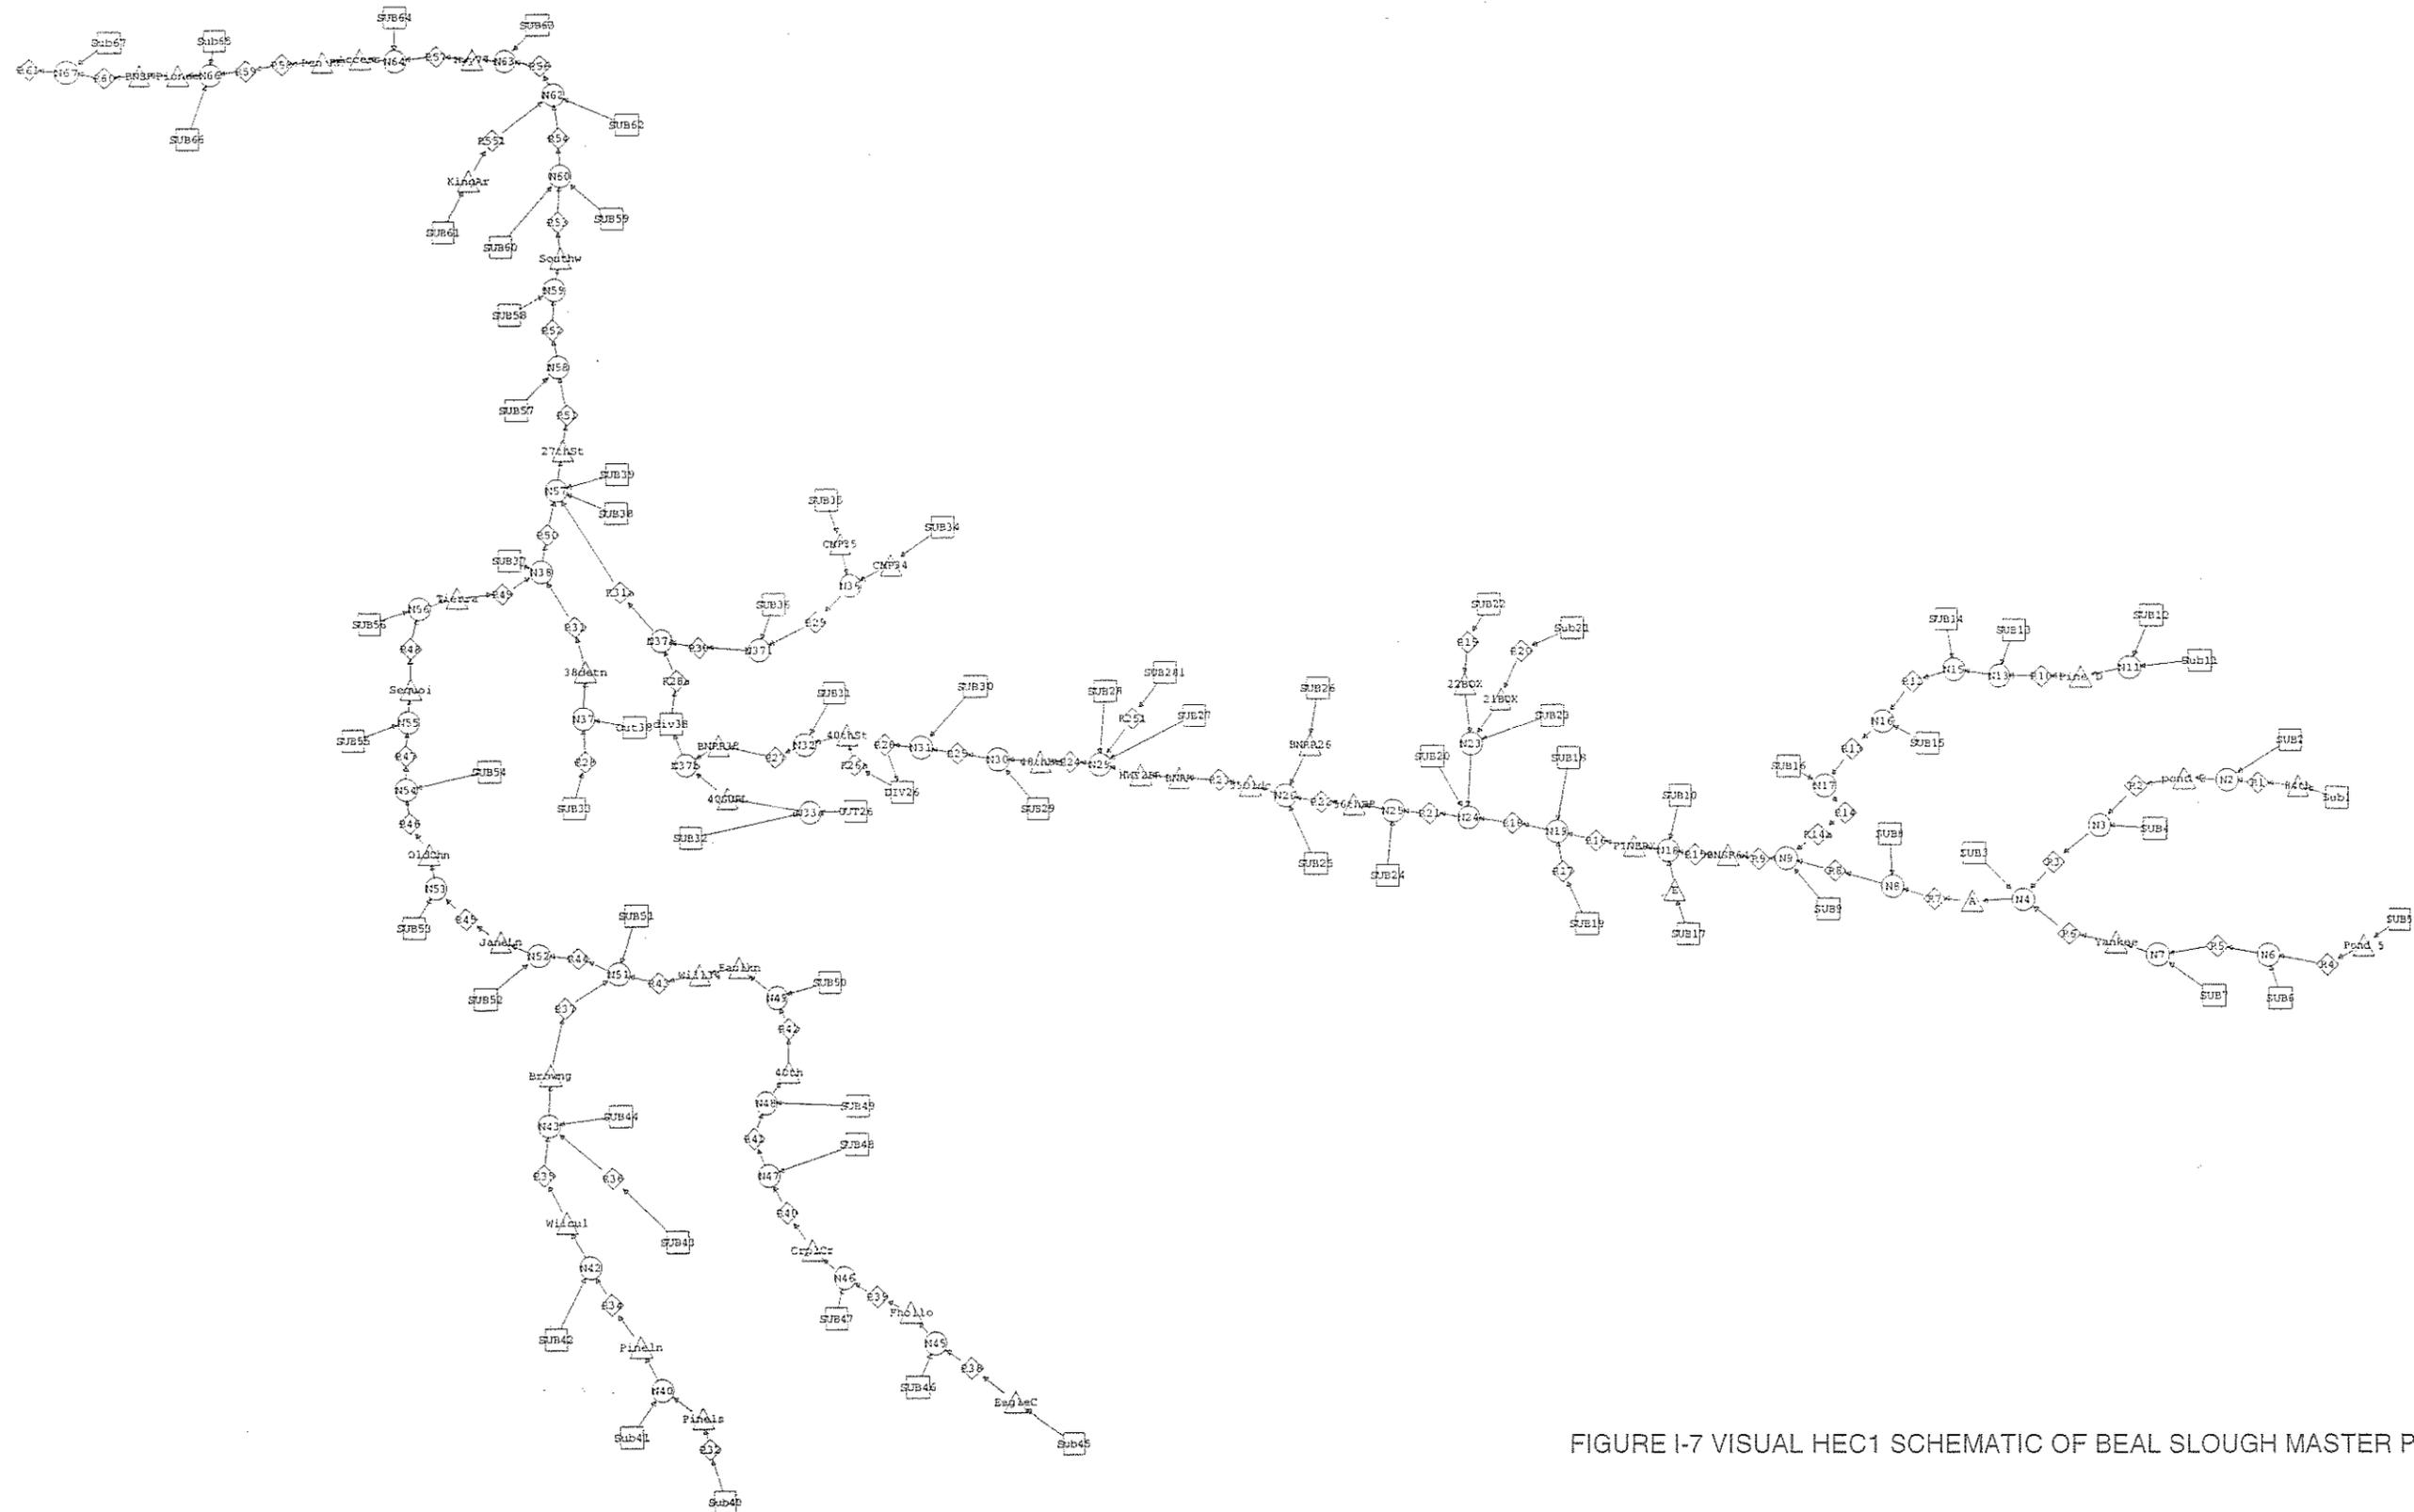
FIGURE I-7 VISUAL HEC1 SCHEMATIC OF BEAL SLOUGH MASTER PLAN MODEL

The runoff from each subbasin is represented by a unit hydrograph. "A unit hydrograph is the direct runoff from a unit depth of excess rainfall produced by a storm of uniform intensity and specified duration" (from Handbook of Hydrology, by David R. Maidment, pg 9.26). The unit hydrograph and excess rainfall are combined to form a runoff hydrograph and the runoff hydrographs from each subbasin are routed through the reaches and combined to form a complex hydrograph at each point of interest. The complex hydrographs for 1997 and projected future conditions can then be compared and used to evaluate the effectiveness of proposed stormwater management practices. A schematic outline of model components shows the sequence in which components are combined, see Figure I-6.

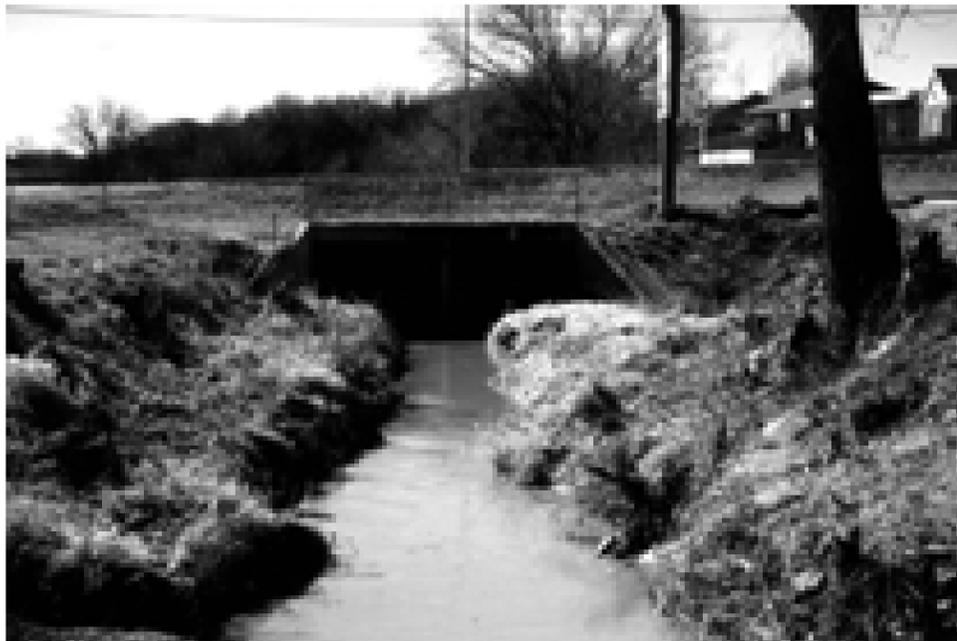
Photograph 10. Looking upstream at the box culvert under Old Cheney Road near 55th Street.

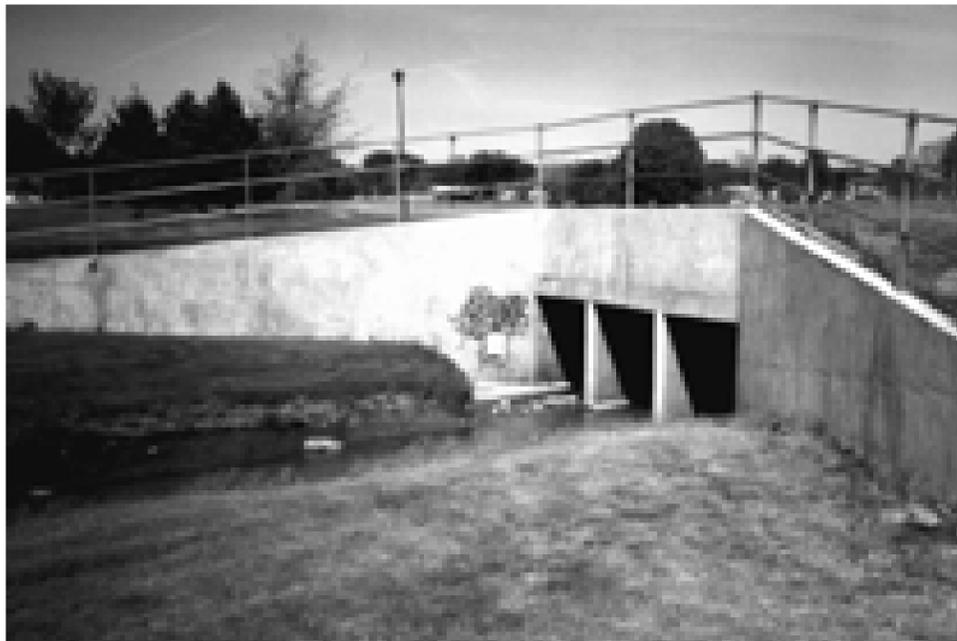
Photograph 17. Looking at the box culvert inlet under Tierra Drive.

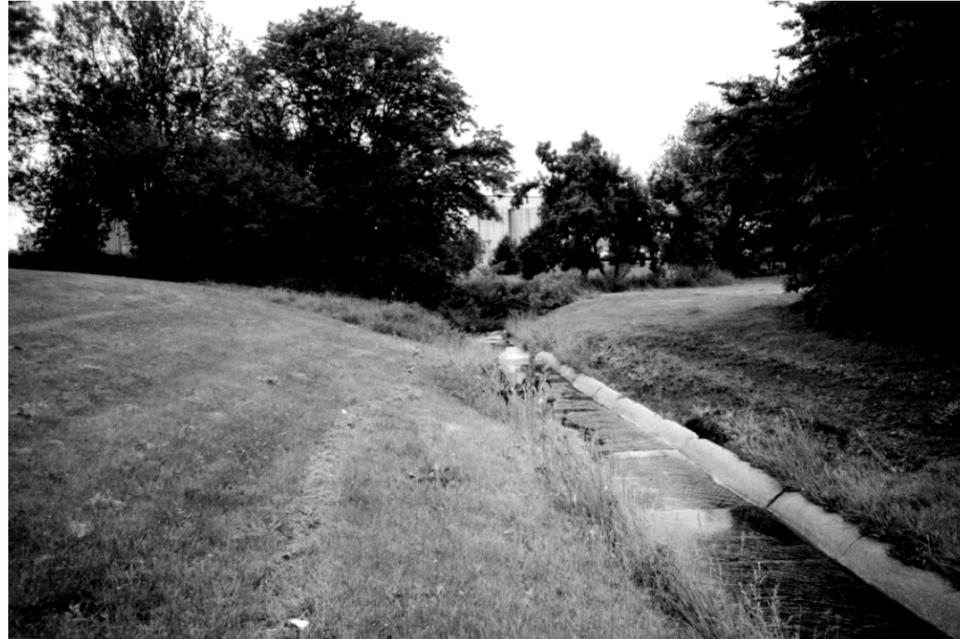
Photograph 24. Looking southwest at terminus of concrete low flow liner.

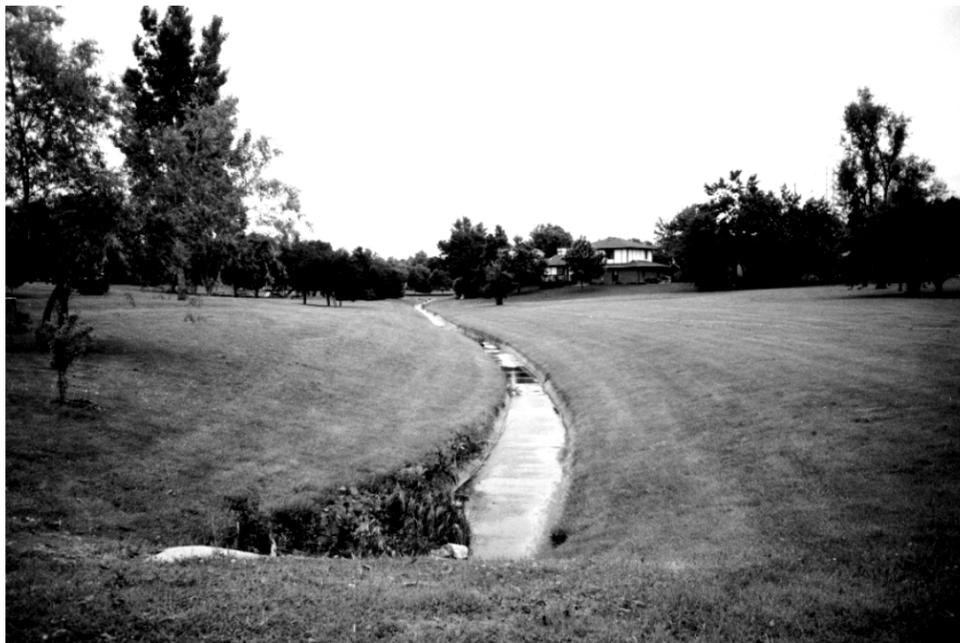
Photograph 25. Looking upstream near Quail Ridge Road at low flow liner.

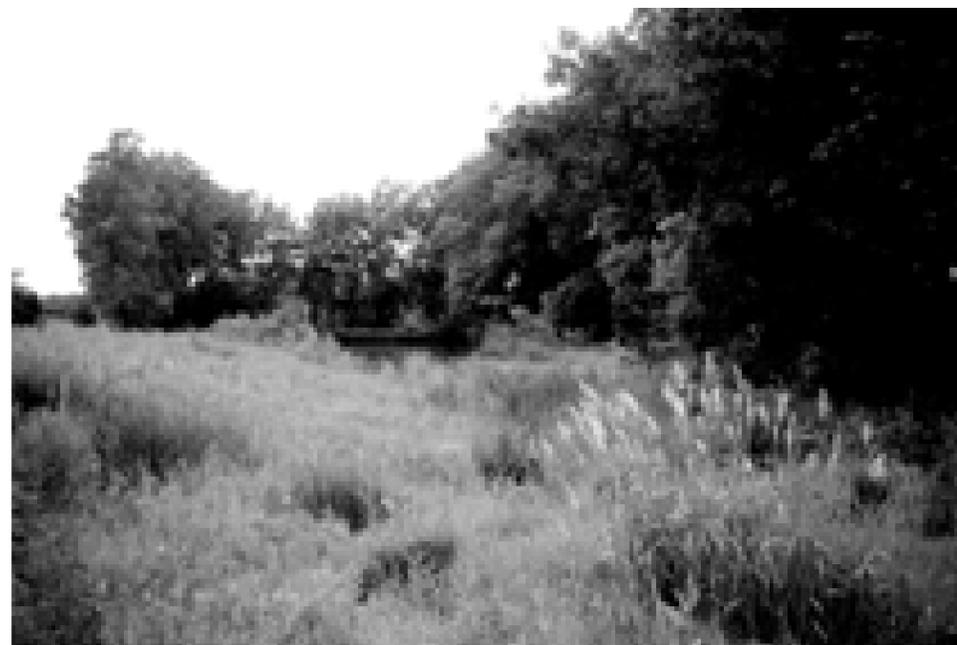
Photograph 27. Looking northerly at upper grade stabilization pond.

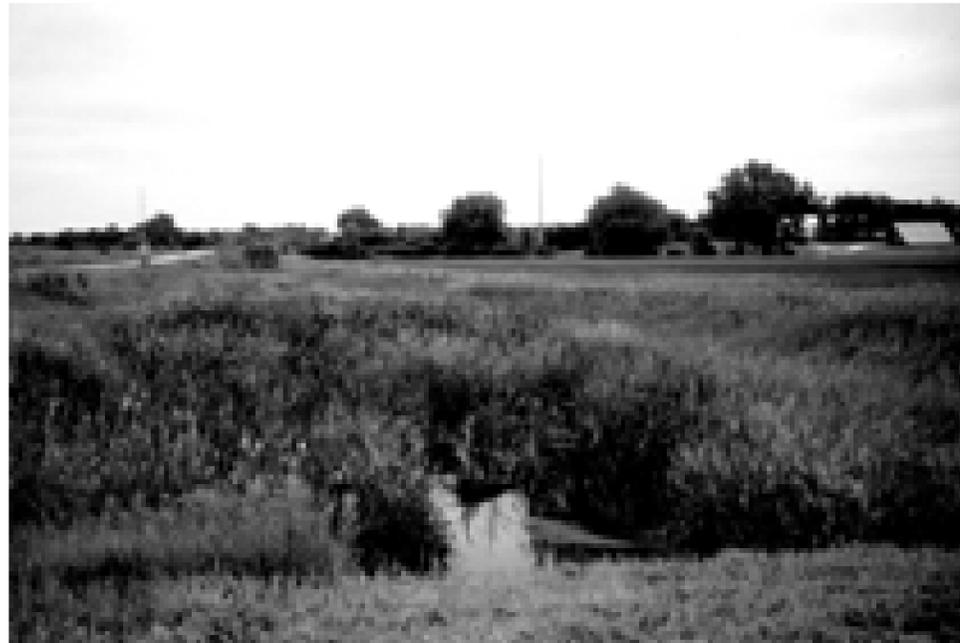
Photograph 30. Looking north from Yankee Hill Road at regraded channel along 70th Street.
