A Pretty Residence Section, "A" Street,
Lincoln, Neb.

Historic Preservation Standards

Adopted: Summer 2024

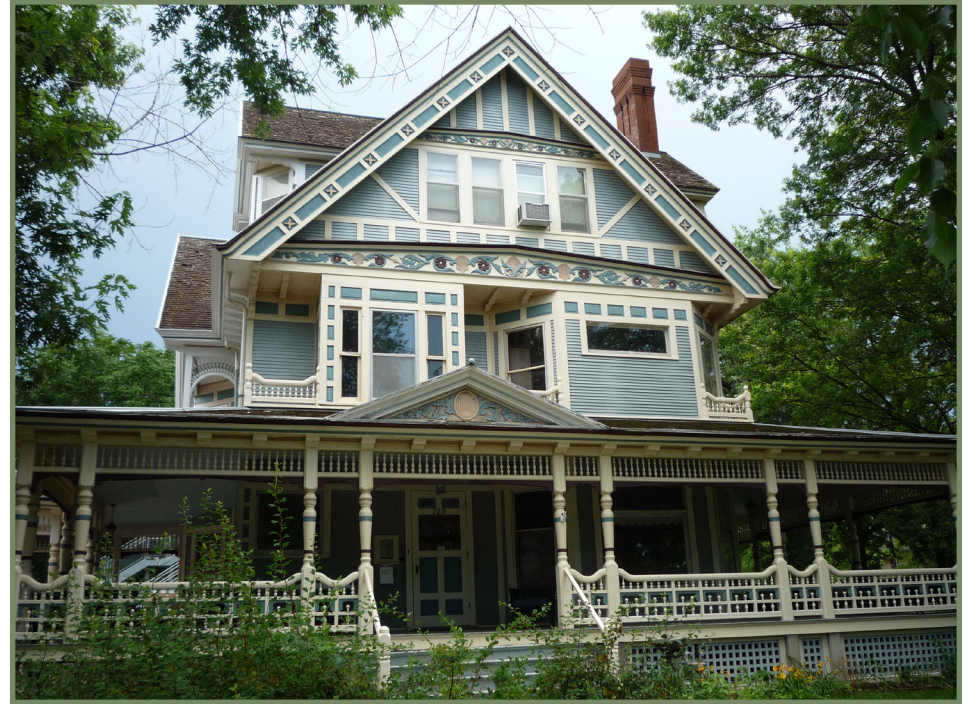
The Hurlbut-Yates home picture above is an excellent local example of significant architectural details as seen in the barge board, porch pediment, and delicate spindles that should be preserved through preventative maintenance.

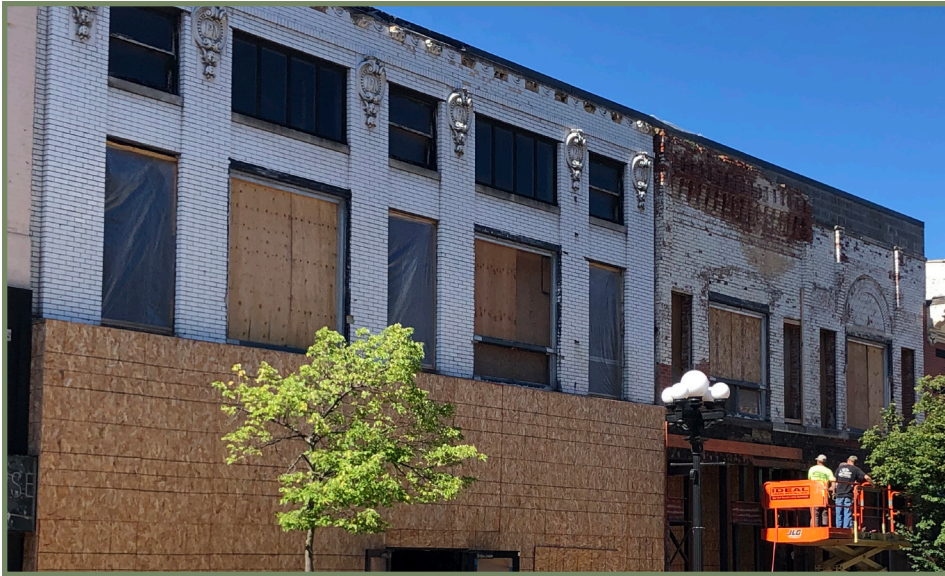
Remaining portions of the cornice details on these two buildings can be used to repair or replace damaged portions of the rest of the cornice lines.

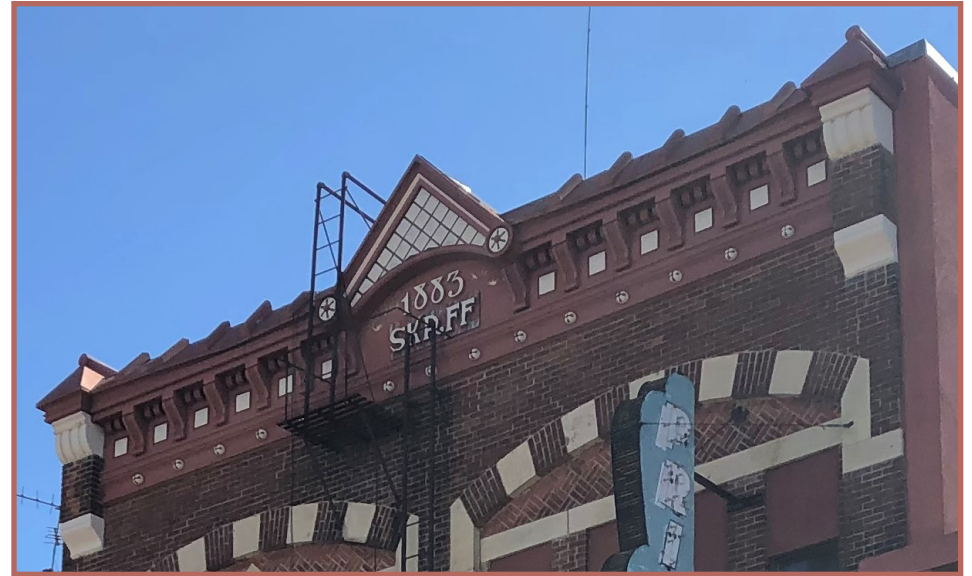
The fire escape on this historic commercial building is obscuring the date and the cornice line of the building and should be avoided by relocating the exit on a side or rear facade.

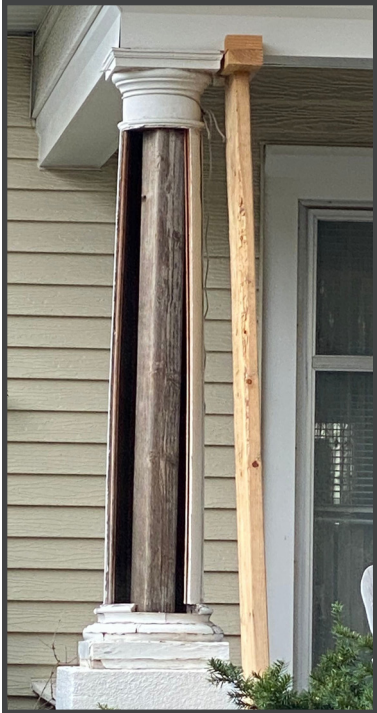
The example to the left shows a rounded column exposed to reveal the true 4x4 structural post supporting the front porch. Alterations that require new structural reinforcement should replicate the original column surround.

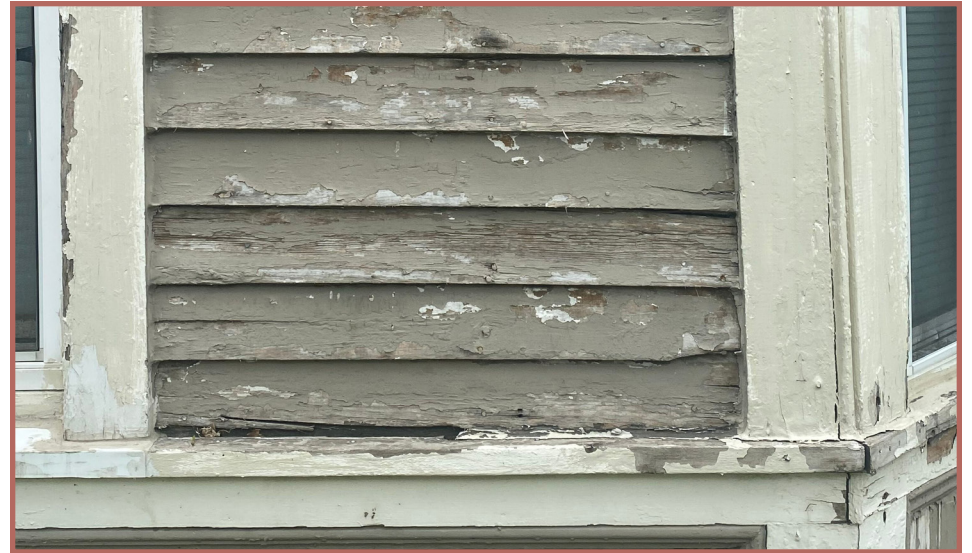
The wood siding above should be repaired with in-kind siding on the lower boards, however the upper boards in better condition should be sanded and repainted.

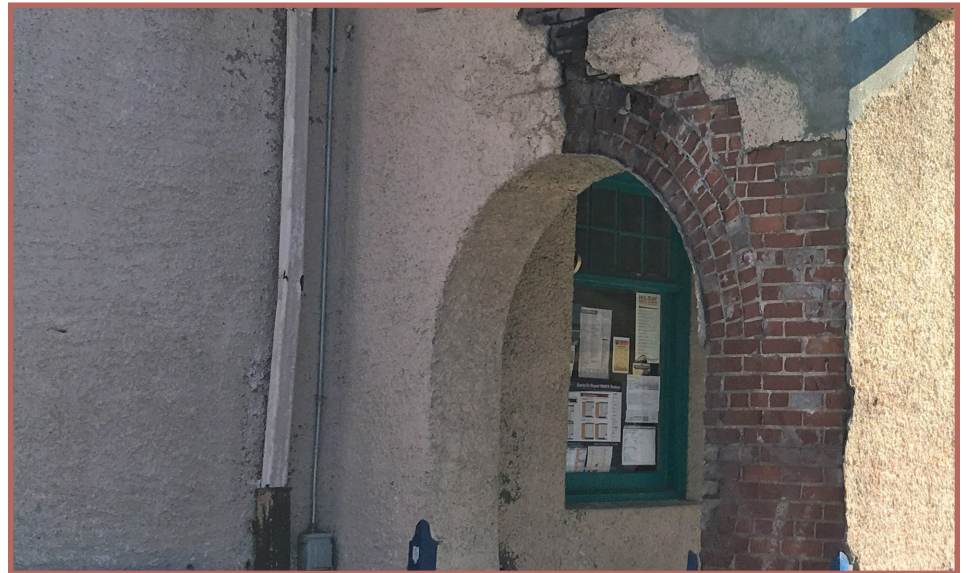
An example of a brick structure once covered in stucco that is failing and breaking away. In this case, the stucco should be carefully removed and the brick and mortar repaired.

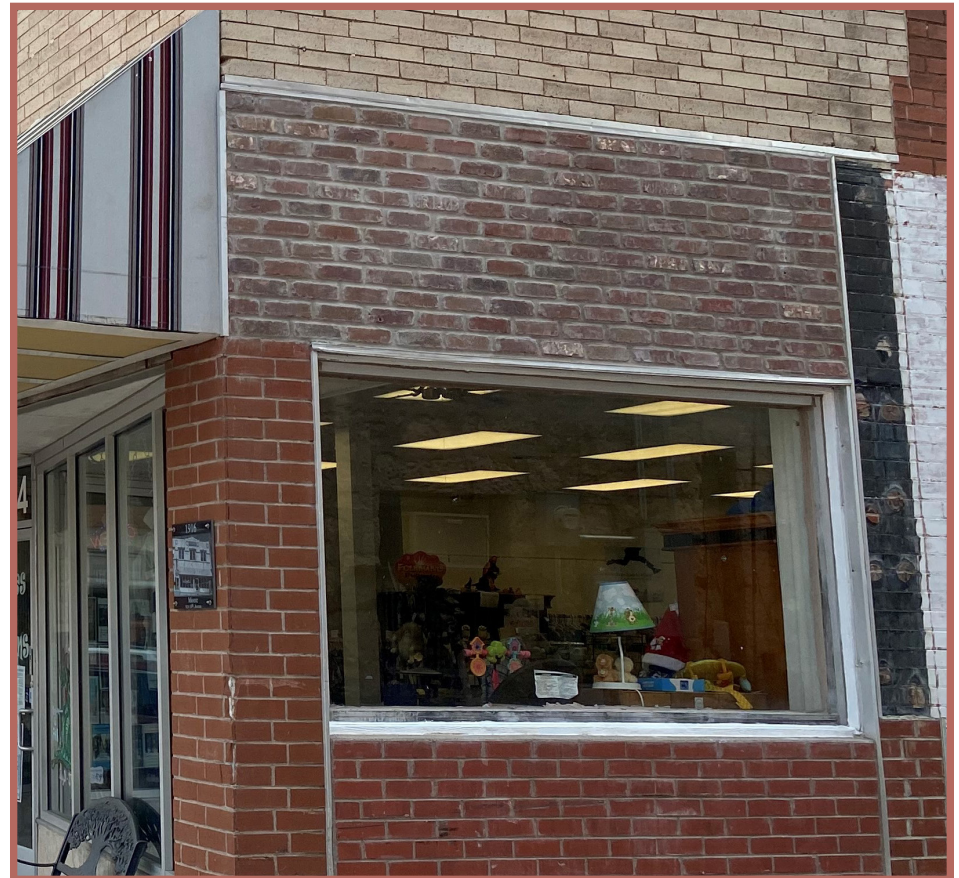
The example above should be avoided as the repair and replacement of brick over time has used three different bricks along with painted brick creating a mismatched appearance.

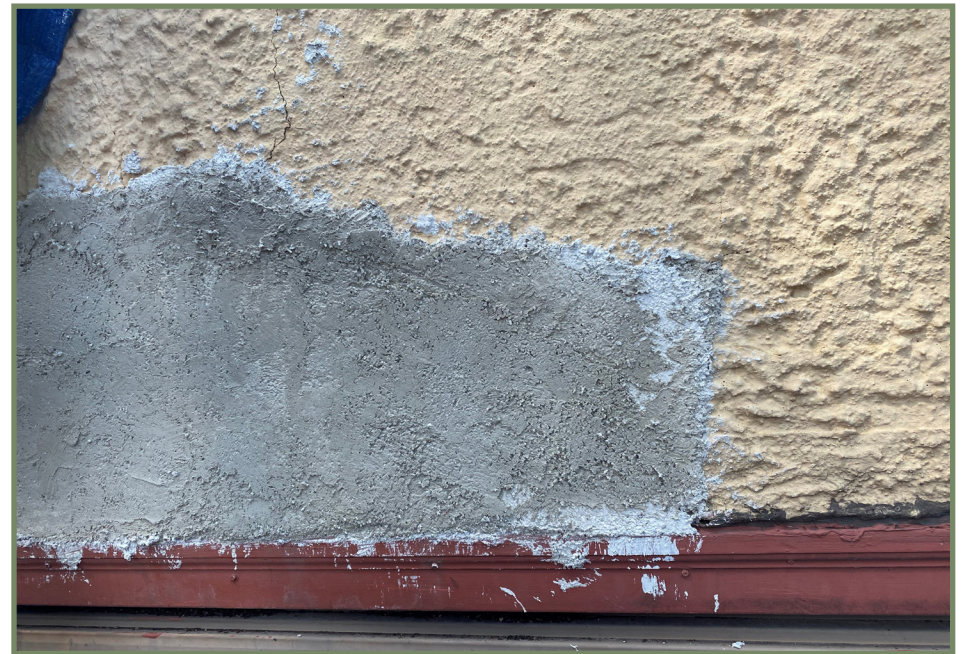
The image above shows a proper patch for an original stucco wall just before painting.

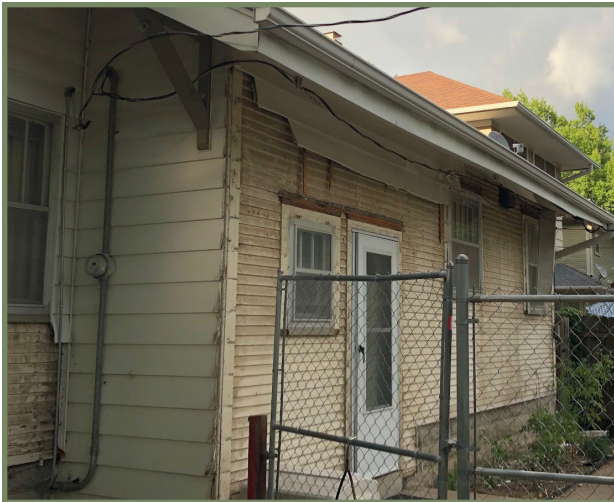
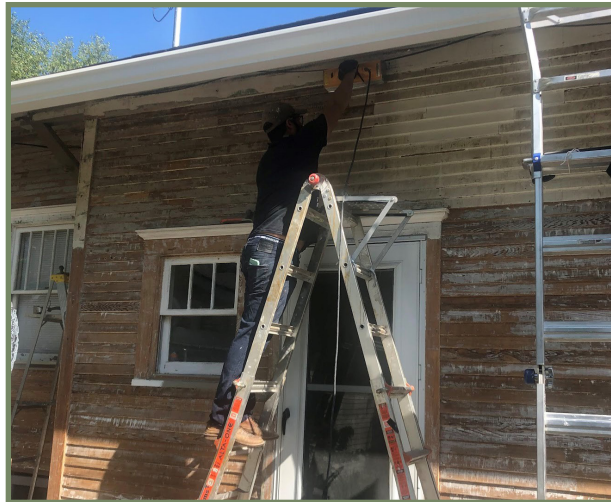
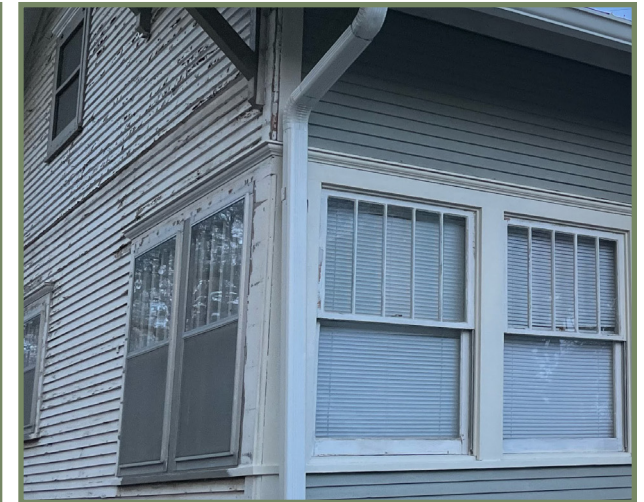
The images above show the progress of removing vinyl siding that damaged the clapboard siding and caused the removal of window surrounds which needed to be rebuilt and patched. The picture on the right shows the front finished elevation, newly painted, with a side elevation relieved of the vinyl siding awaiting a fresh coat of paint.

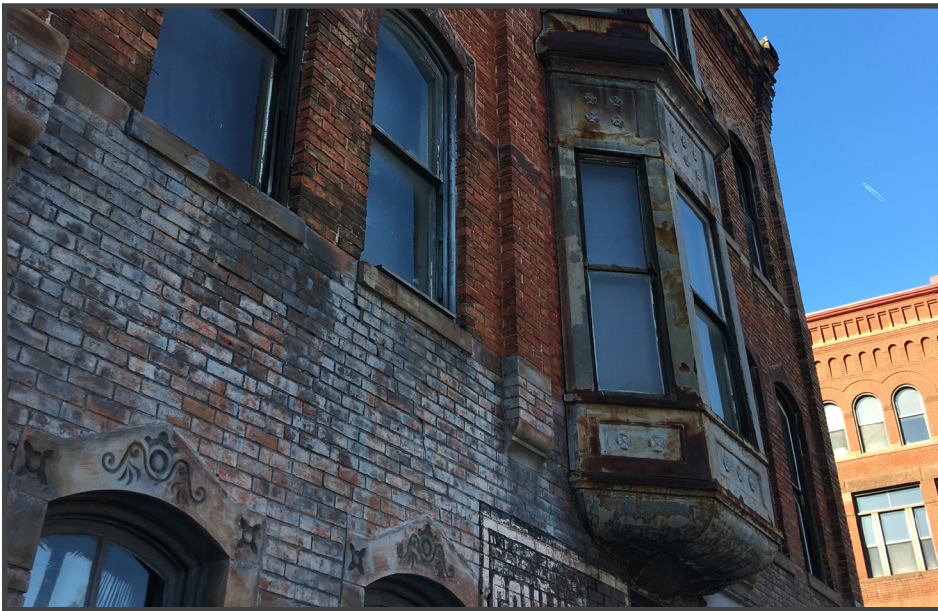
The oriel window clad in metal pictured above has not been properly maintained and is rusting as a result.

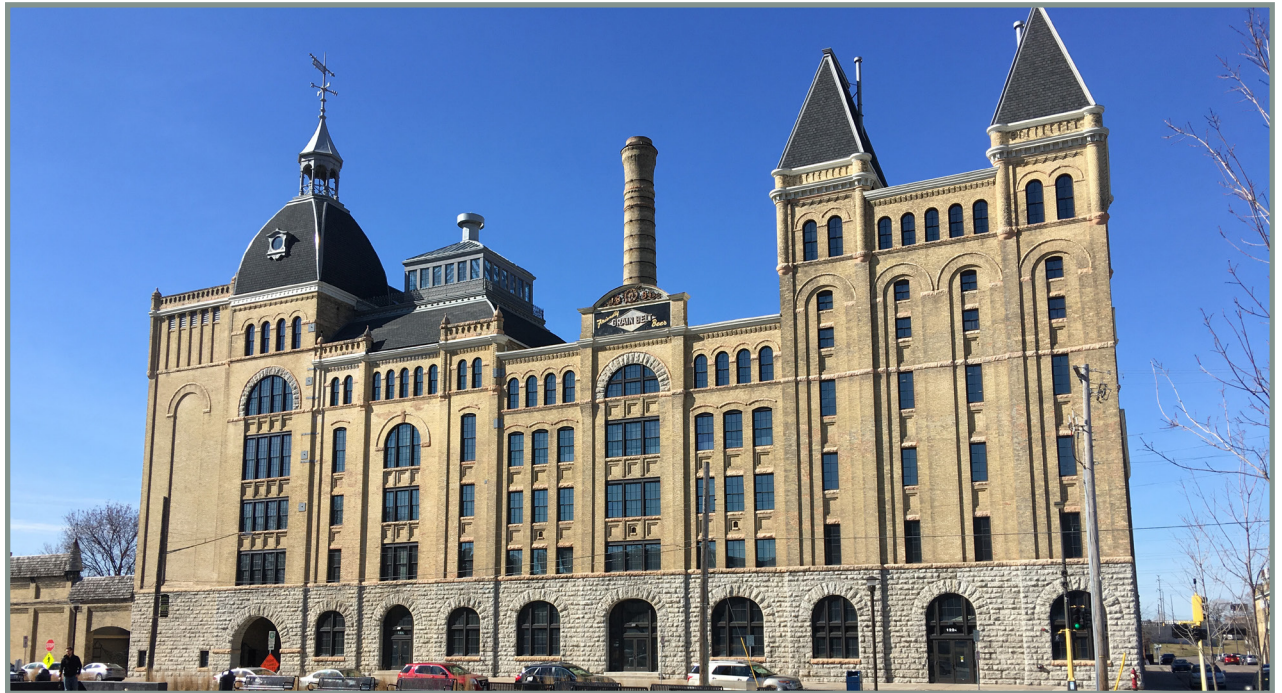
The synthetic slate roof on the Grainbelt Brewery in Minneapolis is nearly identical to the original slate roof given the height and scale of the building.

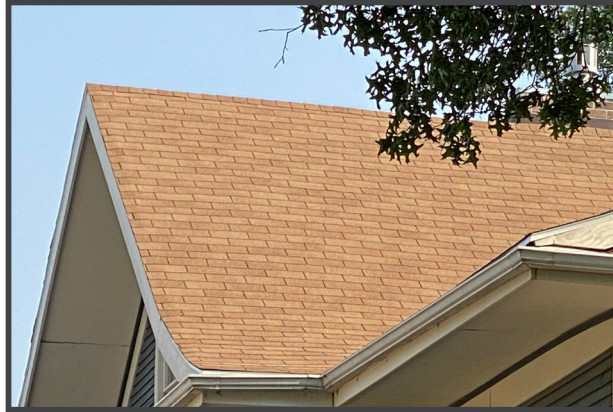
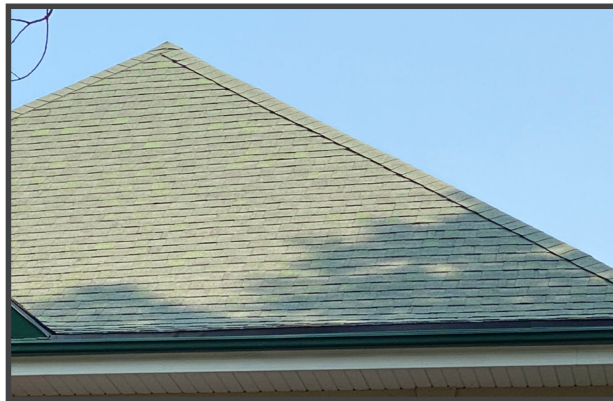
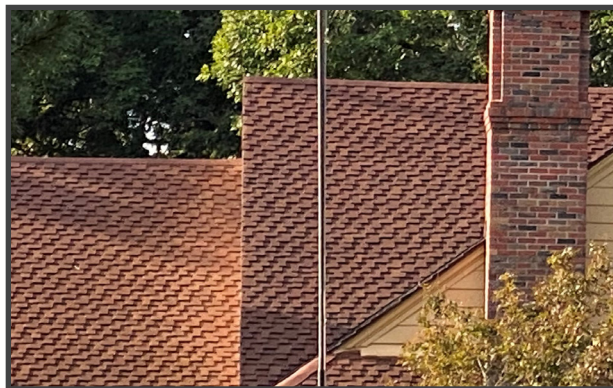
Above: three most common types of asphalt shingle found in Lincoln: rolled asphalt shingle (left), 3 tab shingle (middle), architectural shingle (right)

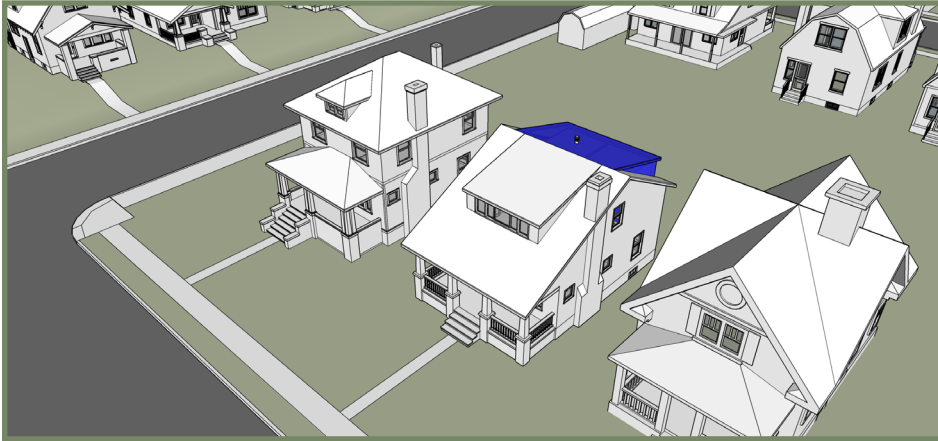
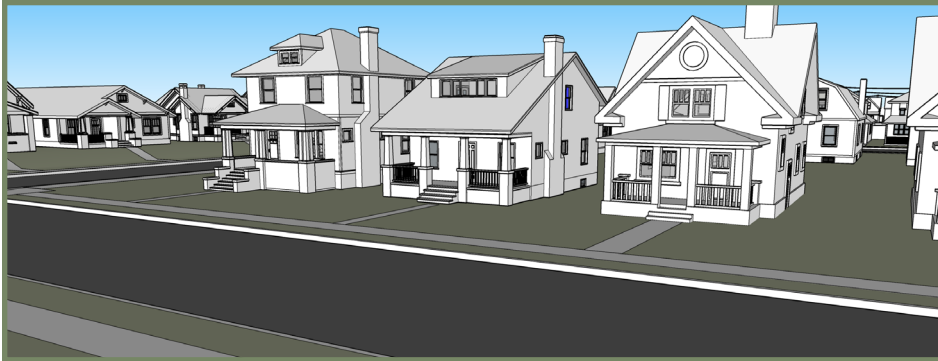
Appropriate Raised Roof

The rear dormer addition is set back from the edge of the roofline and not visible from the public right-of-way.

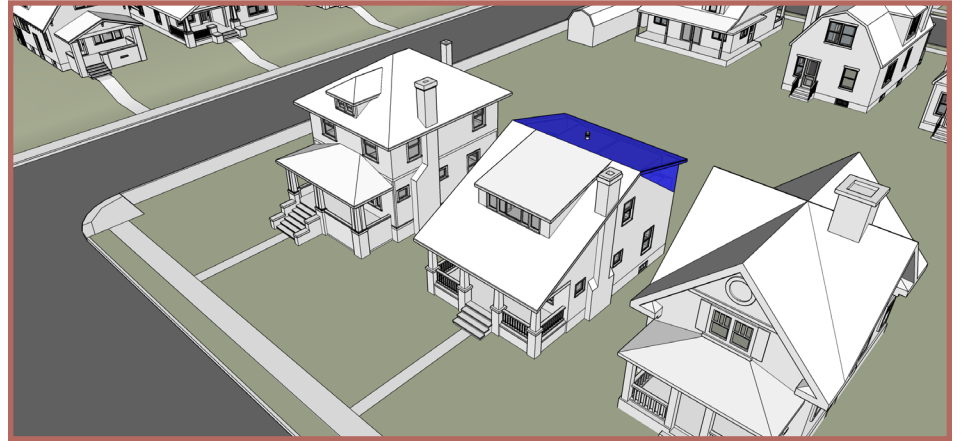
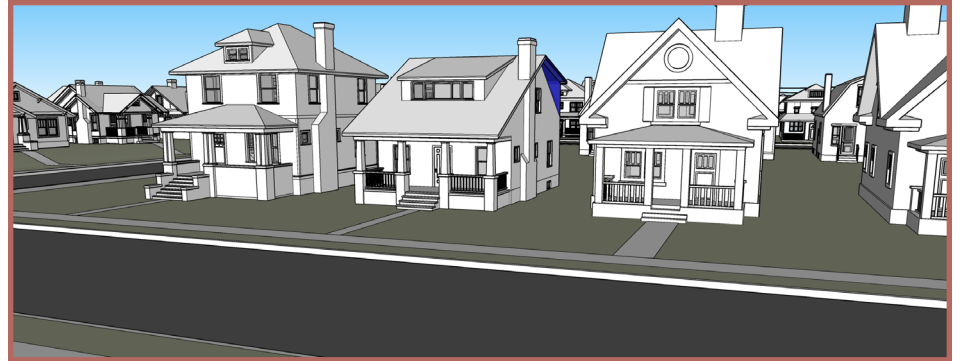
Inappropriate Raised Roof

This approach to the rear dormer raises the entire rear roofline which greatly alters it's original appearance and is visible from the public right-of-way.

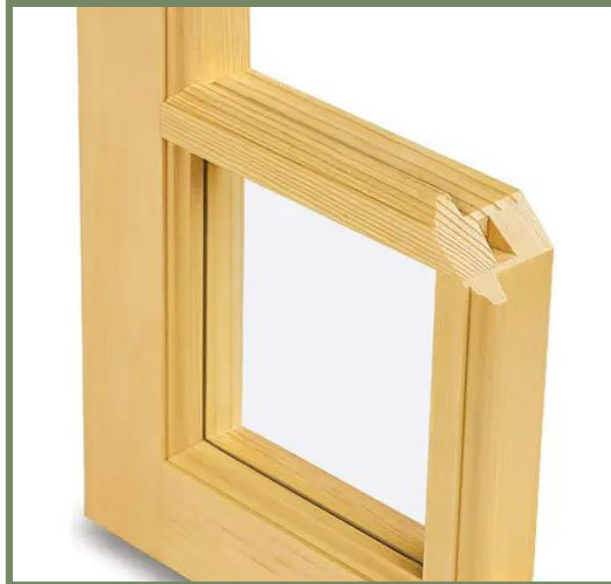
True Divided Light: Each muntin holds a separate piece of glass, so for a four-pane window there are four pieces of glass held by each set of muntins

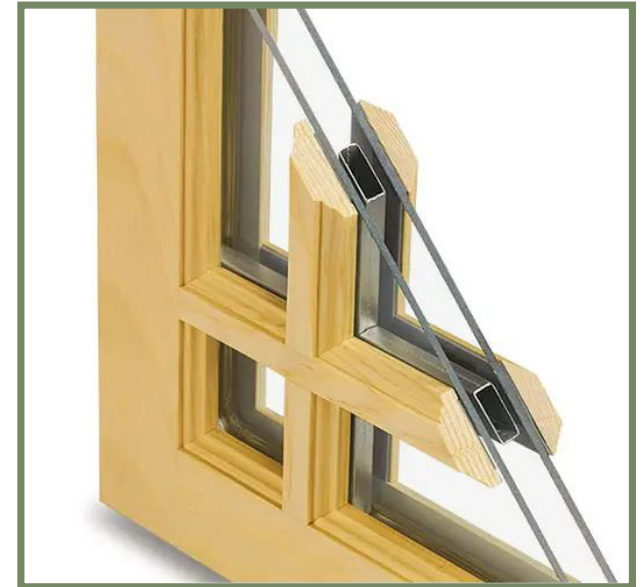
Simulated Divided Light with Spacer: two panes of glass are separated by a spacer bar with muntins applied on the outside of the glass.

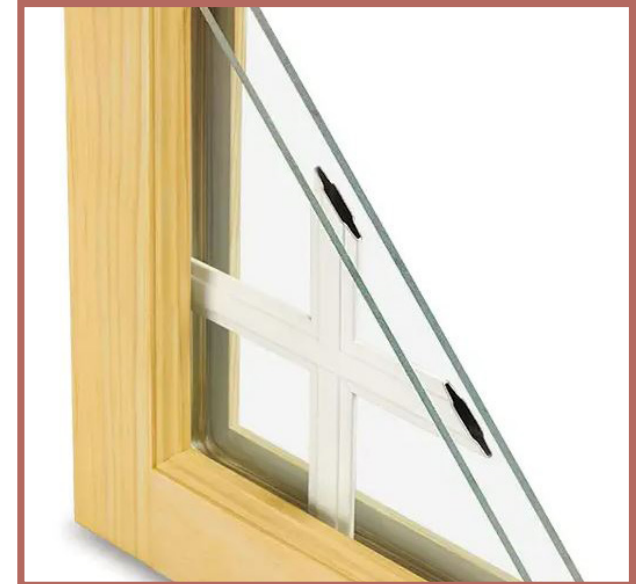
Not Recommended: Muntins are placed between the two panes of glass on the inside.

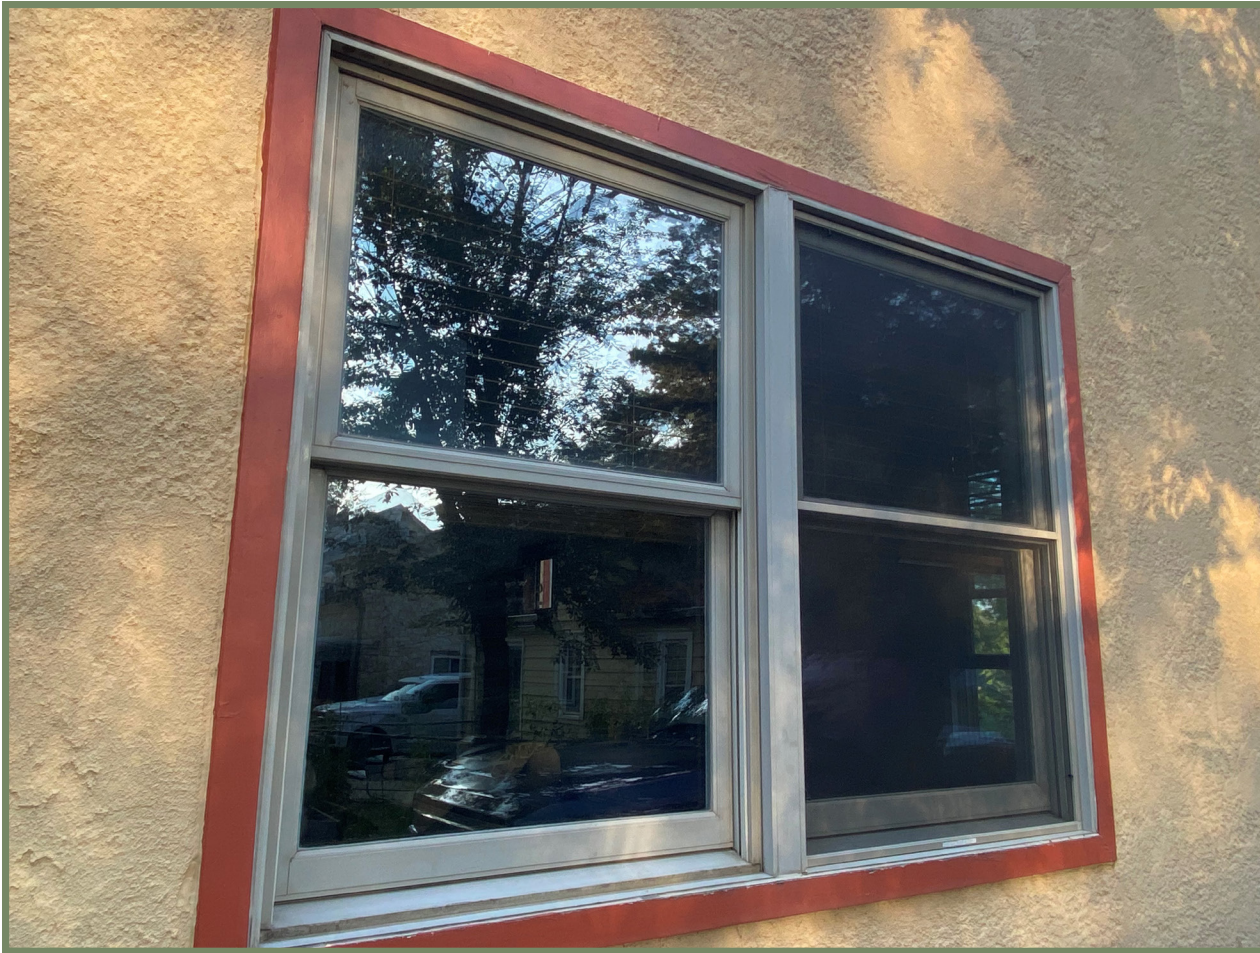
Aluminum clad wood window without screen (left) and with screen (right)

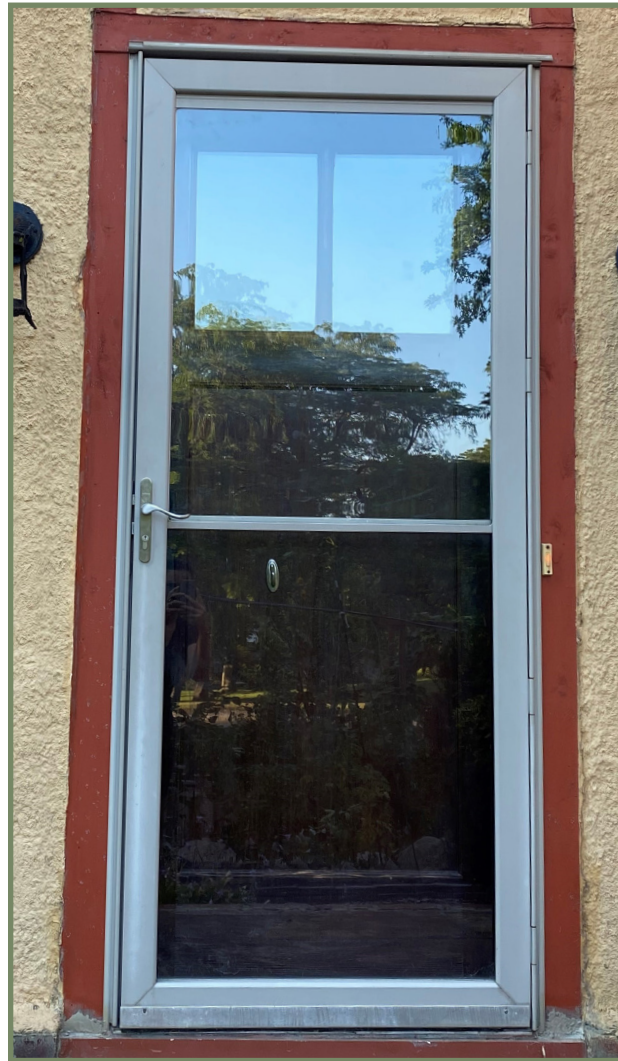
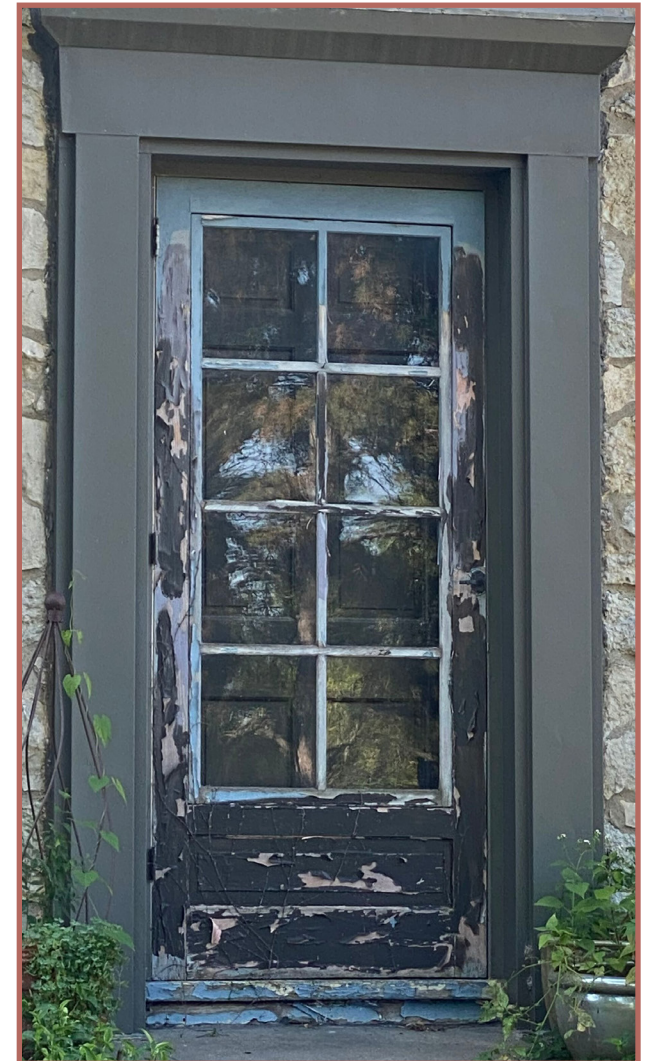
Modern full light storm door with concealed screen (left) and historic 8 lite storm door which needs maintenance to maintain its operability (right)

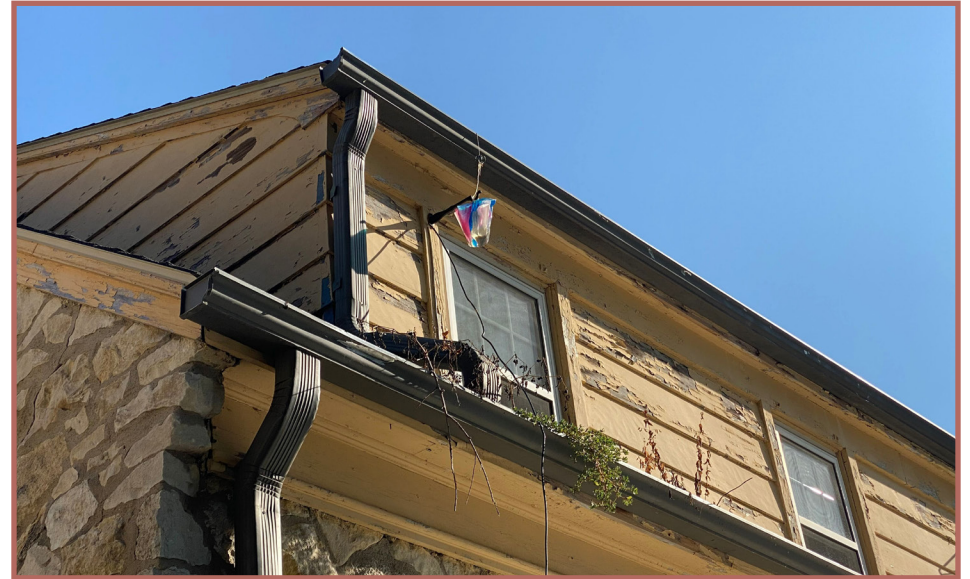
Improper maintenance of gutters which creates risk for water infiltration into the foundation

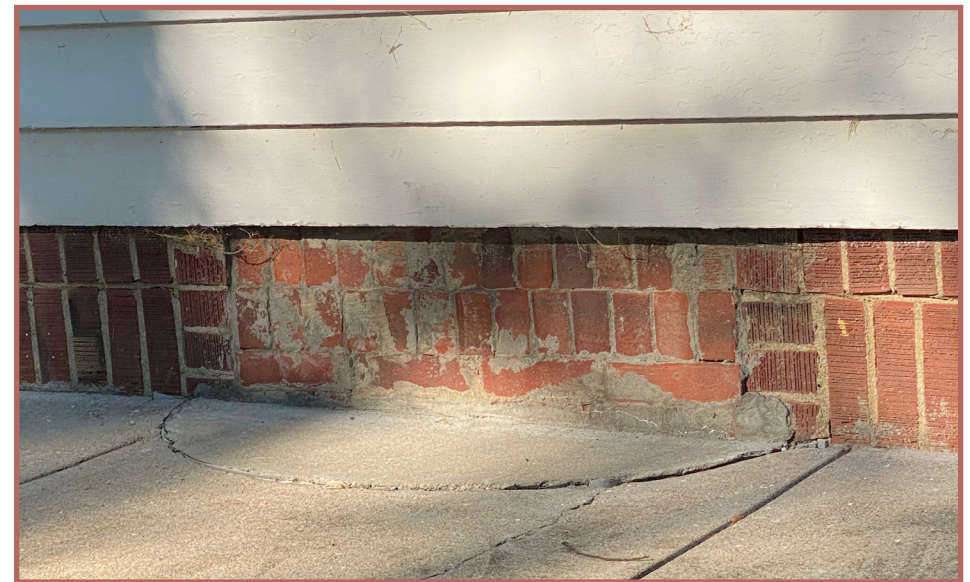
Improper blocking in of basement window

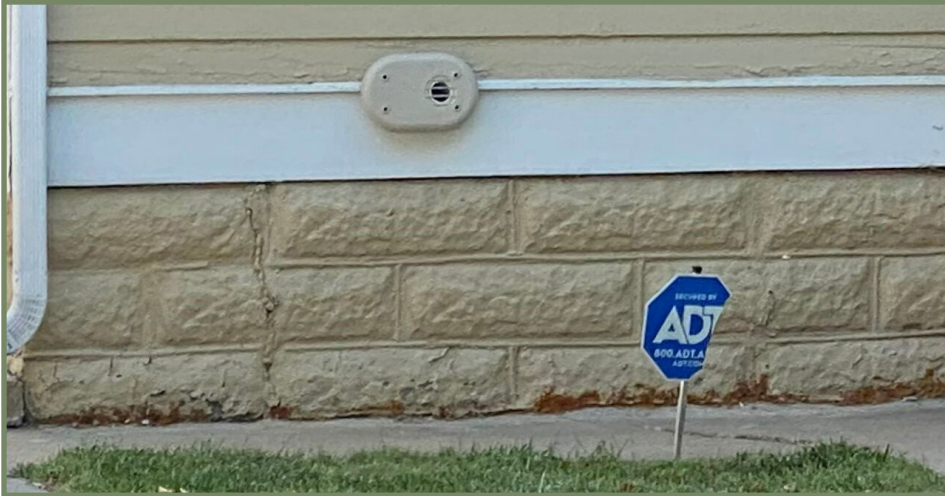
Historic rock-faced concrete block foundation that should be retained for either structural reuse or aesthetic reuse.

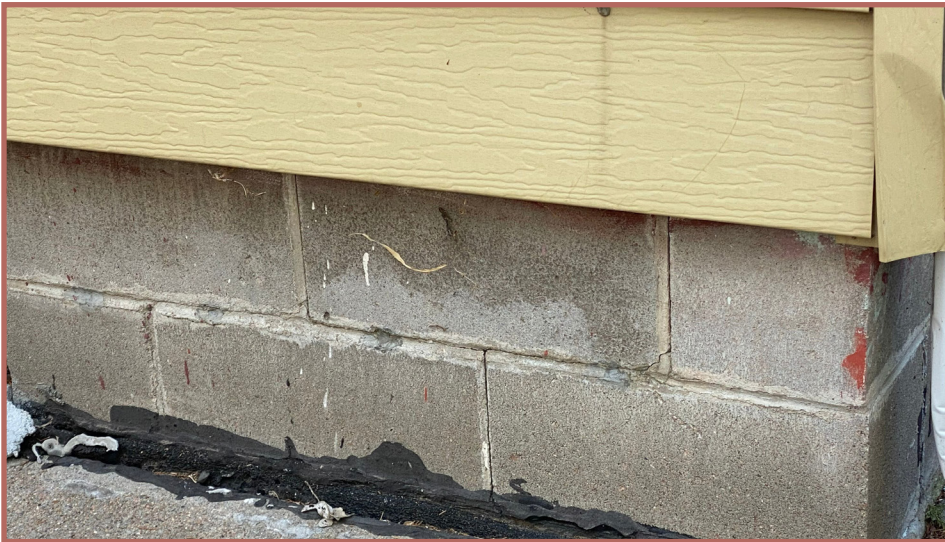
Smooth concrete block foundation which departs from the original look of the rock-faced concrete block.

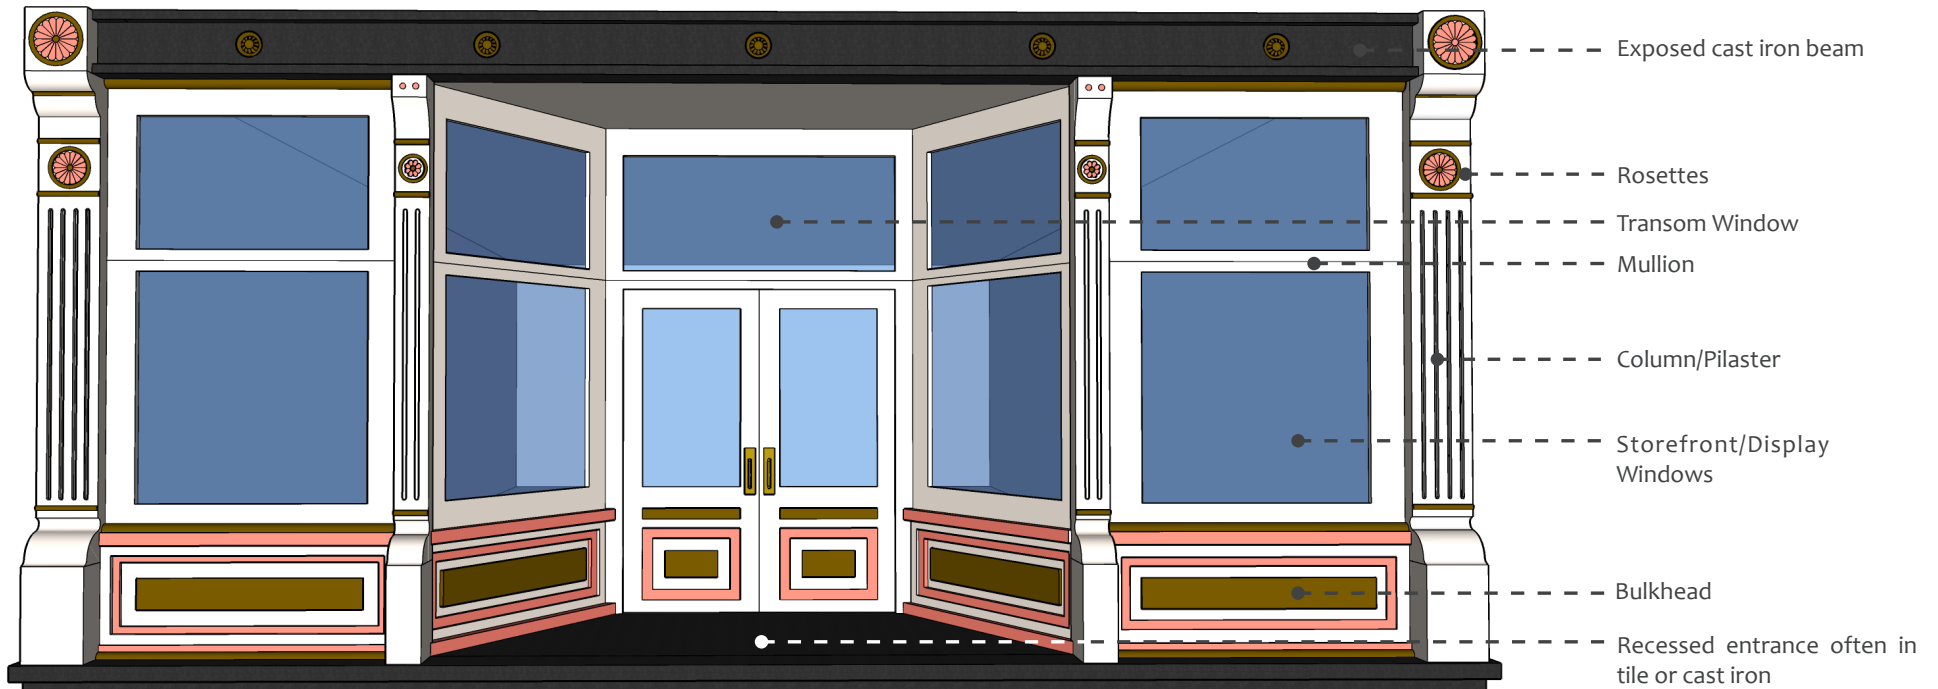
ELEMENTS OF A STOREFRONT

- 7.1. Identify, retain, and preserve storefronts and their functional and decorative features that are important in defining the overall historic character of the building.
 - a. A typical late 19th or early 20th century storefront features a support beam separating the first and second floor with transom window above, masonry support piers on the ends, cast iron columns flanking the main central entry which has a single or double door, and large display windows sitting on a solid panel roughly 24 inches or less above the ground (also known as the bulkhead).

7.2. The storefront materials (including wood, masonry, metals, ceramic tile, clear glass, and pigmented structural glass) and the configuration of the storefront are significant, as are features, such as display windows, base panels, bulkheads, signs, doors, transoms, kick plates, corner posts, piers, and entablatures.

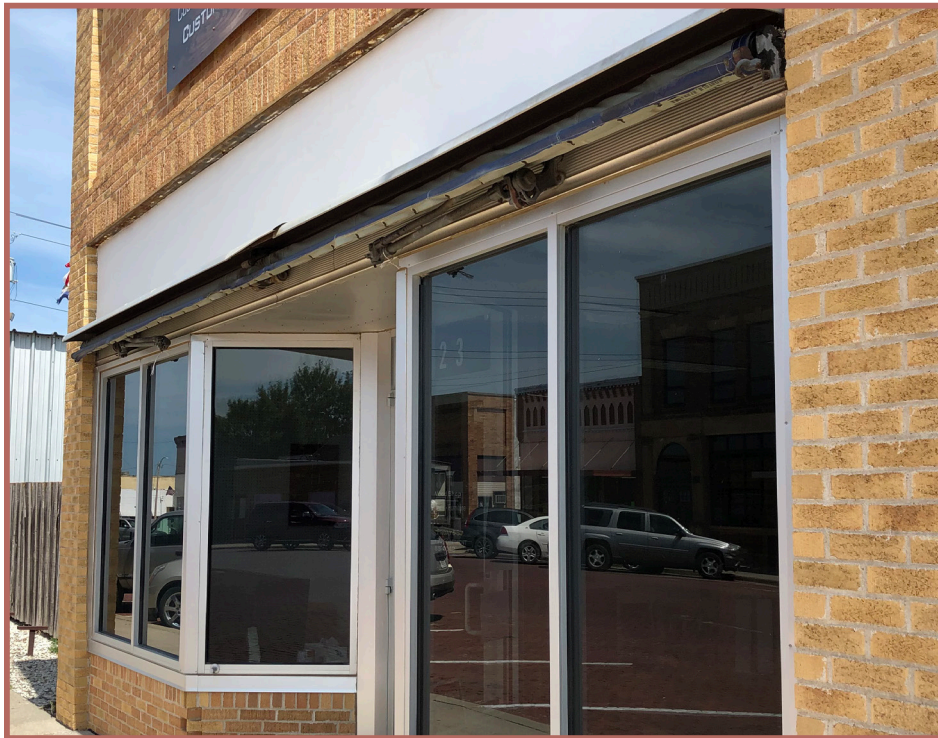
The above storefront has a modern aluminum frame with the original roller awning intact above. The unpainted metal stands out from the buff brick facade and is not a recommended replacement.

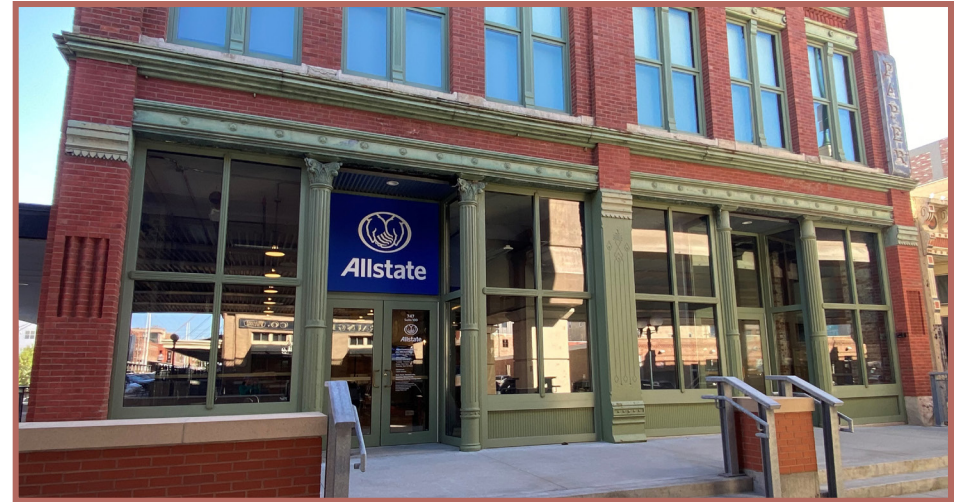
The 1884 Schwarz Paper Building at 747 O Street features a cast iron storefront with engaged Corinthian colonettes, central pier, rosettes and terra-cotta capitals.

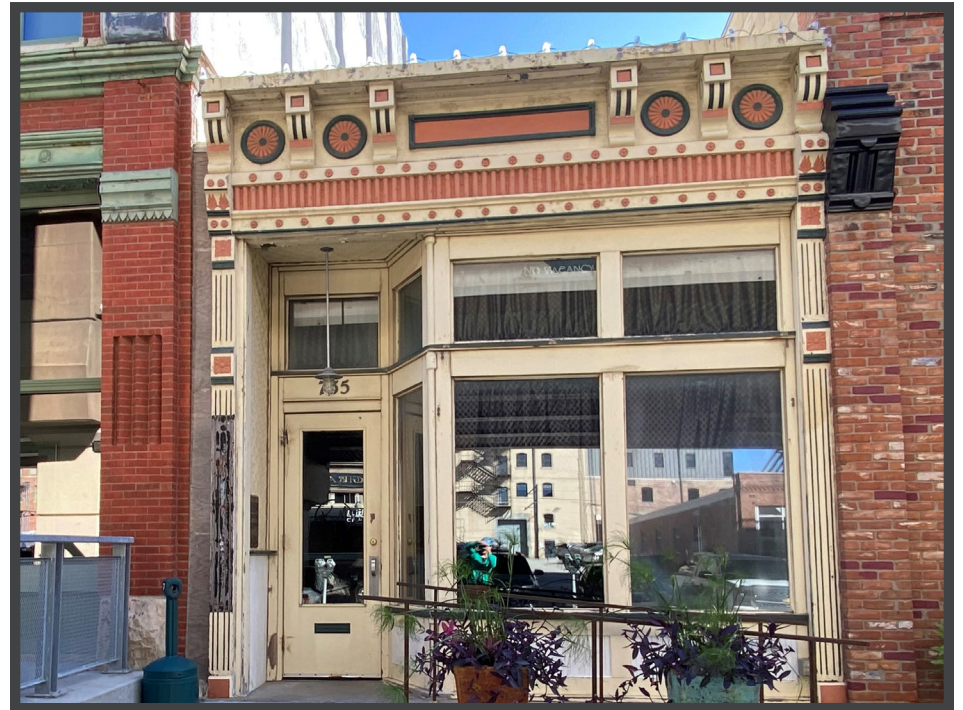
The Occidental Saloon at 735 O Street appears to also be cast iron but is instead the Victorian storefront is carved out of wood.

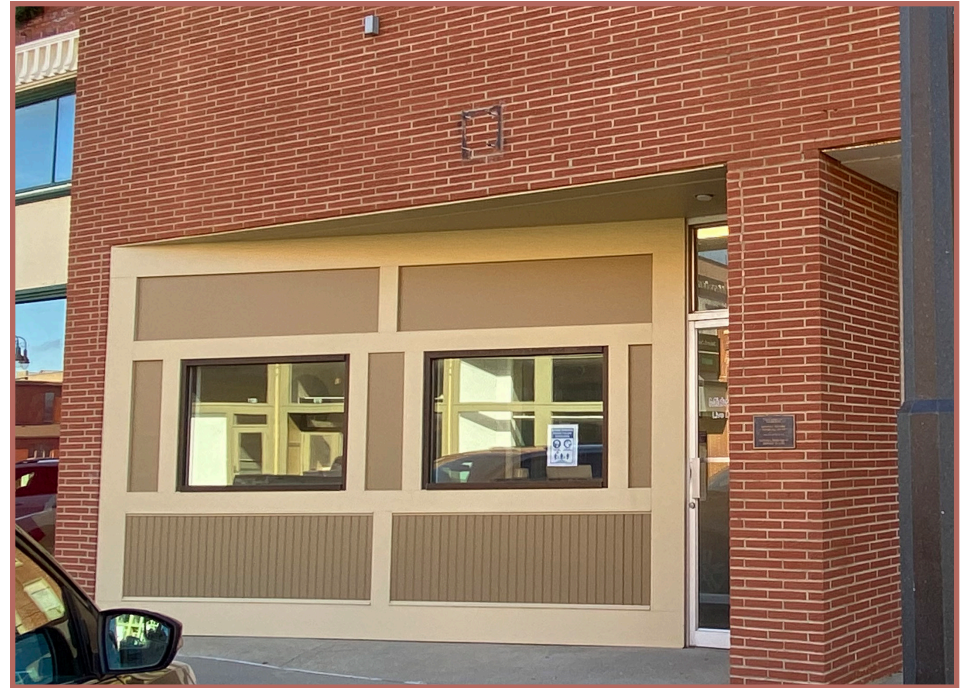
In the example above, the storefront has been greatly altered with modern materials and a design that removes the historic glass display windows and is not a recommended approach.

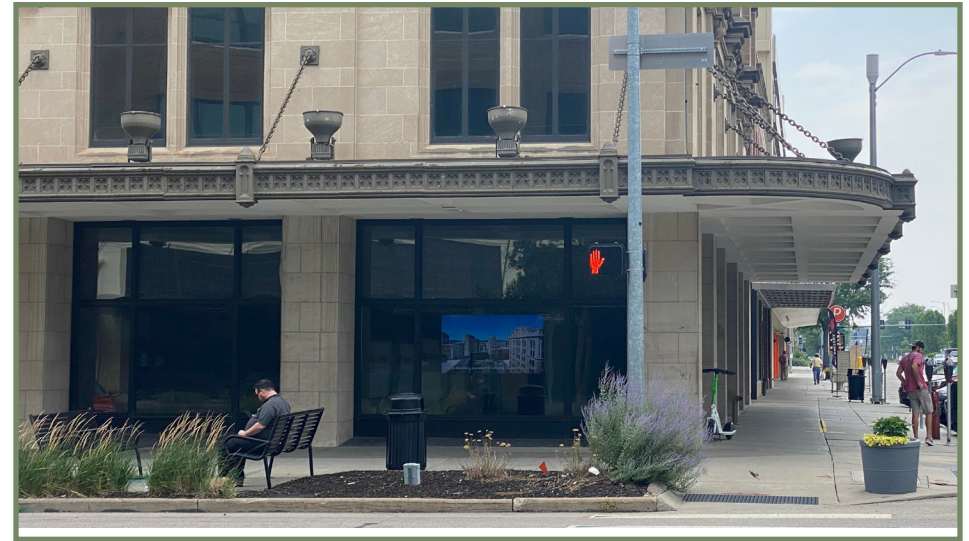
The historic awning above has been carefully preserved and provides protection for pedestrians from inclement weather in addition to reducing glare into the large glass windows. It is also a good example of a chain supported canopy.

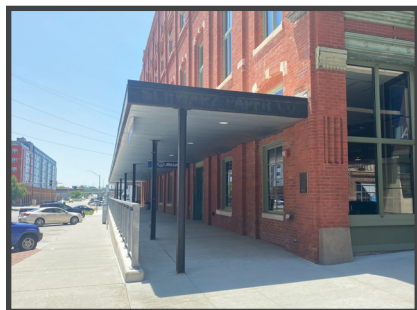
Post supported canopy

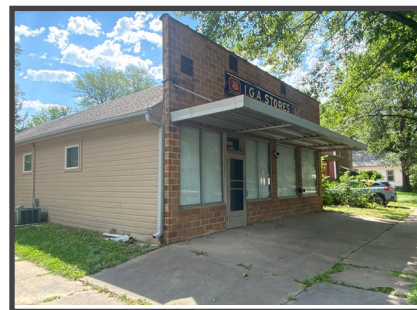
Suspended aluminum canopy

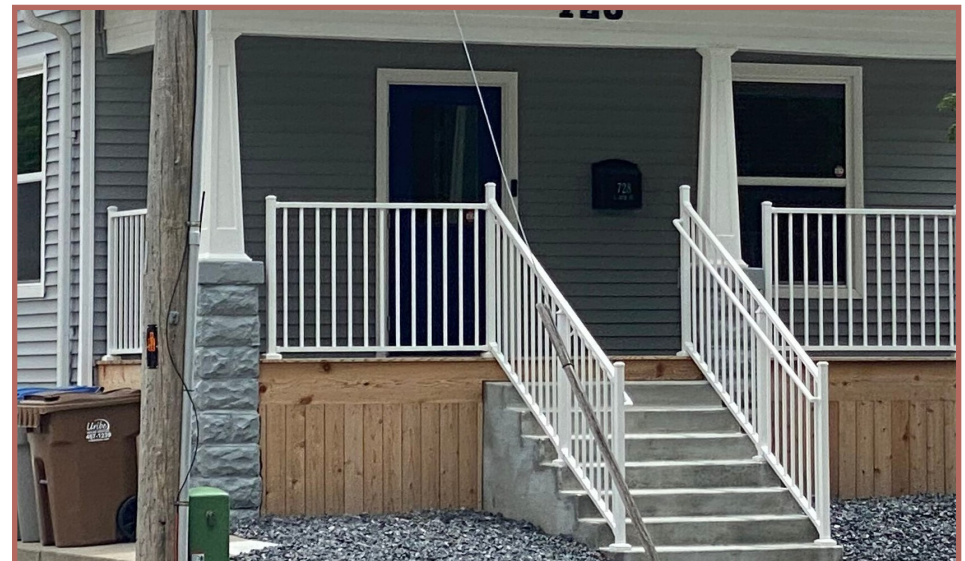
The porch skirting and railings above are not an appropriate treatment for a historic building. The square columns that replaced originally rounded columns illustrate the panel design with base and cap concept, however the tapered design is not true to the prairie box style of the home.

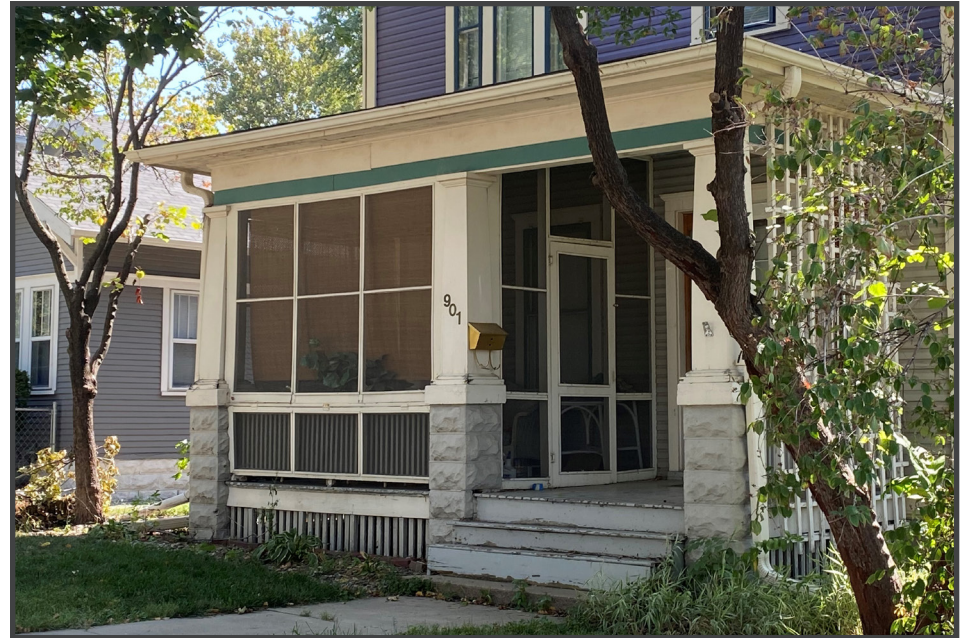
The partially enclosed porch above retains the original railings, columns, and visibility to the front facade.

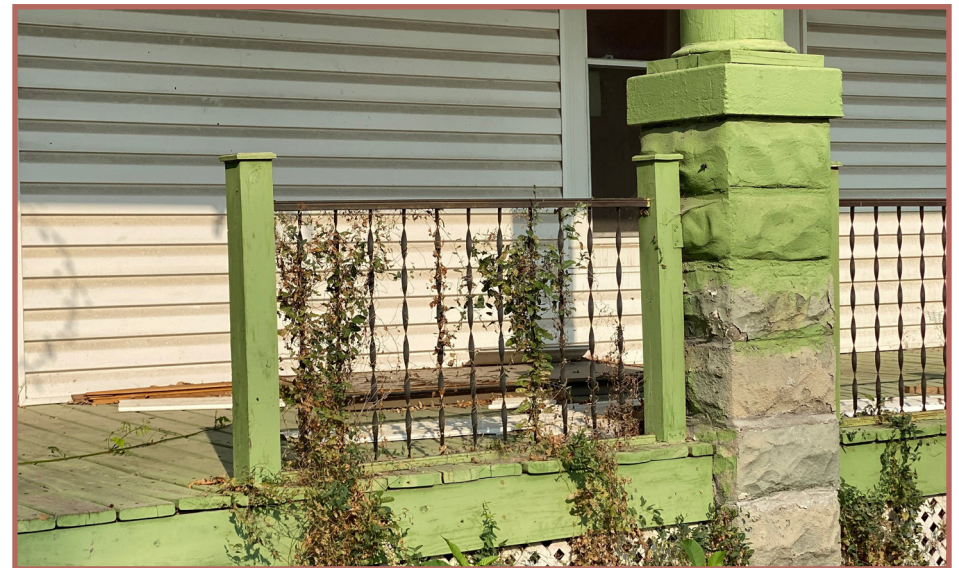
These railings are not compliant with the guidelines, with a modern metal spindle going directly to the porch floor. The stone column base should also not be painted.
