A Pretty Residence Section, "A" Street,
Lincoln, Neb.

Historic Preservation Standards

Adopted: Summer 2024

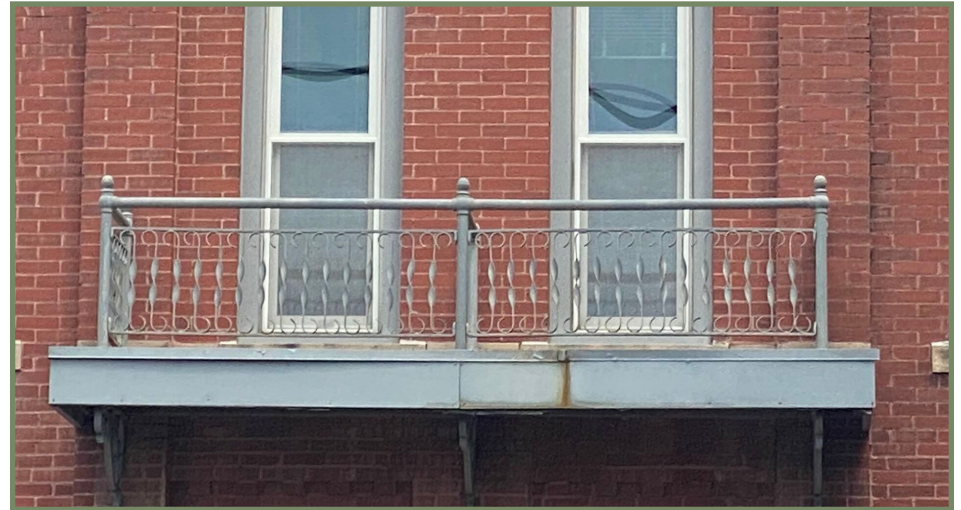
Example of a simple design for a front facade balcony.

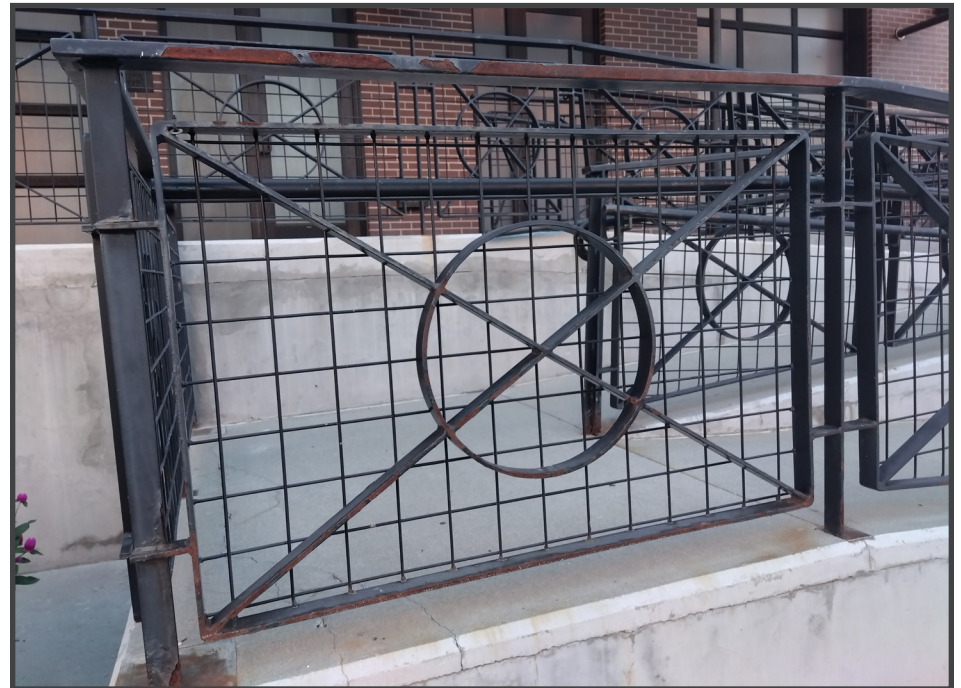
Dock railing example commonly found in the Haymarket Historic District with a simplified design. Given the rust showing, the metal type used on future projects should be looked at for compliance with the guidelines.

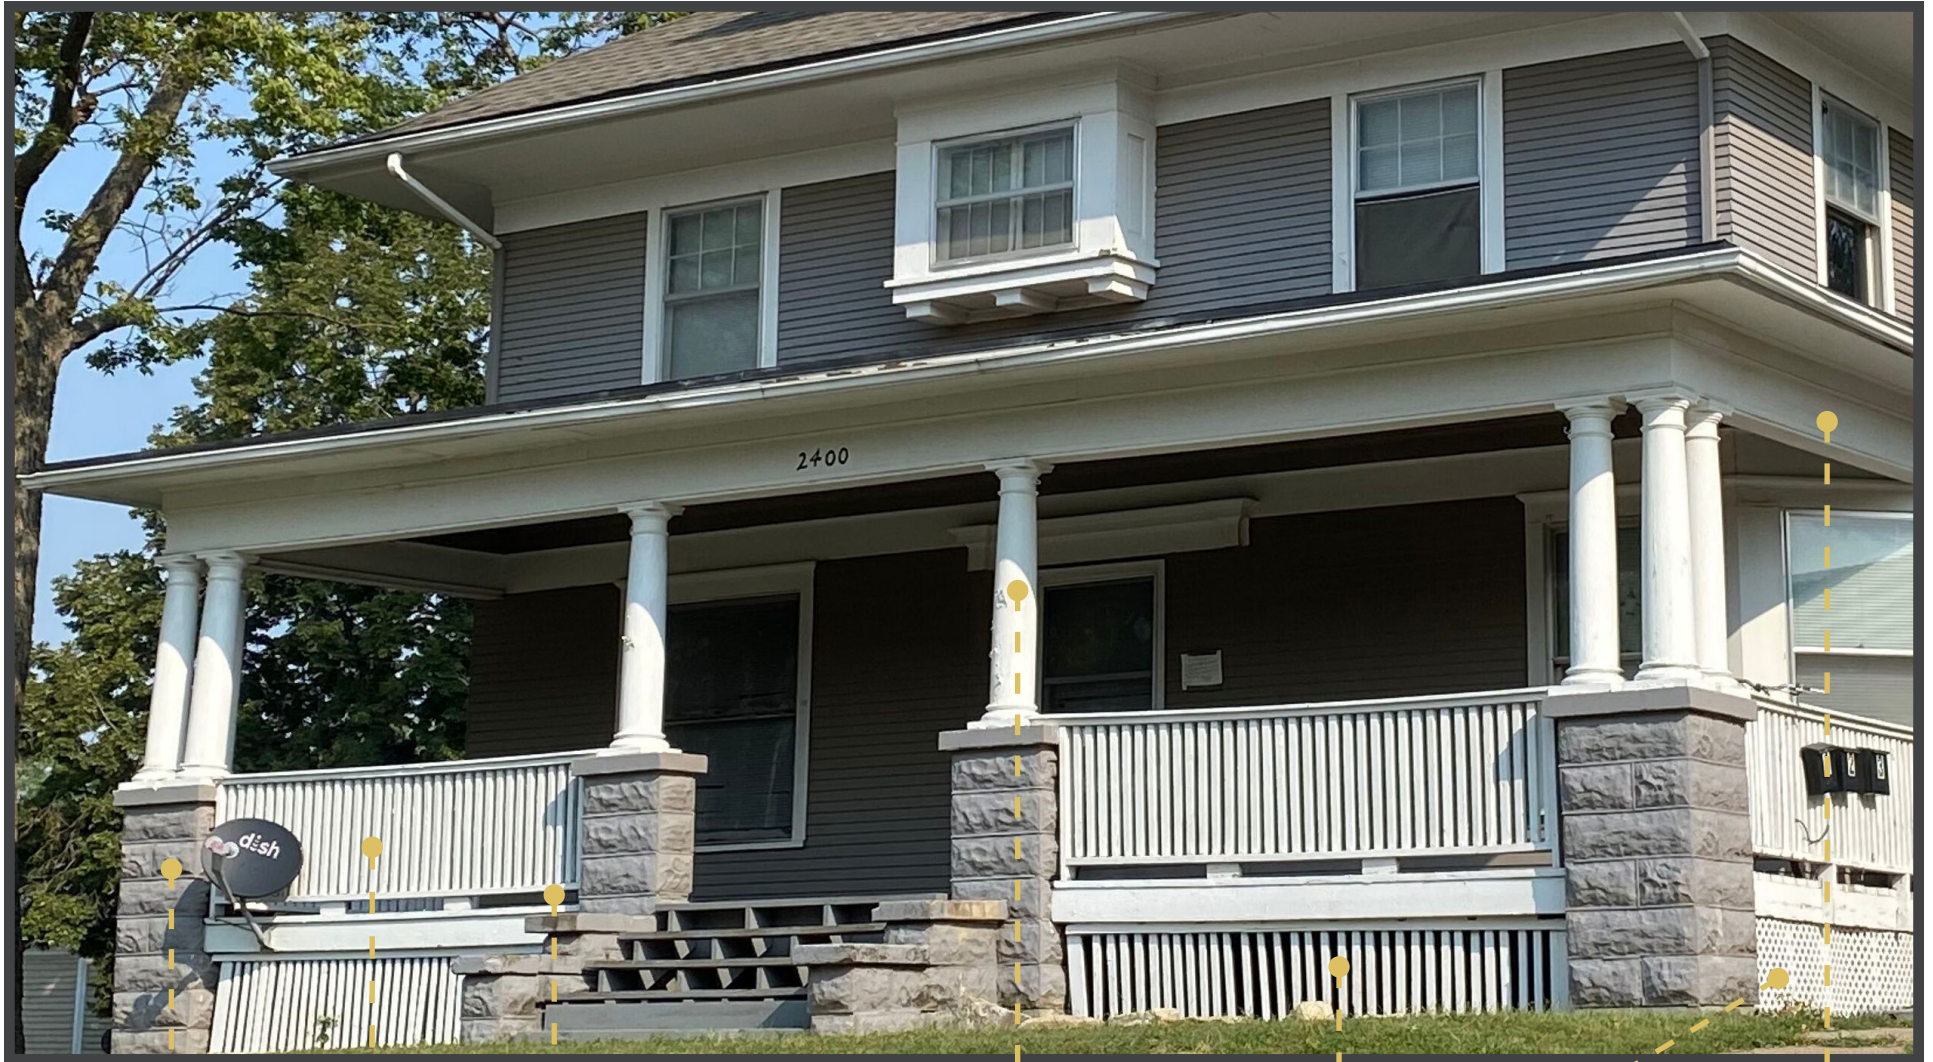
Support piers of original split rock masonry units

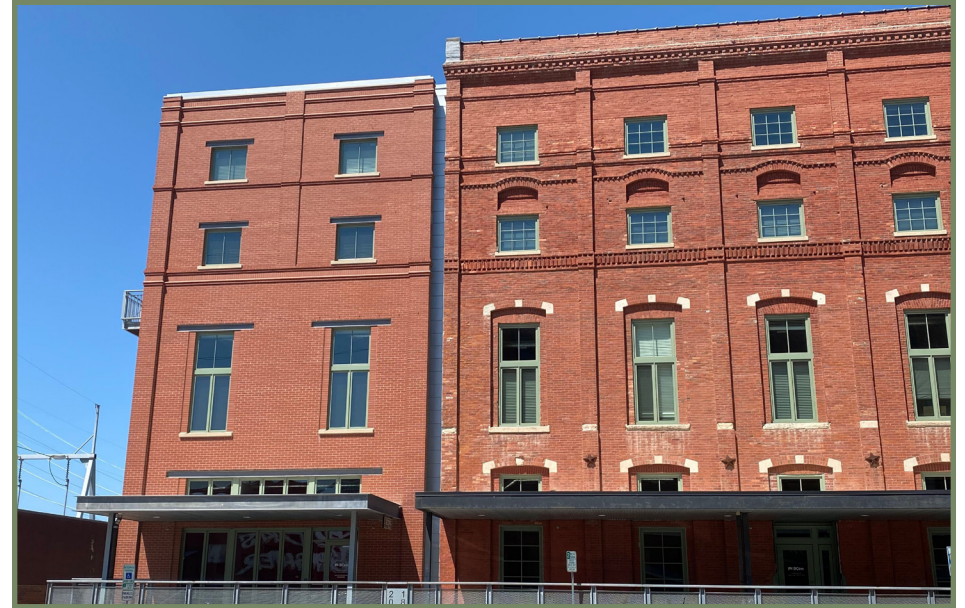
The addition (left) to the Sullivan Building is located at the rear and reflects the character of the original structure in a simplified version of the intricate design.

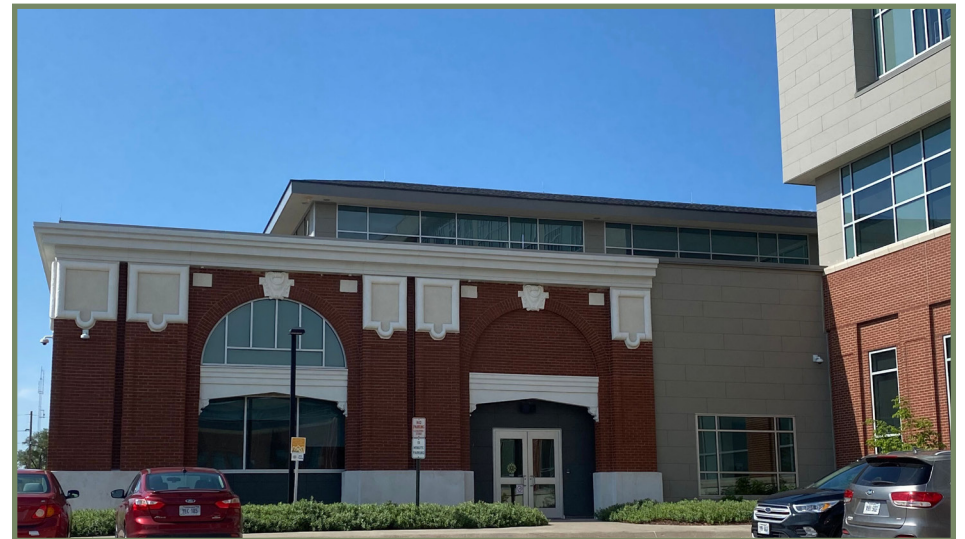
The additions to the Industrial Arts Building is an approach that deviates from the historic character by stepping back from the main facade with a neutral colored palette.

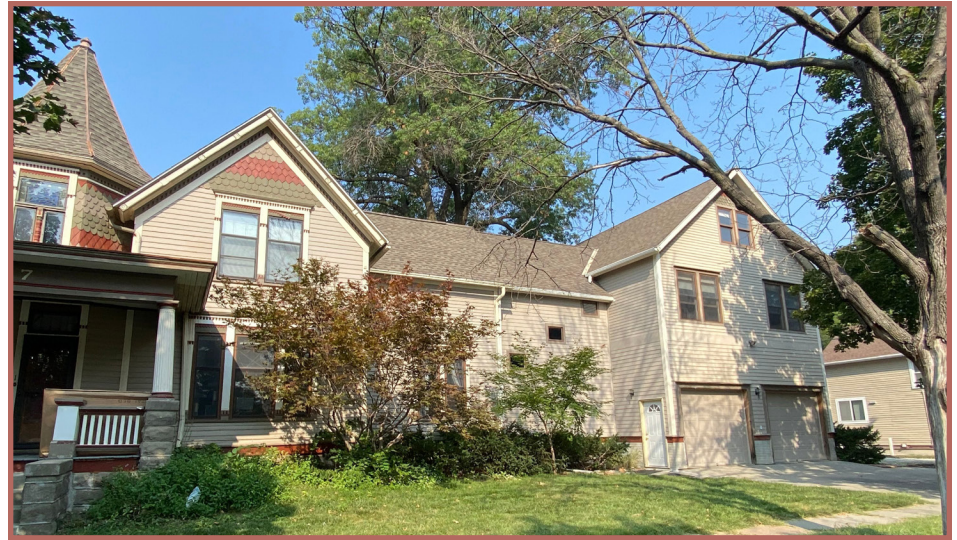
The two story link with three story garage addition competes with the original home in overall scale and massing, however the neutral color palate and matching roof pitch with step back in the link portion are in alignment with the historic home.

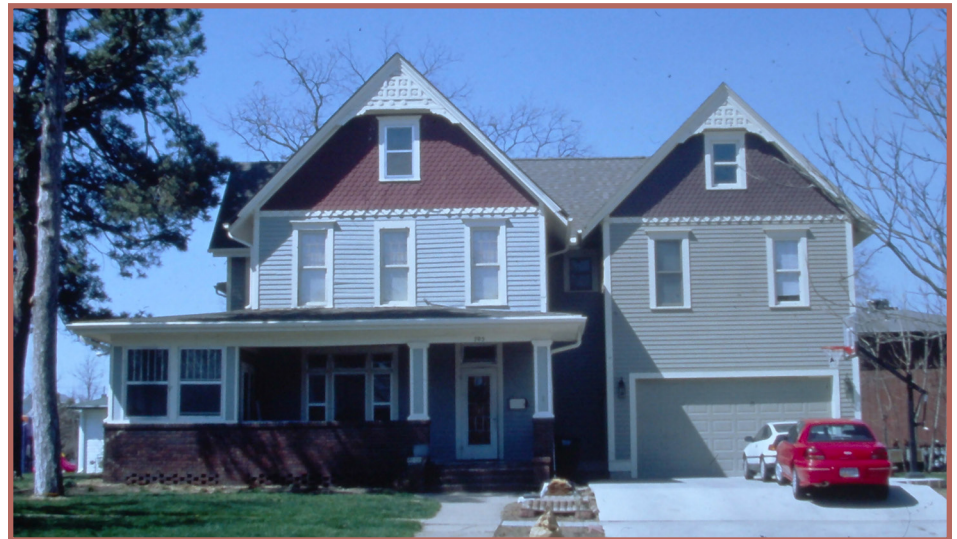
The addition to this home for the garage has similar results as above, also with the problem of a modern garage competing with the main porch and entrance to the home given the close proximity.

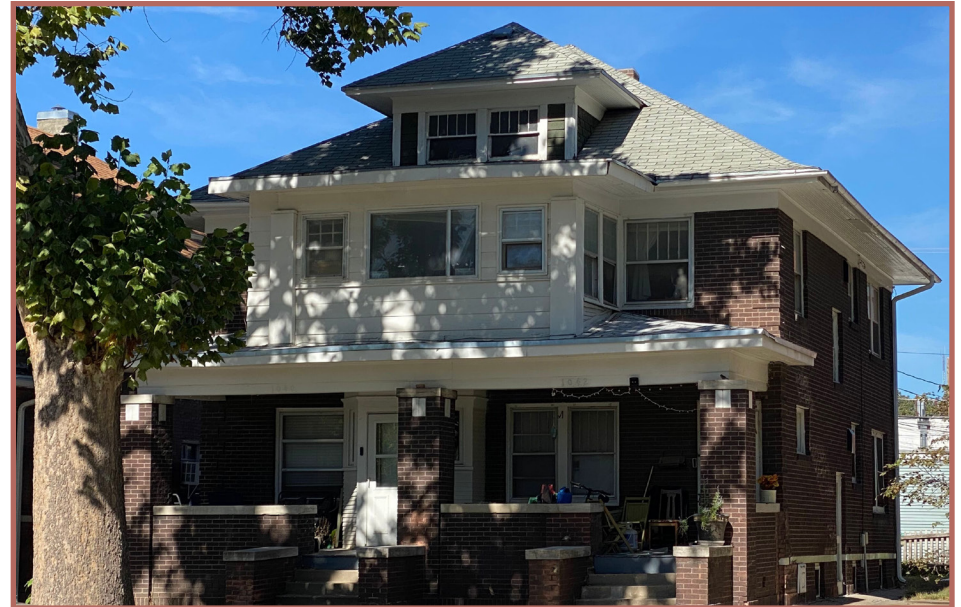
The second story addition detracts from the character of this foursquare home and should have been designed on the rear facade.

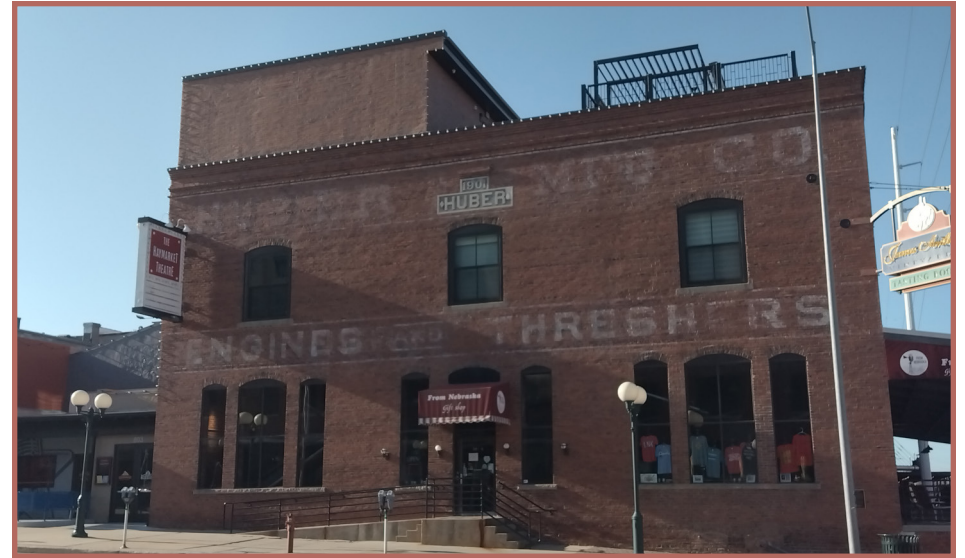
The rooftop addition on this historic building was not set back from the building edge and the blank facade competes with the street facing facade of the historic building.

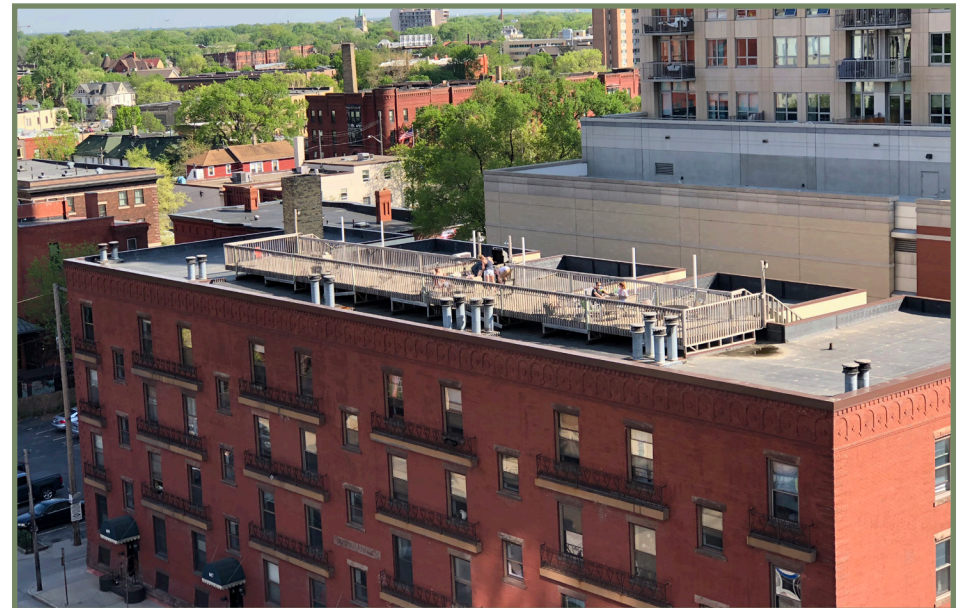
A rooftop patio space on the four story building is minimally visible from the street, but provides some outdoor space for the building tenants.

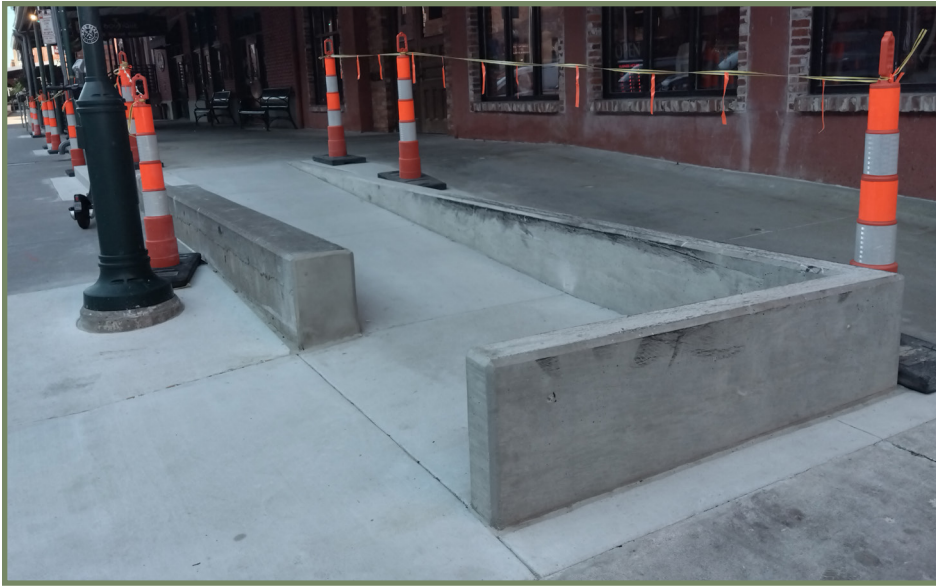
The above ramp was installed to provide ADA access to the businesses in the historic district. The low profile of the ramp walls avoids obscuring the facade of the adjacent historic buildings.

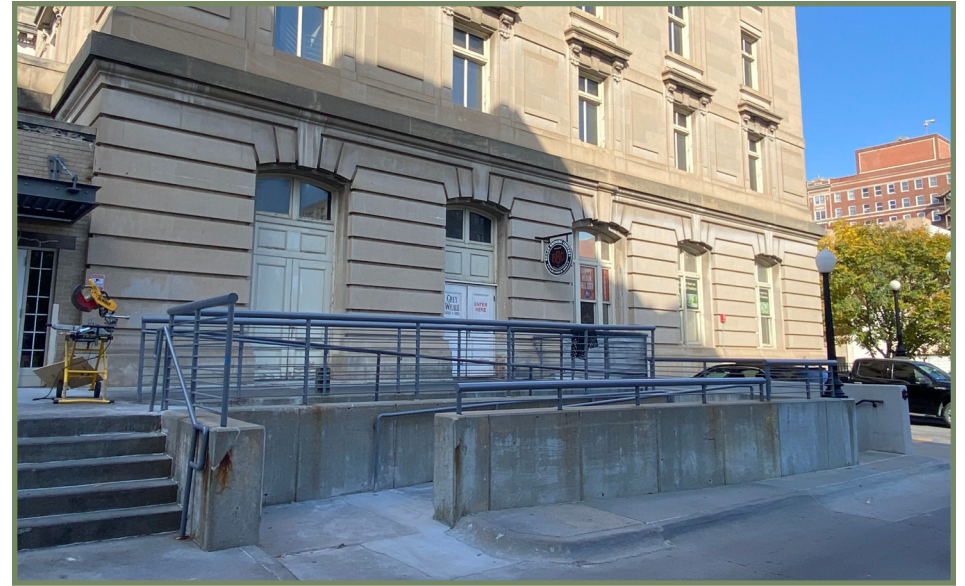
The image above shows the Old Federal Building with a ramp added to the rear of the building. The grey color of the railing does not compete with the building, however the amount of rails starts to interfere with the facade. It's location on the rear is ideal for a treatment of this level.

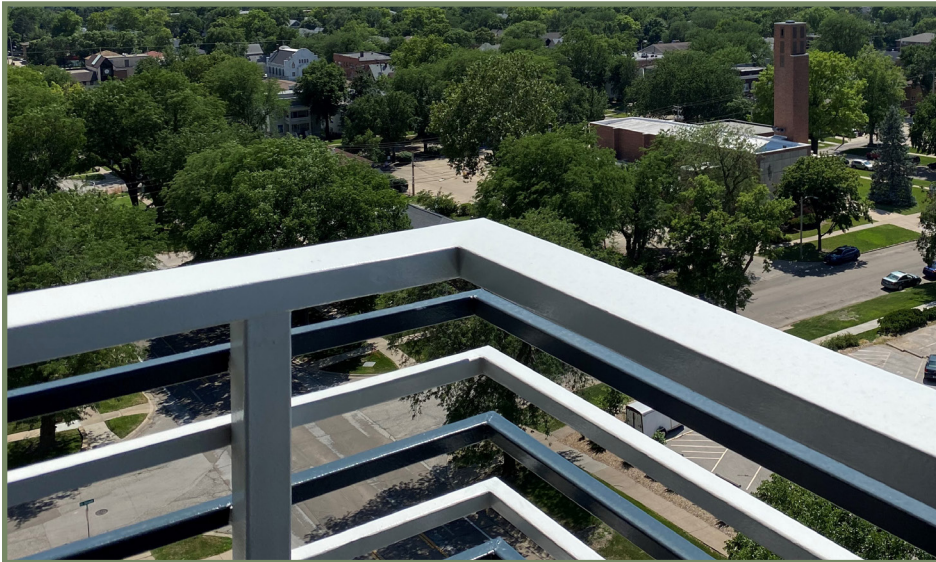
To meet code requirements on guard rail spacing, the Sky Park Manor project added the additional horizontal black rails which fade into the background, allowing the original aluminum rails to stand out.

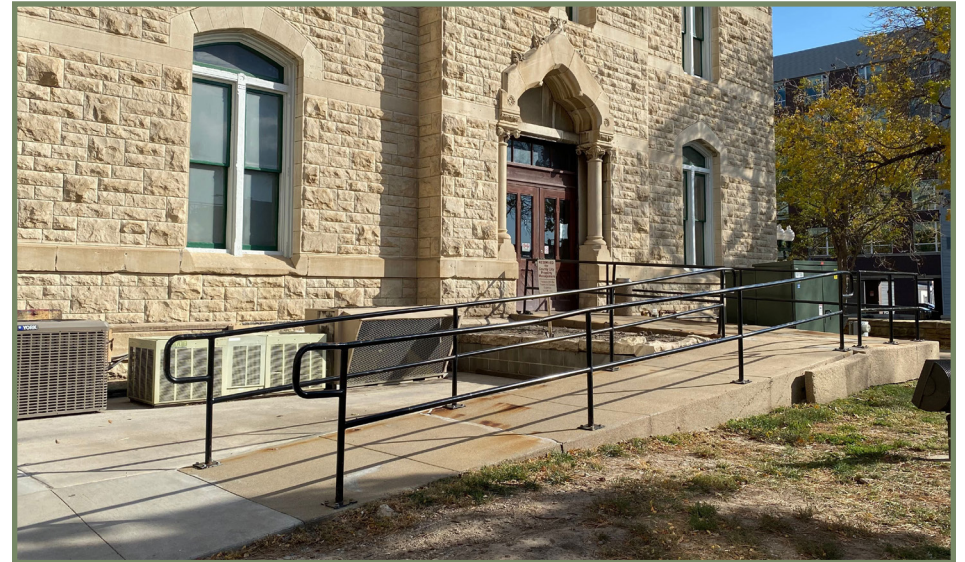
The image above shows the Old City Hall with a ramp added on the side with a simple black railing that does not obscure the facade.

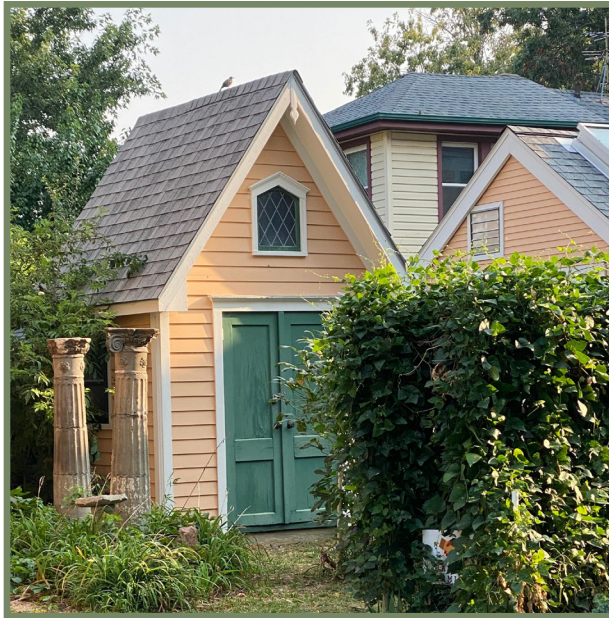
The accessory building above matches the color and material of the adjacent house, with a slightly steeper pitched roof. The wrapped corners and simple bargeboard are additional features that make the building blend into the site.

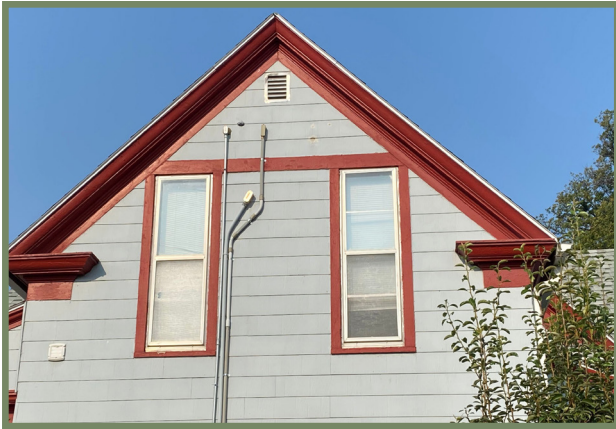
The image above was submitted with a certificate application for a new garage in a local landmark district. The garage, located on the rear of the lot accessed from an existing driveway, is designed with a matching Palladian window in the attic space, cedar siding, and gable returns seen on the home (left). The illustration shows the proposed taller garage to accommodate attic storage remaining subordinate to and in scale with surrounding homes.

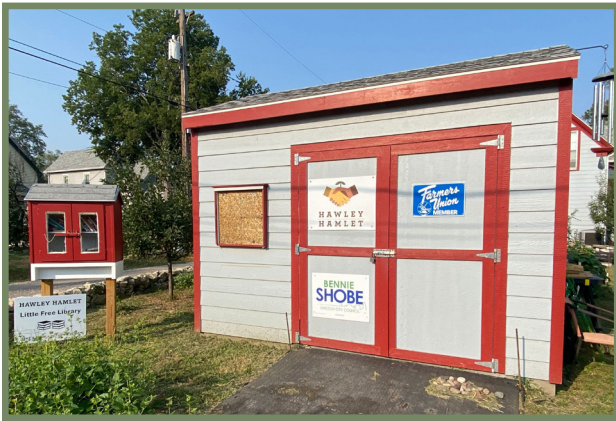
The shed above is located on the alley with simplified design that is similar in color, texture, and scale, while using a modern material, to the home above.

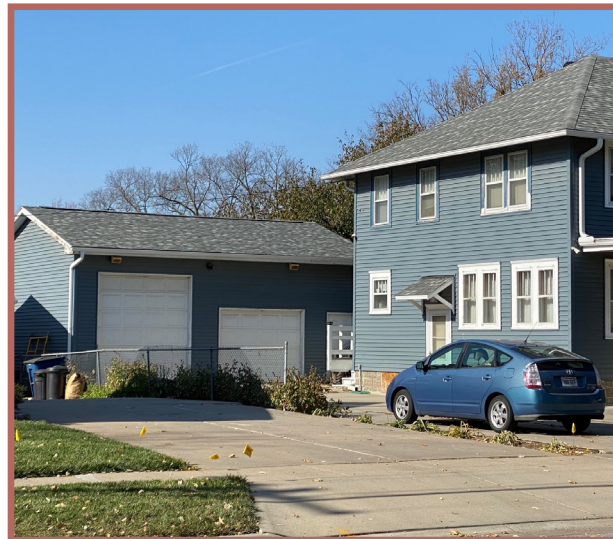
The garage above is slightly too tall to fit with the historic character of the primary dwelling with one overhead door as tall as the first floor of the home.

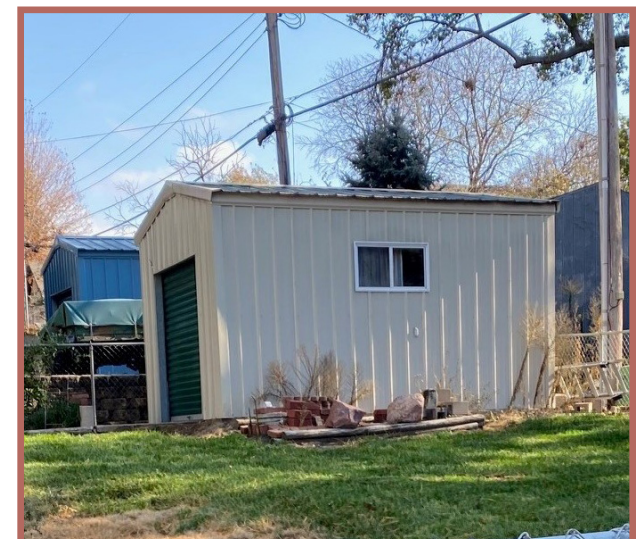
A prefabricated metal shed shown above would not be a suitable accessory building for a historic property if visible from the street.

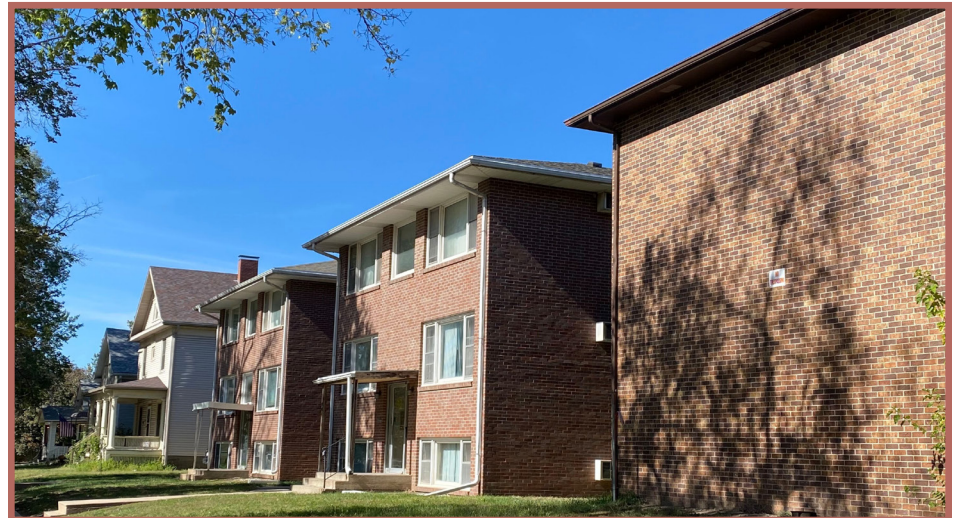
The three apartment buildings above do not fit with the historic district as the building to the right is a blank facade, the roofline configurations are hip whereas gable is predominant, and the windows on the middle apartments are at a height lower than the neighboring building. A positive is the overall height fits with the adjacent buildings without overpowering them.

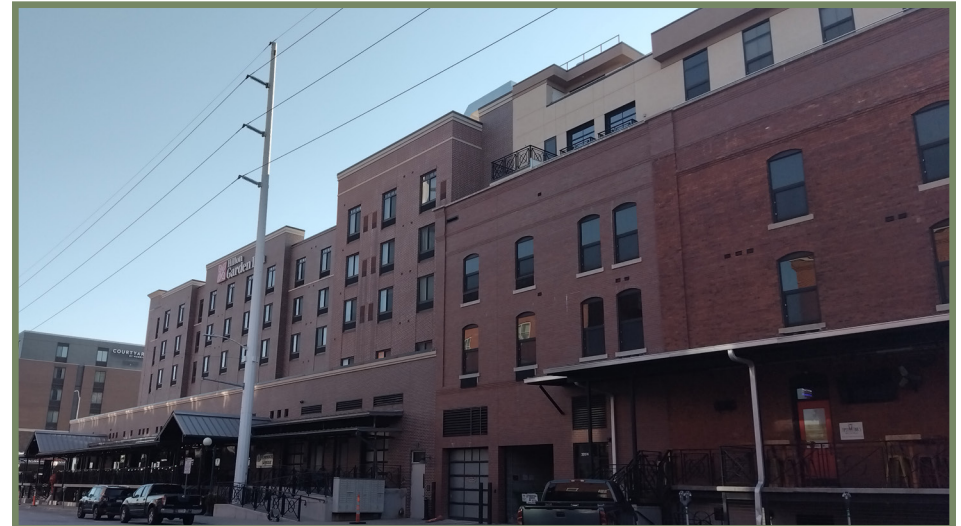
The new Hilton Garden Inn located on 8th Street in the Haymarket Historic District is compatible with the district but can clearly be seen as a modern building. The dock height is continued along the new facade replicating the design of the Henkle and Joyce Building. The brick is distinguished with a new color and the offsets on the facade reduce the overall massing.

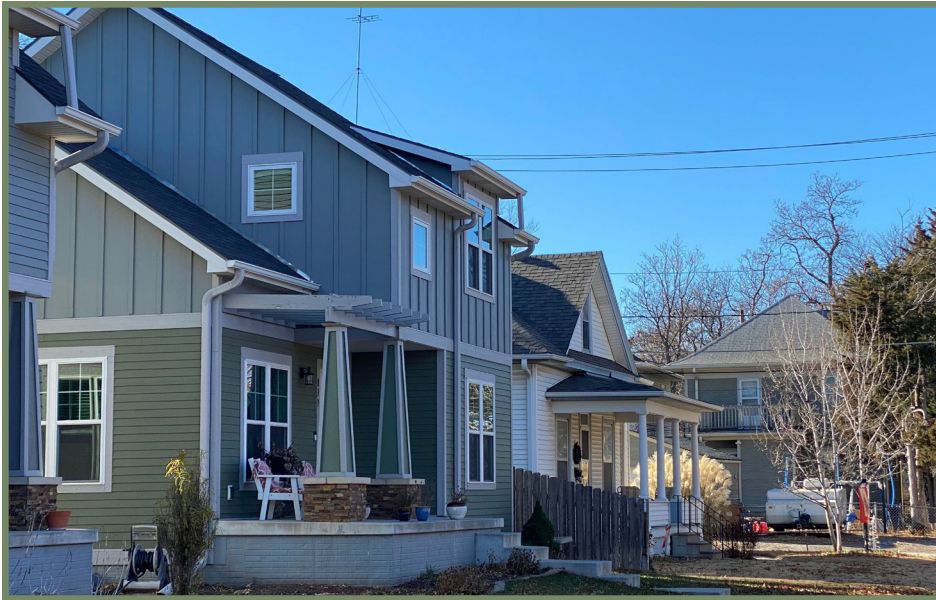
The above infill housing in the foreground was designed with durable materials, similar roof pitches, similar building setback, and a craftsman style that fits with the bungalows located across the street.

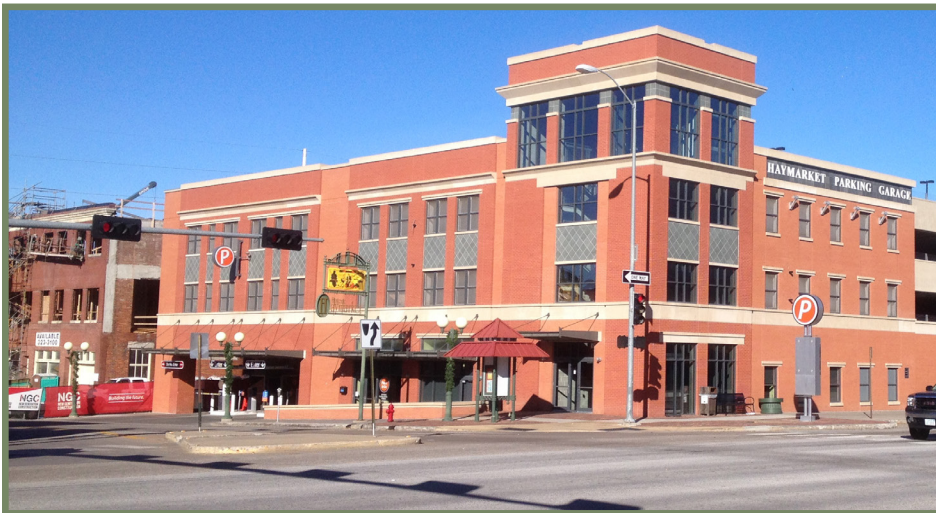
The Haymarket parking garage does an excellent job aligning the floor heights, fenestration pattern, and cornice line of the adjacent historic building. A slight offset in the facade creates three distinct bays, breaking up the large building mass.

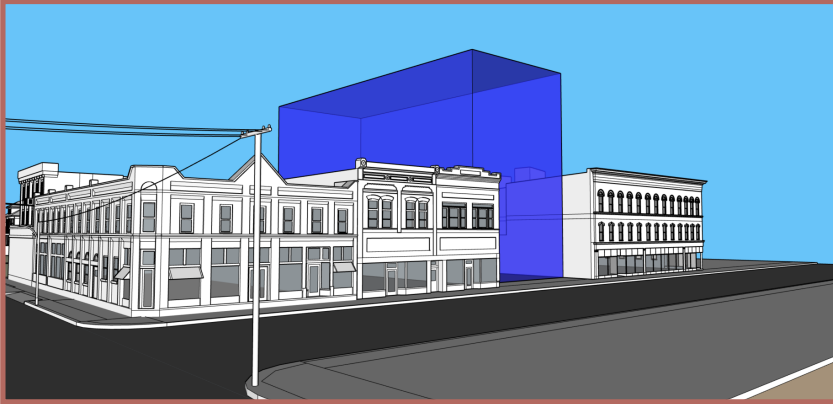
Not approvable:

- The height of the infill is nearly twice that of the adjacent buildings
- The building sets back from the established building line

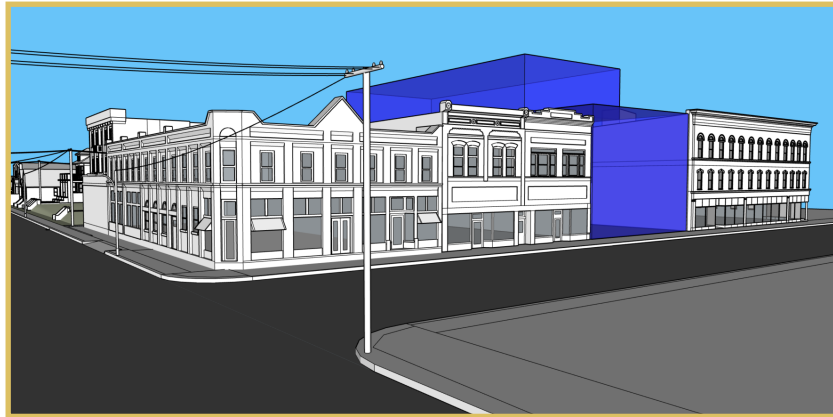
An acceptable infill option:

- The larger height of the building is stepped back at least one bay from the front facade
- The building is placed in line with the established street facade

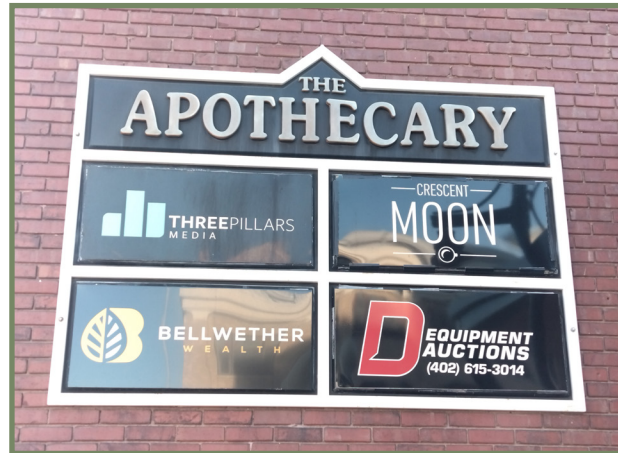
Central tenant sign for a multi-tenant building to the side of a main entrance.

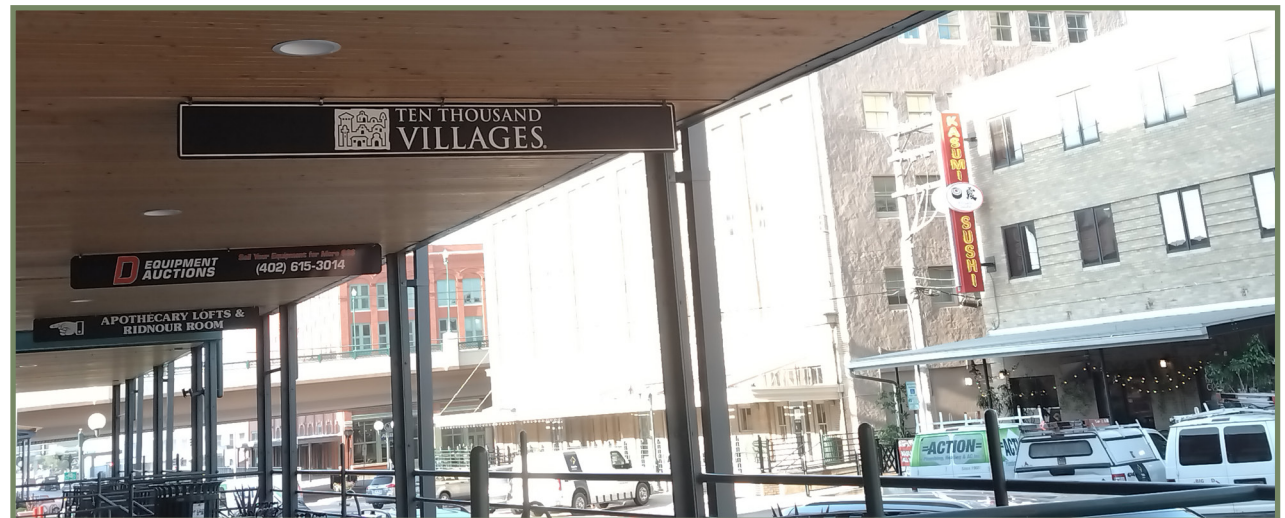
Pedestrian scaled signs (marquee signs) located in front of each business entrance.

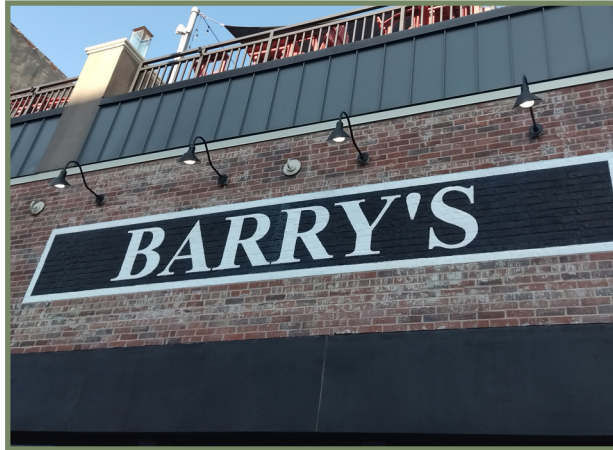
Appropriate painted sign

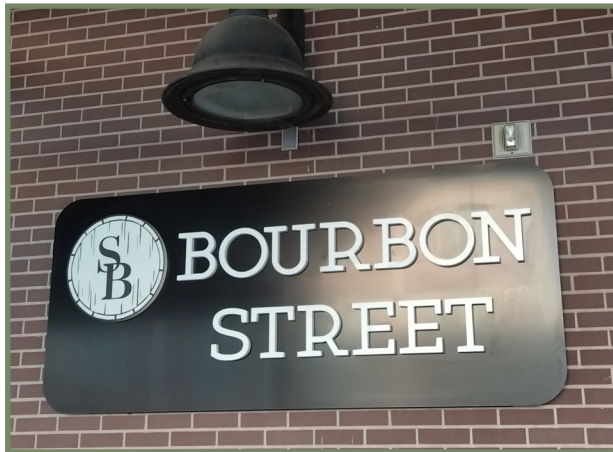
Appropriate metal sign

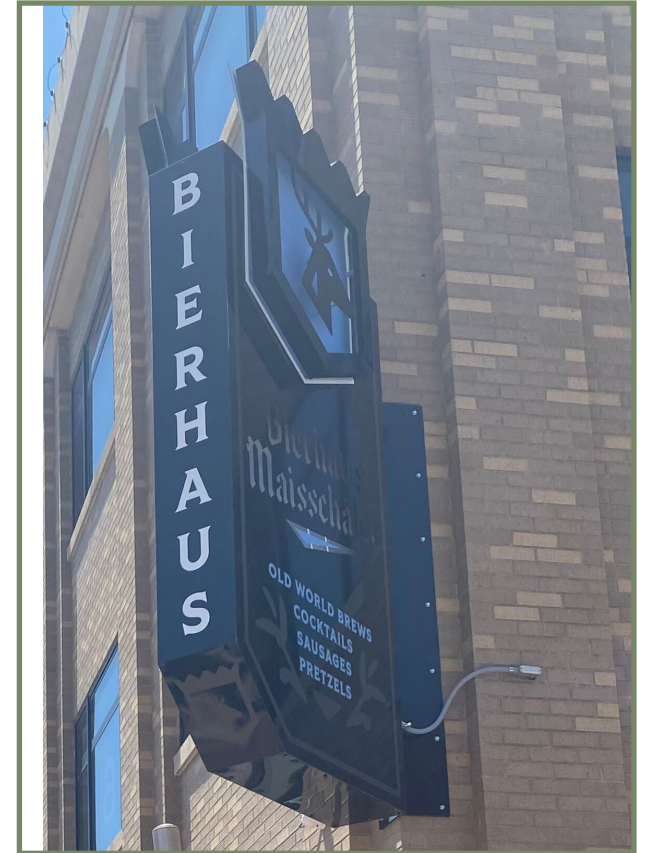
Example of limited amount of conduit and wiring exposed on the building to illuminate the sign.

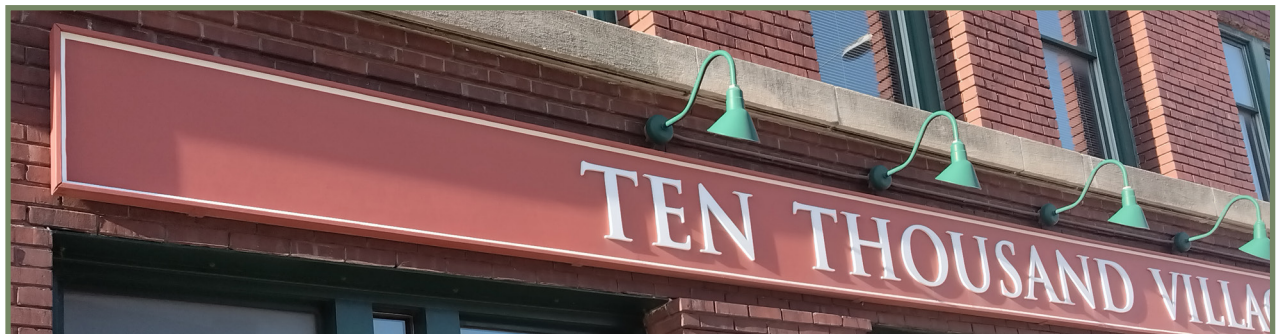
Appropriate wood sign

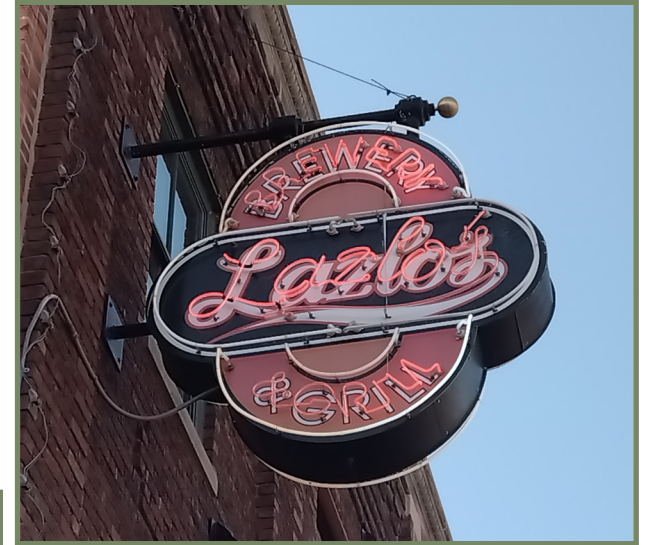
The neon sign above is an iconic element in the Haymarket Historic District.

- 13.18. While neon signs were not common in a warehouse district setting, they would add to the character of the district. Additional signs with exposed neon tubing, either in the form of signs within windows, or projecting exterior signs, will be carefully reviewed on a case-by-case basis for their traditional quality of design, appropriateness to the individual building, and overall impact on the streetscape.

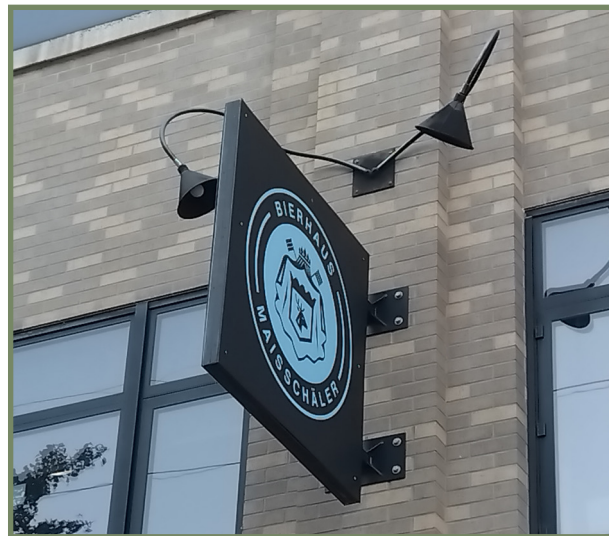
The image above shows gooseneck lighting to illuminate the sign with indirect lighting.

- 13.16. Illumination should be either externally shielded to spotlight wall signs, awnings or projecting signs, backlit to create a halo effect, or exposed to form individual letters (usually in a metal channel).
 - a. For externally shielded lights, simple designs such as a gooseneck lamp or simple contemporary fixture should be used.
- 13.17. Window signs in brightly lit storefronts are encouraged as they provide attractive signs at night and increase the ambient light on the sidewalk for pedestrians.

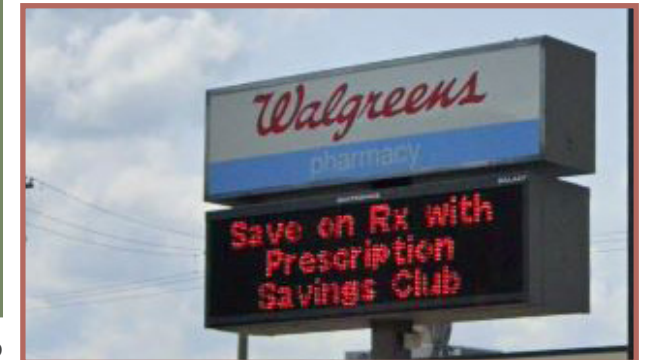
The above internally illuminated cabinet and changeable copy signs would not be appropriate in a historic district or on a historic landmark.

- 13.11. Internally Illuminated Cabinet Signs. Existing signs may remain but are encouraged to be replaced with a sign compliant type. Face changes will not be approved.
- 13.12. Translucent awnings of plastic or vinyl materials with interior illumination.
- 13.13. Electronic Display Signs
- 13.14. Flashing Signs
- 13.15. Billboards will not be approved in the landmark district because the graphic design and changeable nature of their messages are seldom appropriate in appearance to a district.

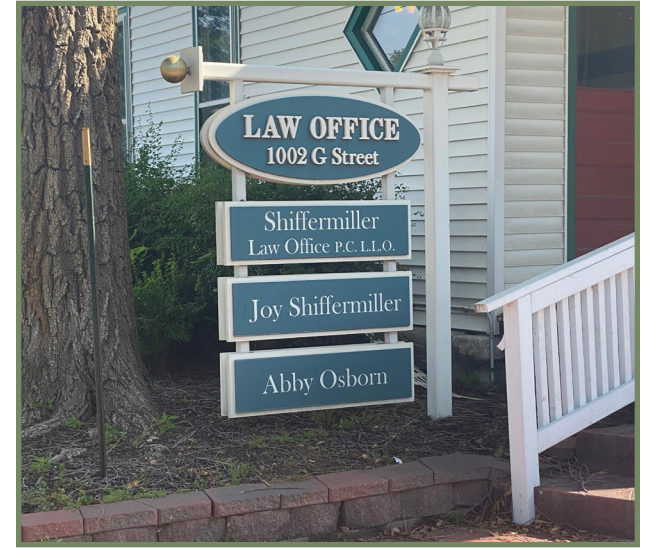
The above freestanding sign identifies tenants of a former house converted to an office use.

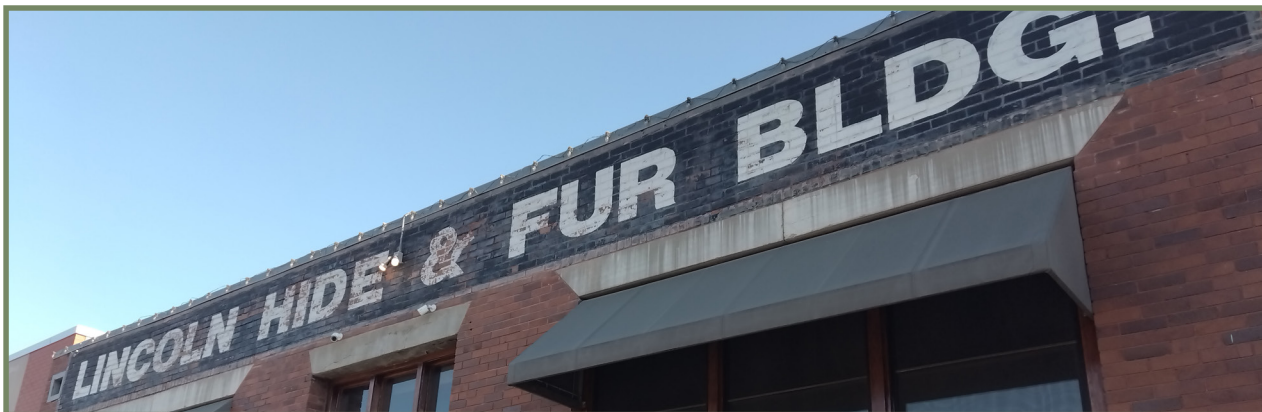
Maintenance of the Lincoln Hide and Fur Building signage shown above.

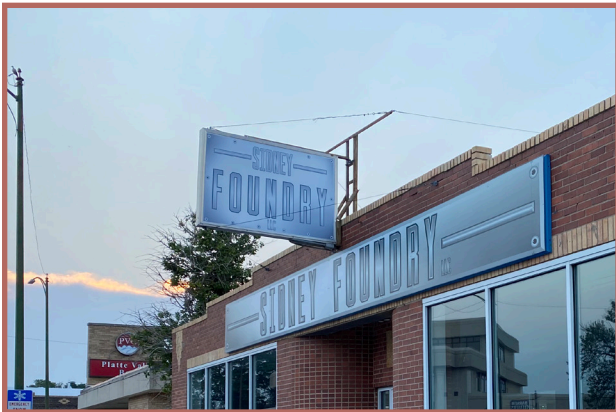
The wall sign above is too large to fit within the open space between the buff brick boarder. A smaller sign would fit better within the sign band area.

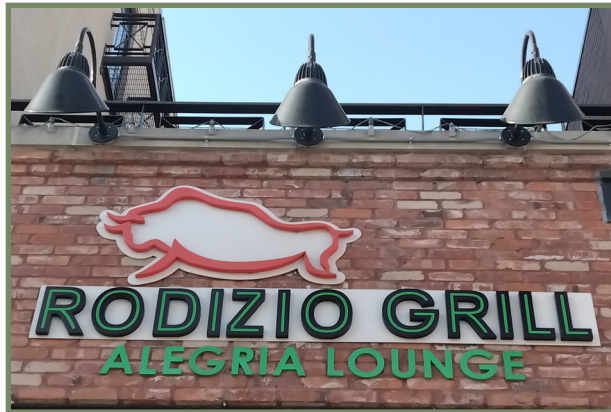
The above wall sign is scaled to fit below the corbeled brick cornice and does not compete with the architecture of the building.

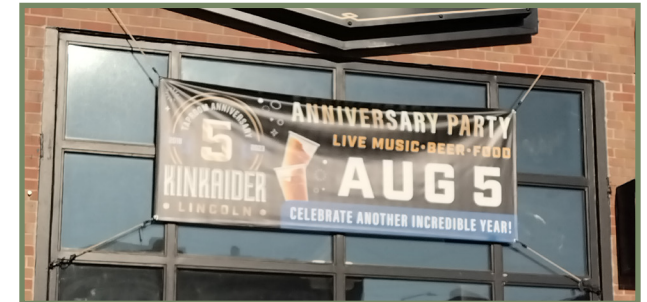
Example of a temporary banner for an event. The installation does not obscure architectural details on the building and is located higher up in the window, allowing visibility at eye level.

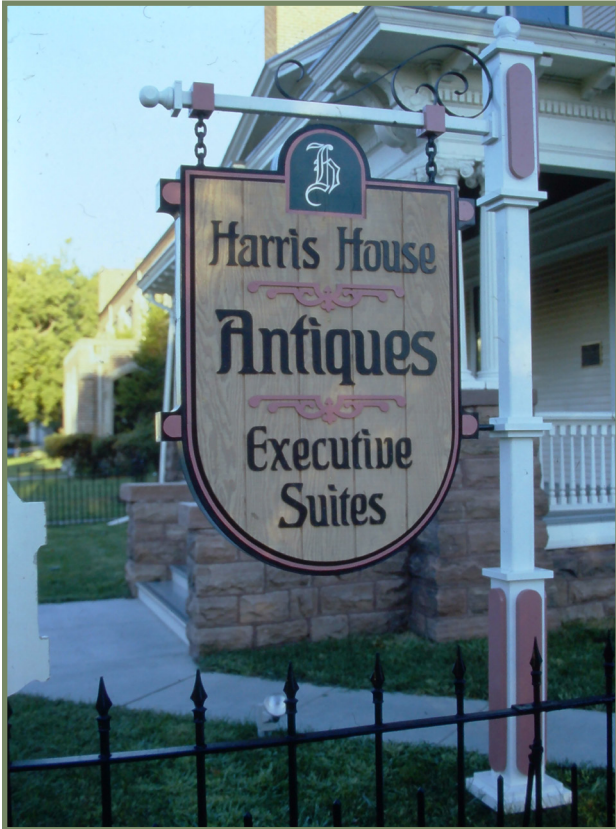
Freestanding sign mounted to a pole for the Harris House Local Landmark.

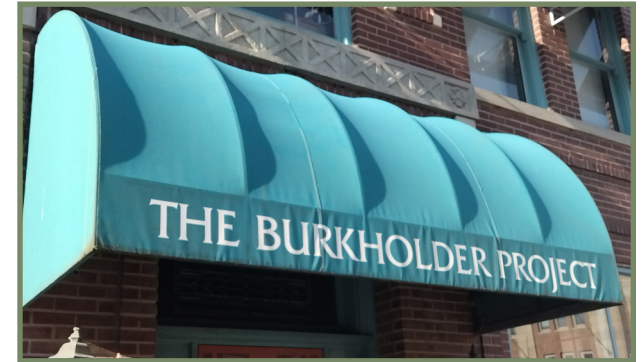
The above canvas canopy illustrates the ideal location of the business name in the valance area.

- 13.44. On an awning, messages should be confined to the valance area (bottom edge) as was historically the case. If serving as the only signage for the building, the body of the awning may be used to identify the business. For guidance on awning design see the Awnings and Canopies section.

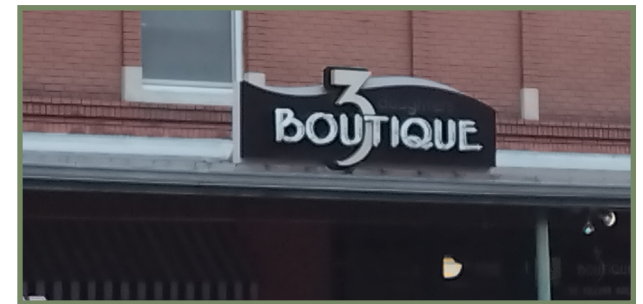
Shown above is an example of signage mounted above the canopy, but within the edges.

- 13.42. Signs on canopies should not remove or alter architectural details when mounted.
- 13.43. Signage should not project outside the edges of the canopy and instead be contained within the area; however, signs may be mounted above or below the canopy.

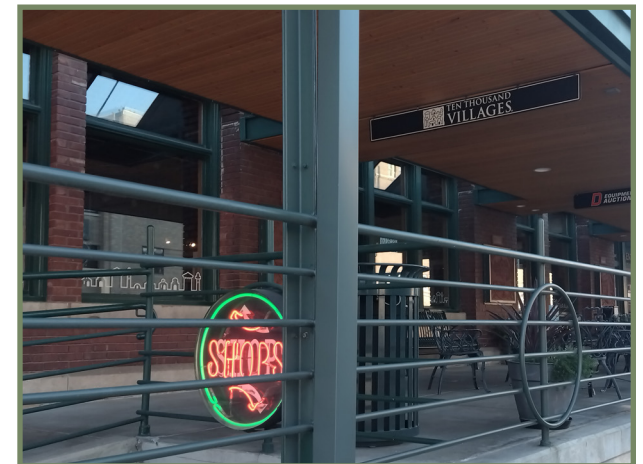
Two types of marquee signage are shown above, mounted to the marquee roof perpendicular to the shop as well as the neon sign mounted

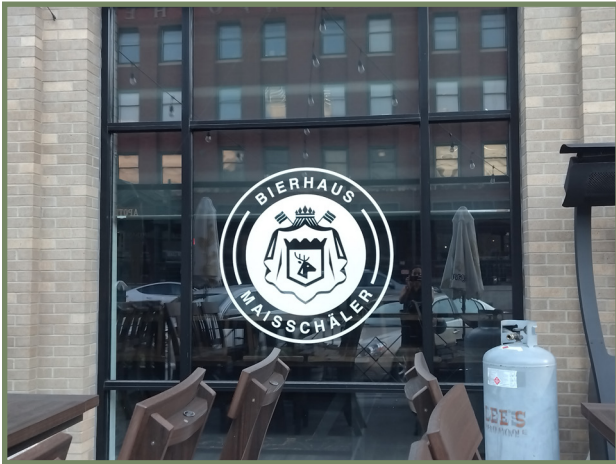
The above window sign is simple and scaled to the opening, however it's placement obscures views into the building. Moving the logo to the window pane above would allow better visibility.

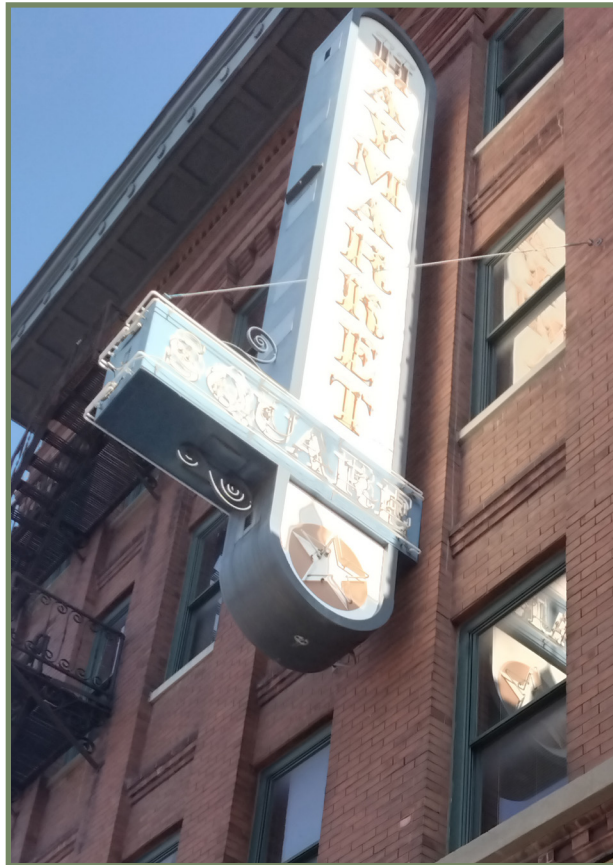
Projecting sign identifying the building which is positioned in the center of a pilaster.
