A Pretty Residence Section, "A" Street,
Lincoln, Neb.

Historic Preservation Standards

Adopted: Summer 2024

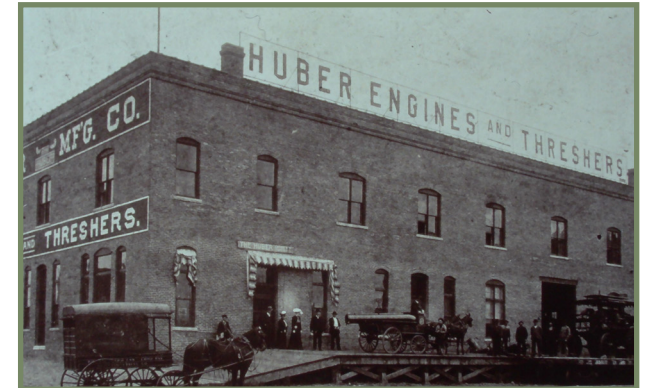
Example of historic roof signage on the Huber Building (801 Q Street) in addition to painted signage and fold up canvas canopies.

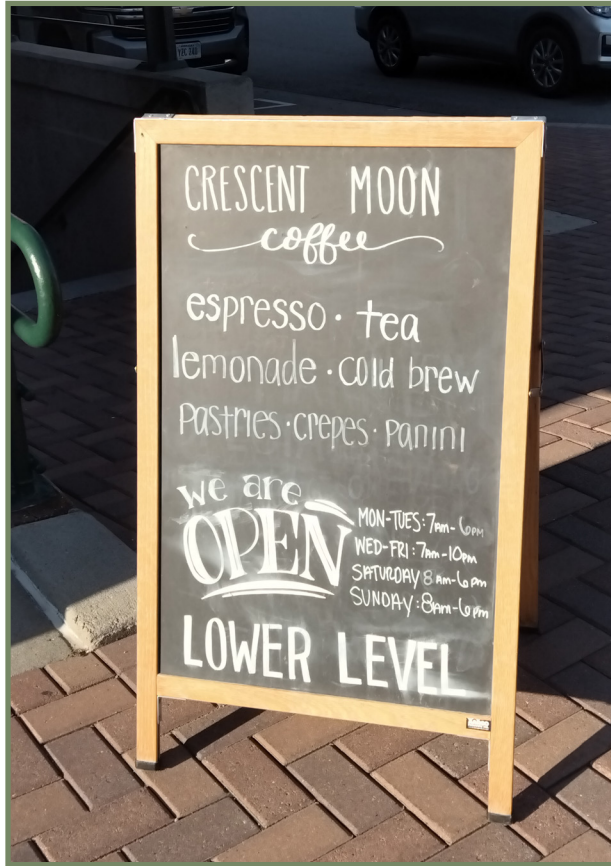
The above sandwich board is appropriately scaled and placed out of the pedestrian way in front of the building.

- 13.54. One “sandwich board” sign is permitted per first floor business, not to exceed 4 feet in height and 26 inches in width.
- Signs should only be placed outside the business during business hours and stored inside when closed. When outside, the sign should be weighted down to ensure it does not collapse or blow into the street.

- Signs should be placed out of the pedestrian walkway and allow a clear path for travel.
 - Sandwich board signs are permitted to be displayed for a period not to exceed 48 hours when in conjunction with a special event and meeting the above requirements.

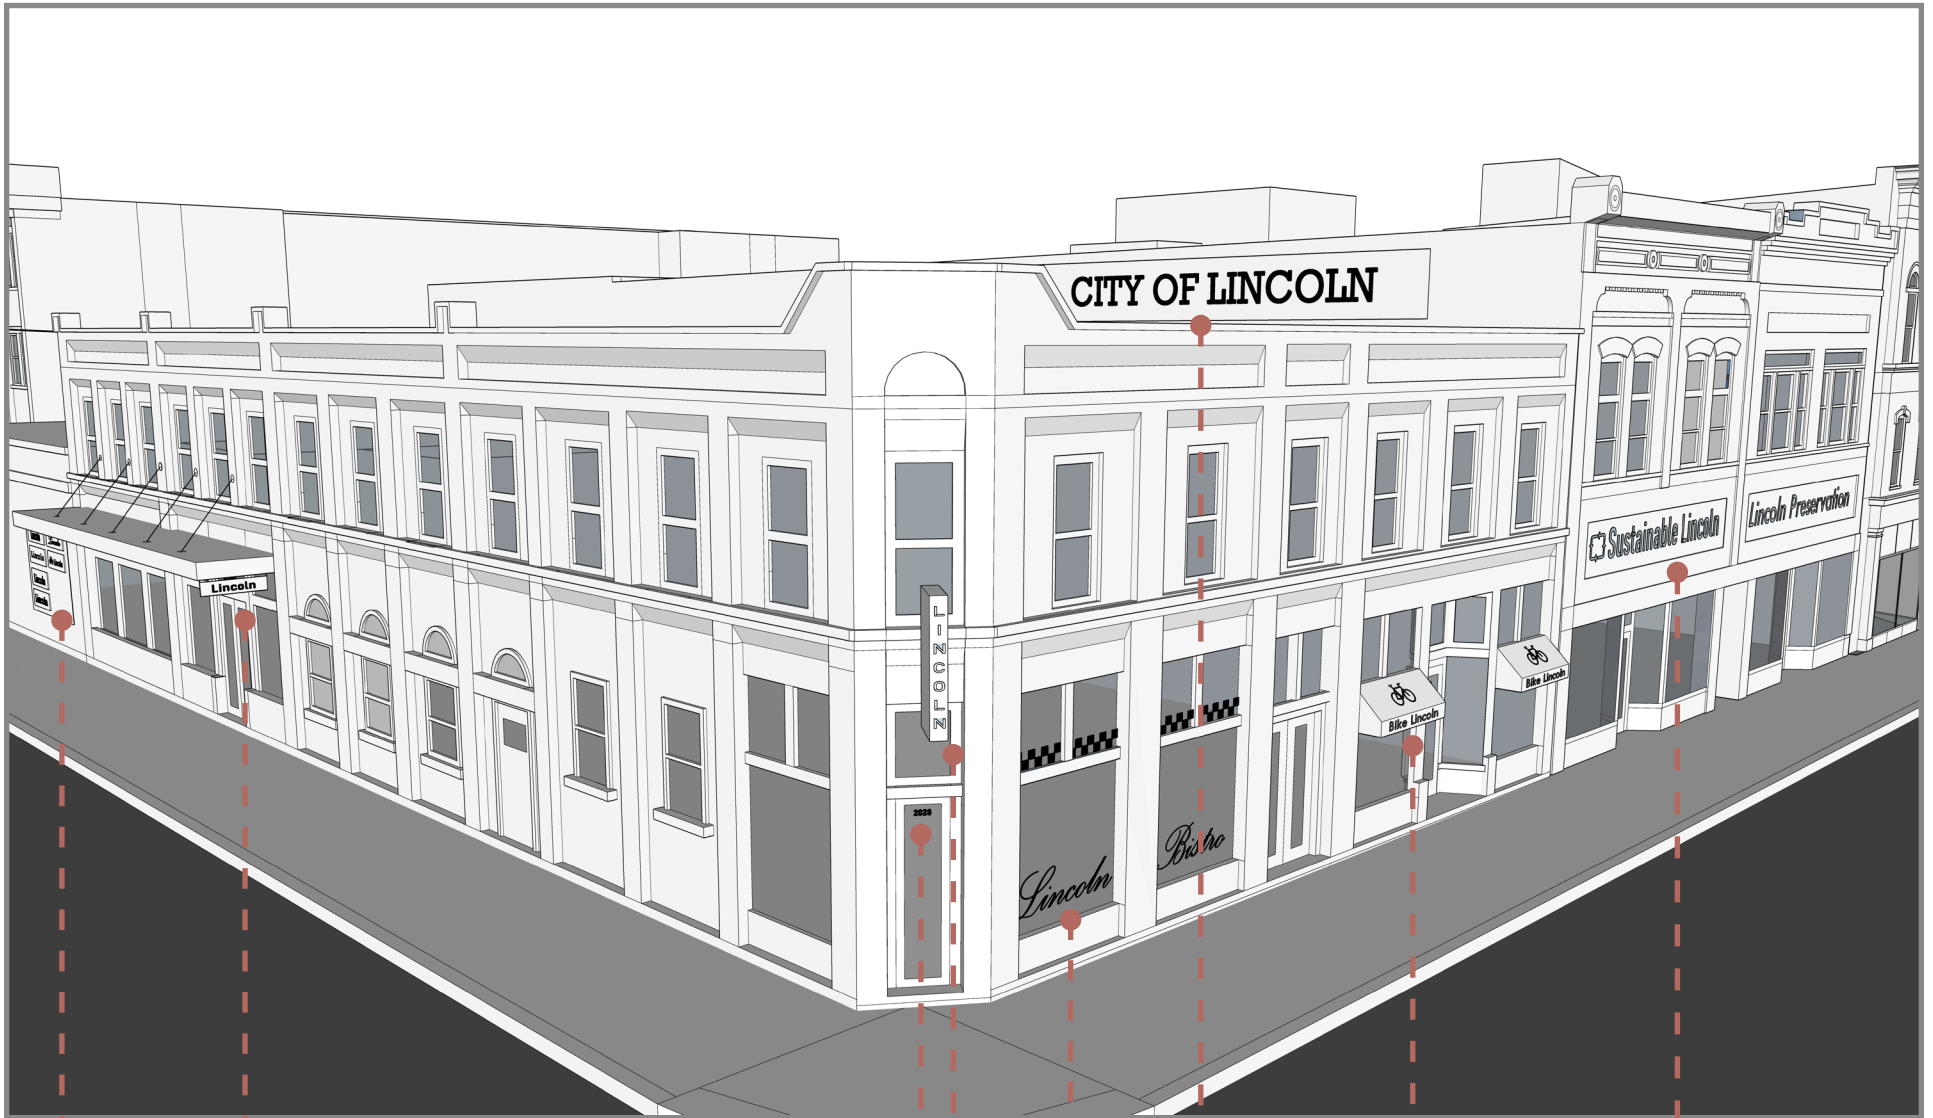
SIGN TYPE DIAGRAM

Multi-Tenant
Sign

Marquee Sign

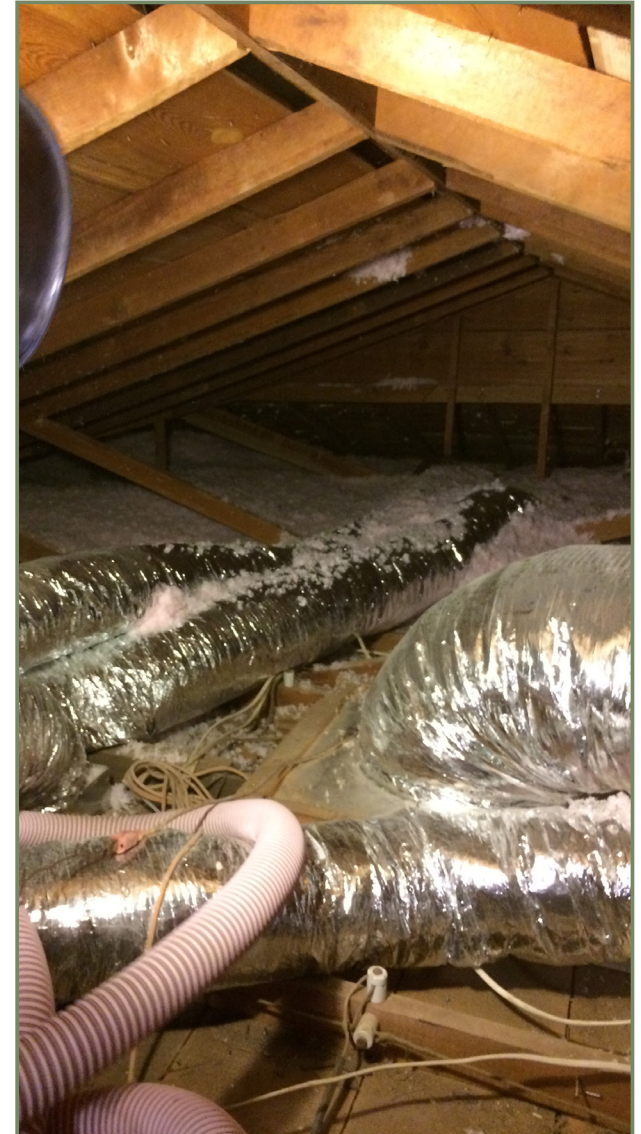
The above addition of blow in insulation in an unused attic space increases the thermal barrier without compromising other areas of the home.

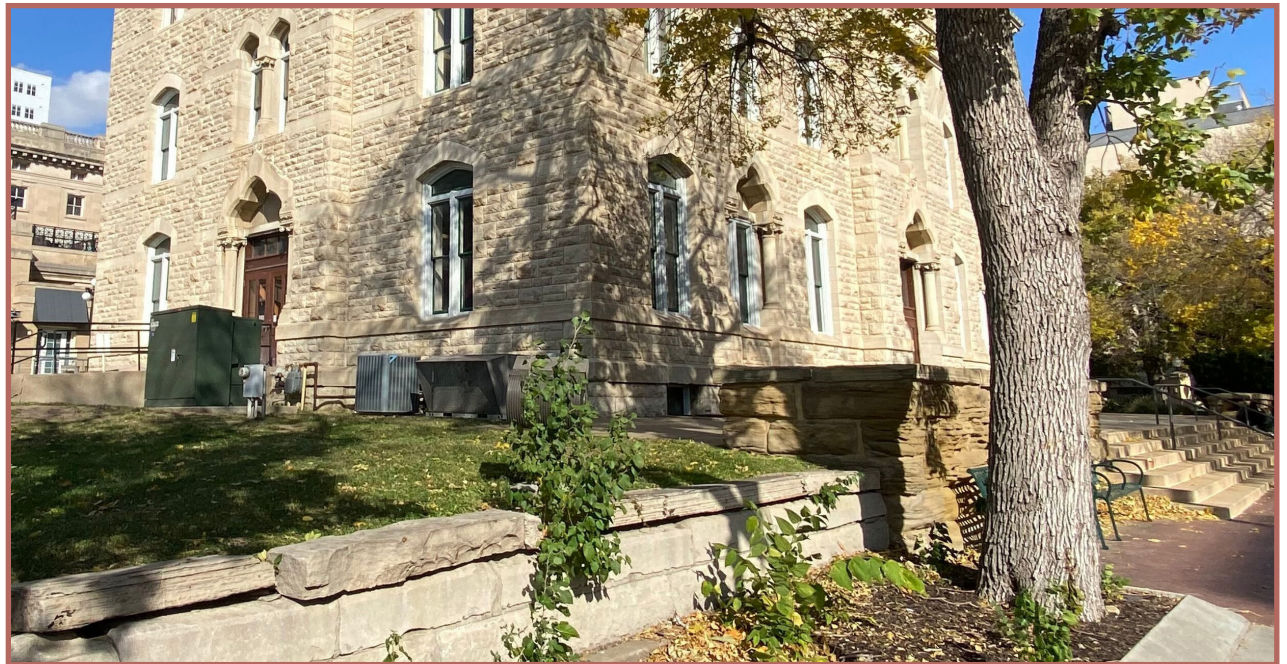
The ground mounted mechanical units at Old City Hall are very large and visible from the public right-of-way and not properly screened with fencing material.

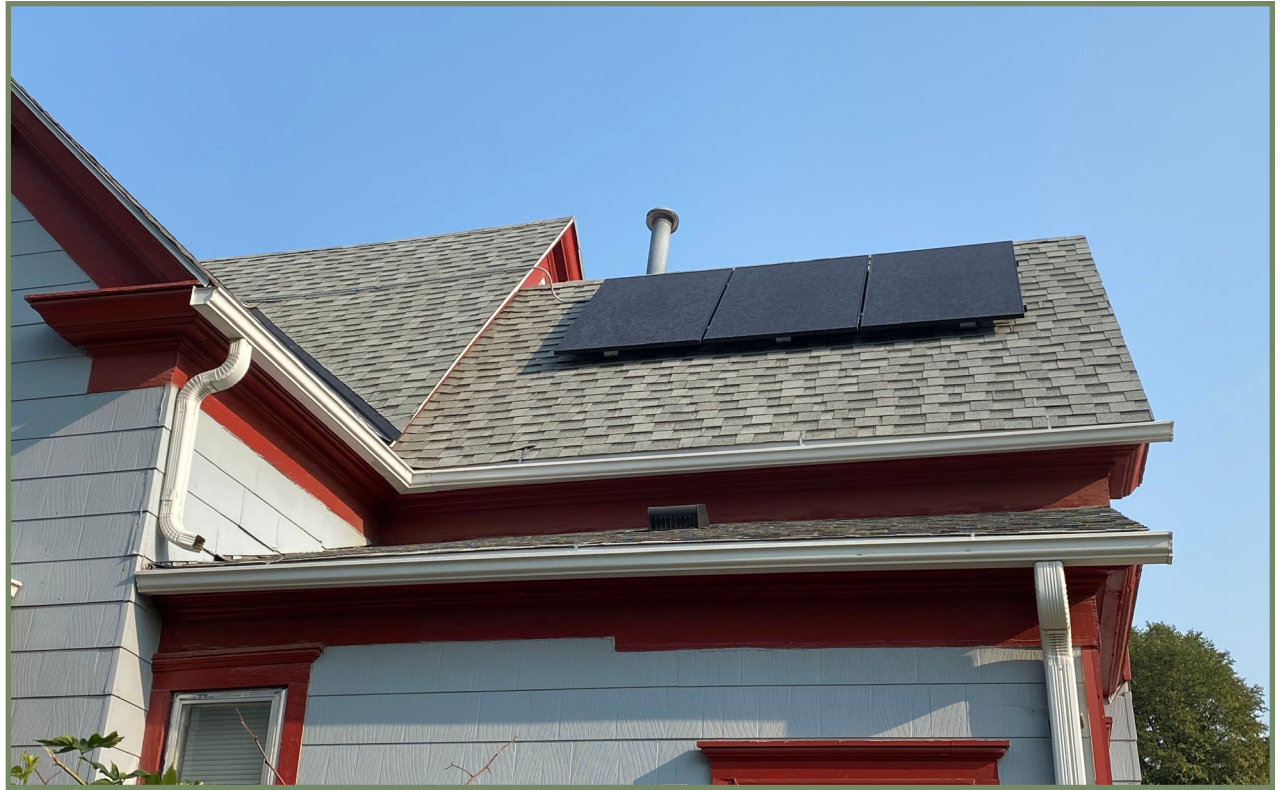
Solar panels mounted with a low-profile, flush against the slope, on a secondary slope.

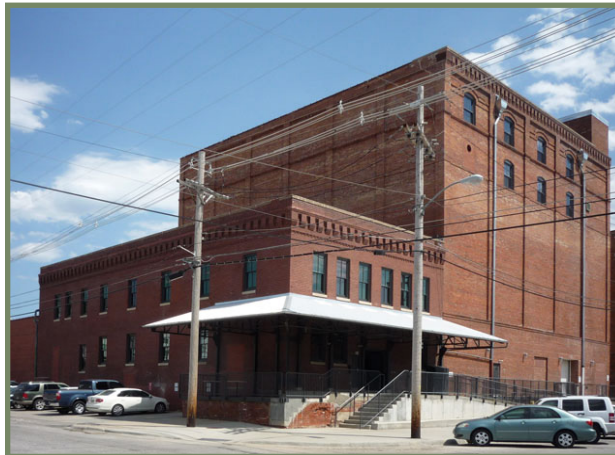
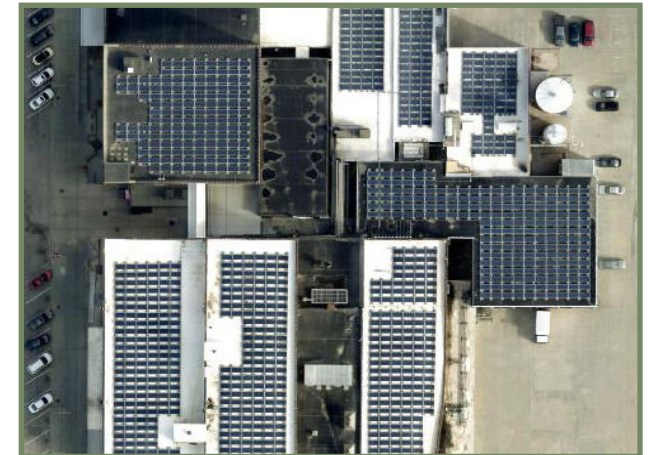
The Meadow Gold Complex above is an excellent example of solar installations. Viewed from the street (left) you cannot see the panels. Viewed from above (right), the entire roof is providing clean energy for the building.

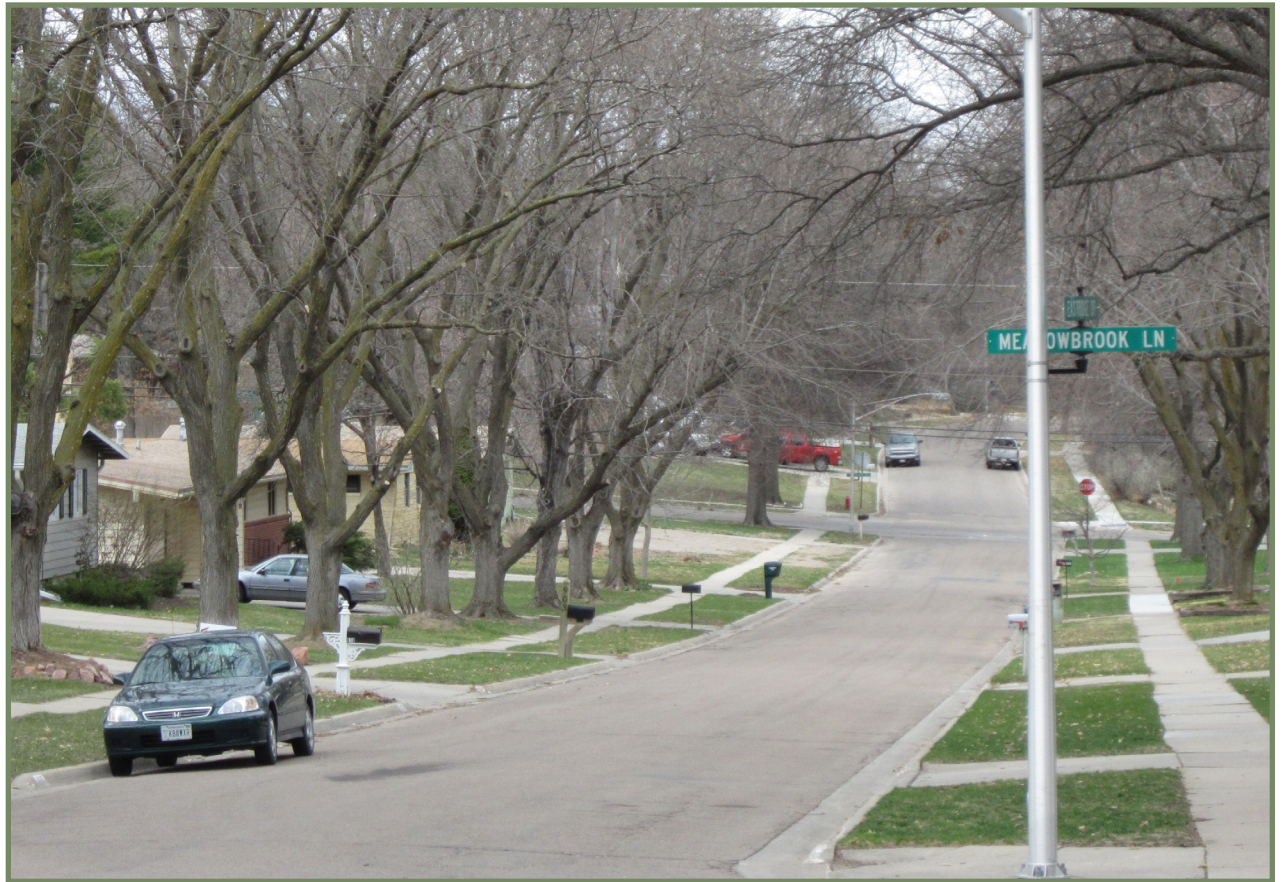
The setting of the Eastridge National Register District shown above is characterized by its wider boulevards, established tree canopy, and concrete sidewalks on both sides of the street. Widening a street like this would compromise the setting of this district.

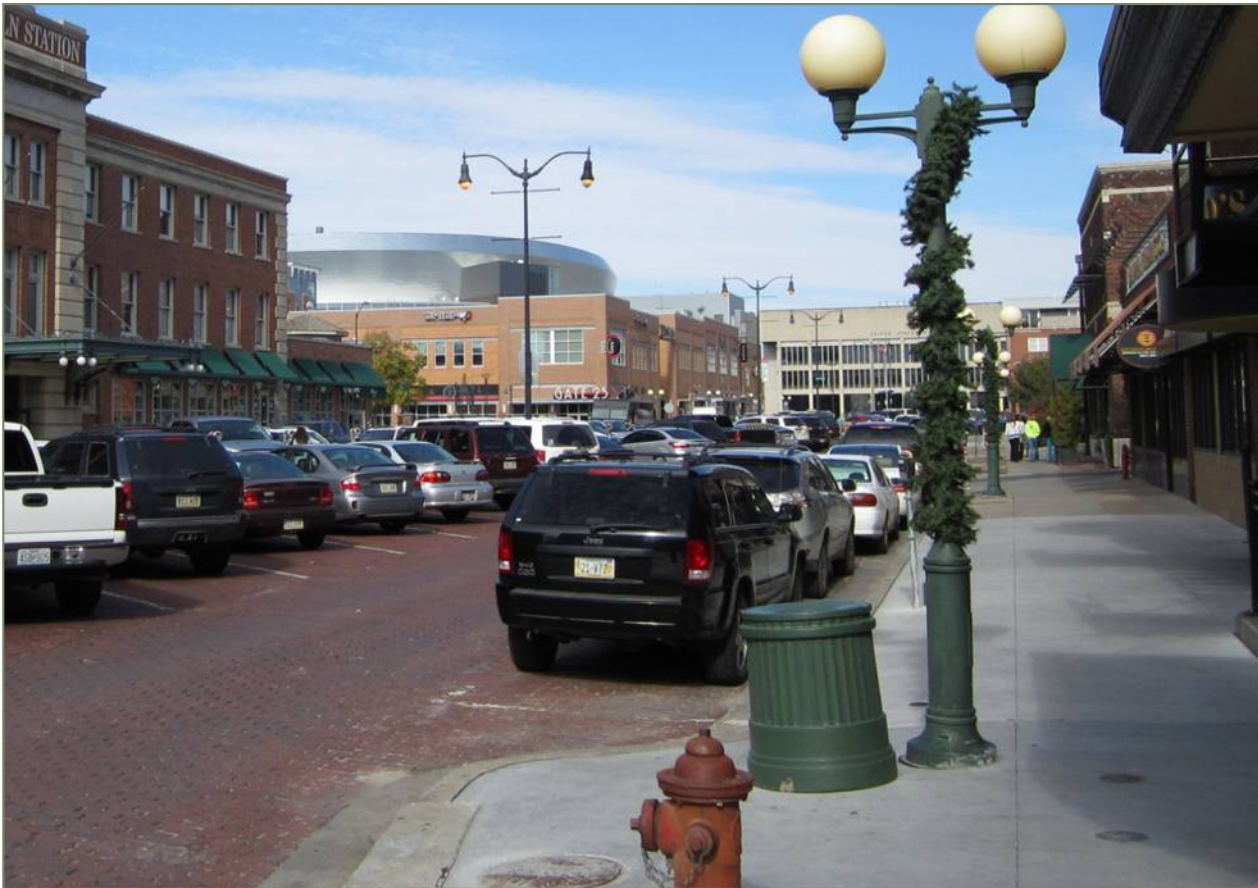
The above image of 7th Street in the Haymarket Local Landmark District, while updated to allow for more vehicle parking and pedestrian bump outs, preserves the historic brick streets, uses period appropriate lighting, and maintains the relationship of the buildings and to the setting.

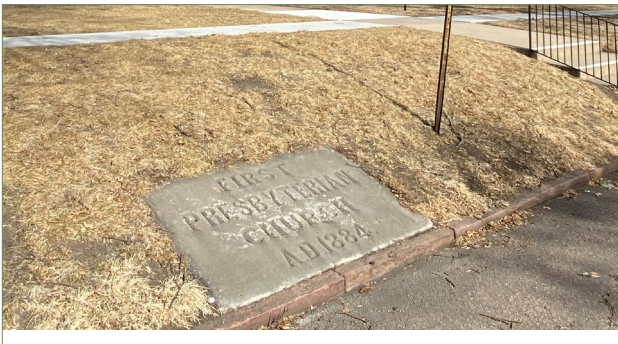
The above image shows two important features in the boulevard—original sandstone curbs and a stone marker for the adjacent church.

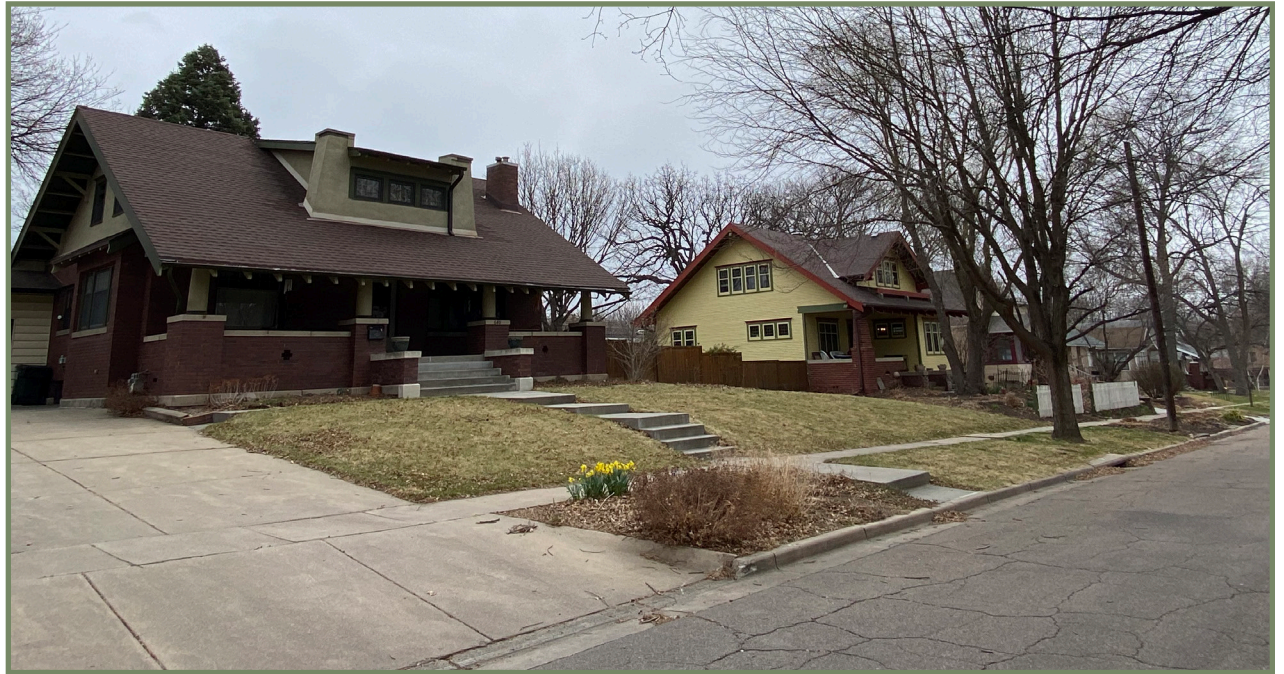
The homes in the Woods Park Bungalow District were built mostly without front access garages. Shown above, paving to the house should be avoided unless using permeable materials and curb cuts kept to a minimum.

- a. If necessary, paving up to the building foundation should be done with permeable materials. Impermeable paving adjacent to foundations causes splash back that can erode and damage the foundation material.

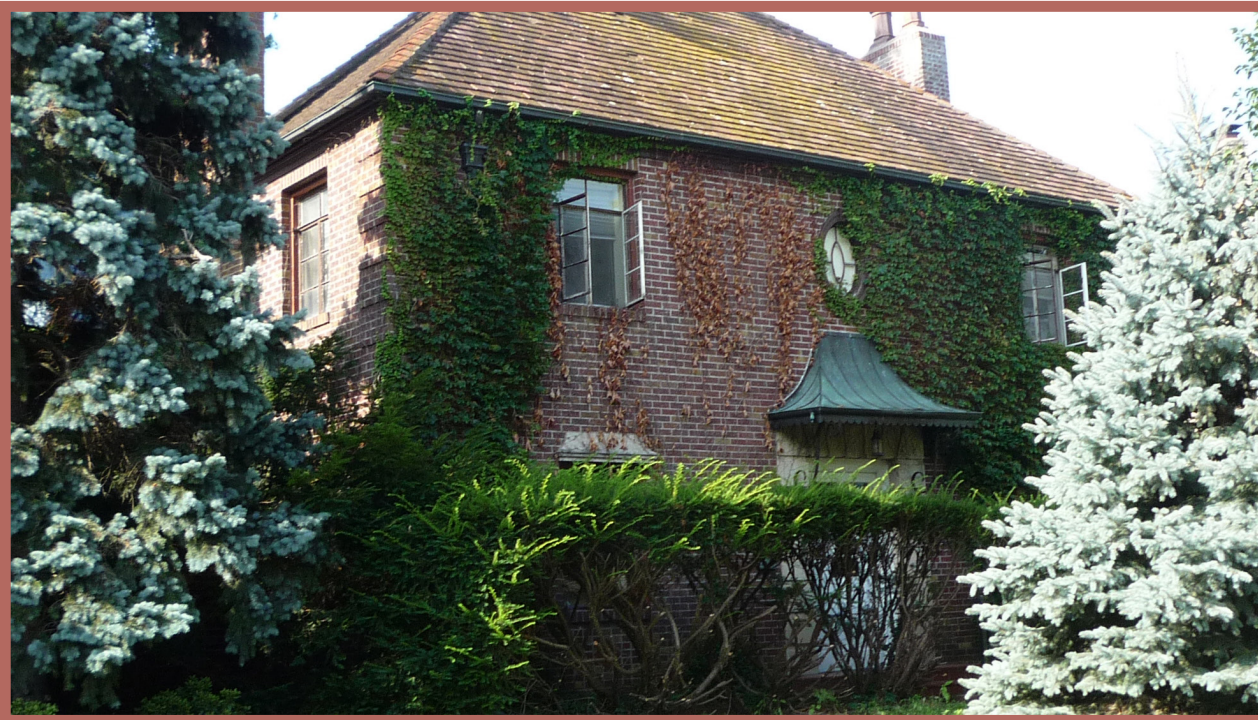
The landscaping has grown to a height that obscures first floor windows and the vines are growing over second floor features.

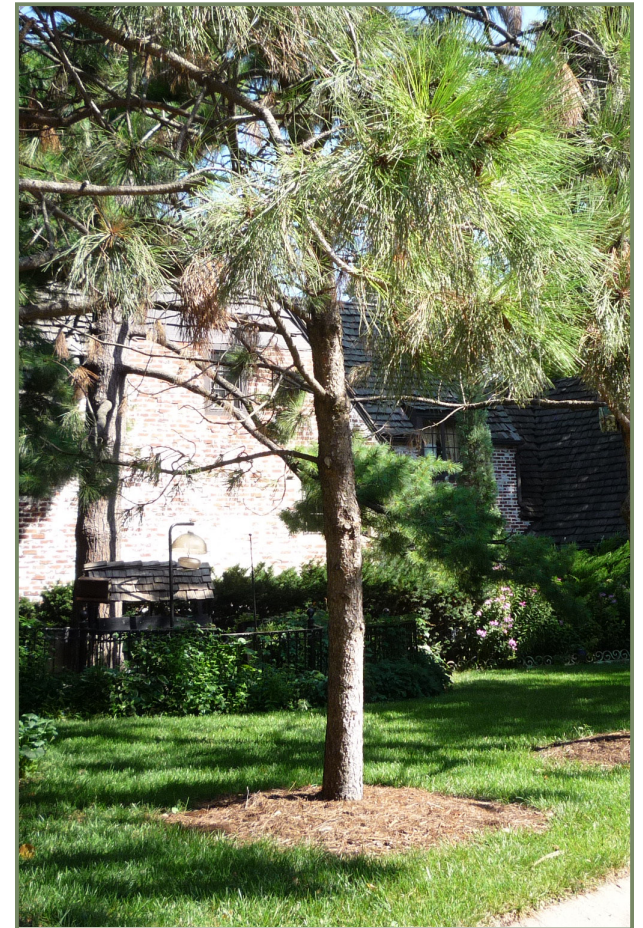
The above coniferous tree has a mulch ring that protects its bark from string trimmer damage.

16.25. Trees should have a mulch ring or other similar barrier at the base and not grass to avoid damage to the base of the tree by lawn care equipment.

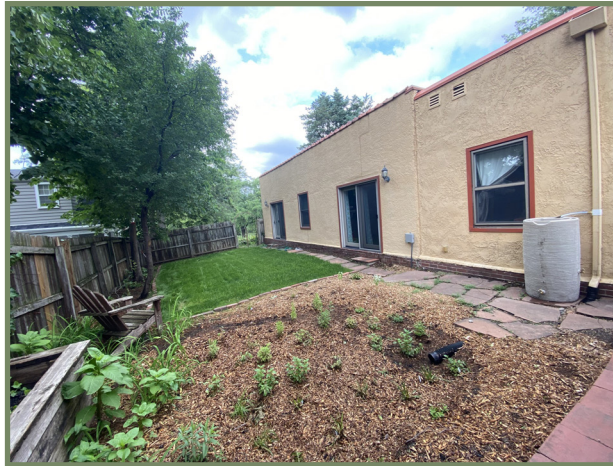
The above newly planted rain garden is located in the rear yard of this home. On the right is a terra cotta colored rain barrel, selected to match the style of the Mission style of the home.

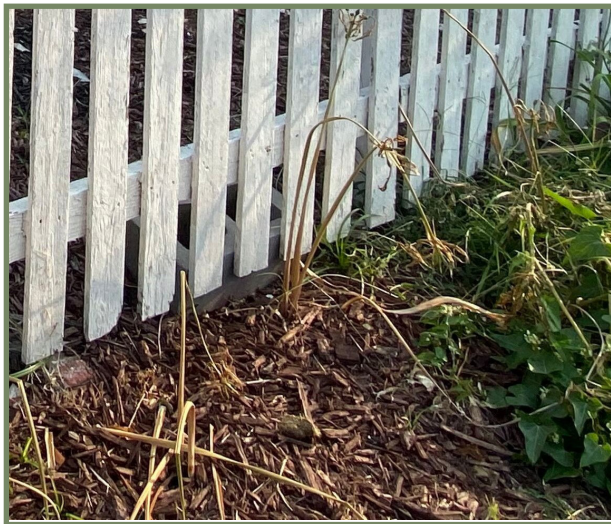
Example of a fence less than 48 inches in height with greater than 50 percent opacity.

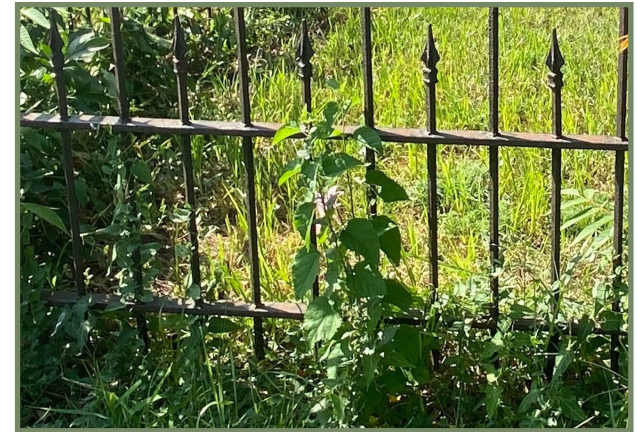
Example of a historic iron fence located in the front and corner front yard.

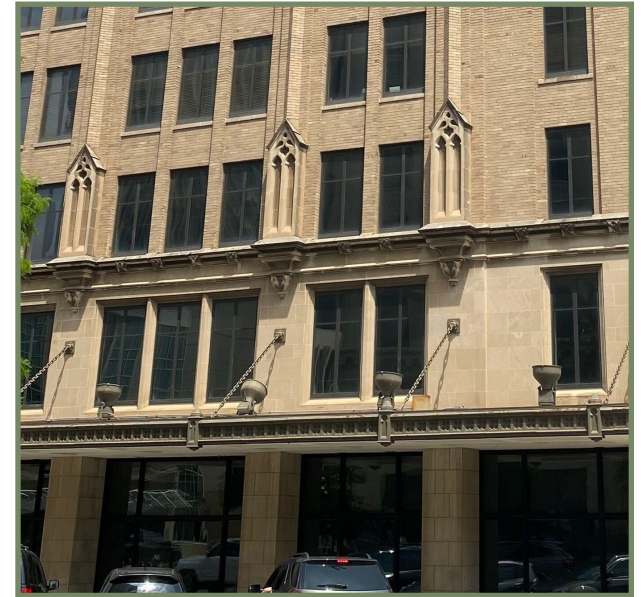
The above facade lighting mounted to the top of the canopy is appropriate for the historic commercial building, with an attempt to conceal their presence by painting them a similar color to the canopy.

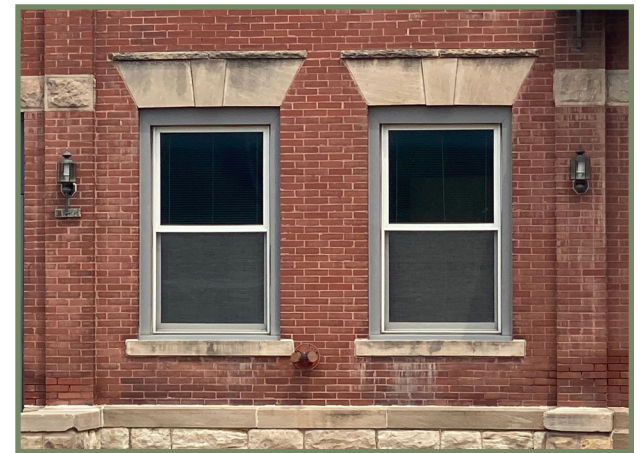
Wall sconces installed in the first floor pilasters are scaled appropriately and fit the period of the historic architecture.

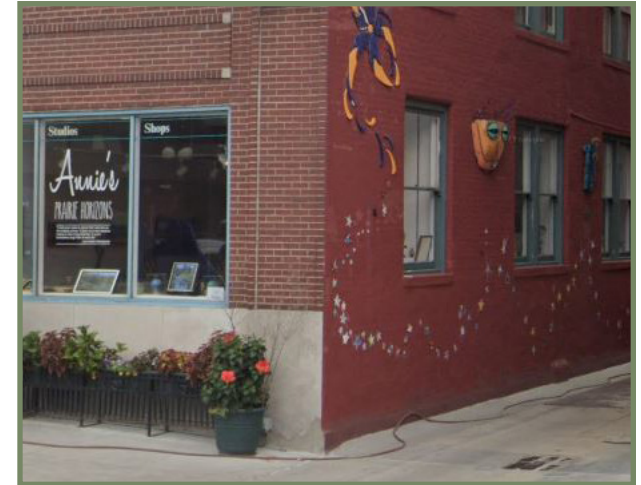
Gallery Alley in the Haymarket Landmark District is a good example of locating artwork on a secondary facade that does not obscure architectural features.
