Section 7

Capital Improvement Projects

7.4.1 Project SSC-1: Grade Control Tributary SC005R005

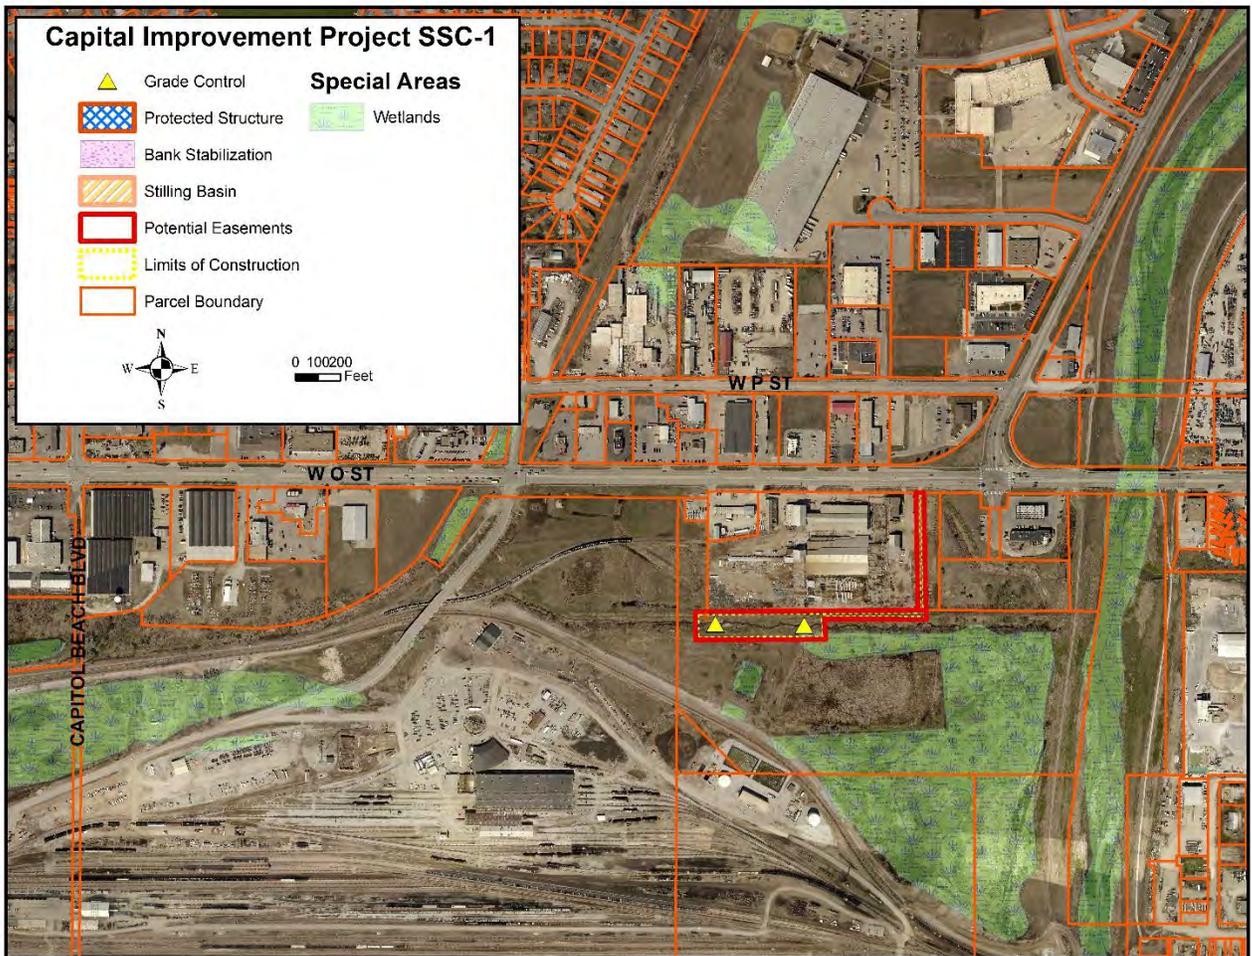
Figure 7-6: Conceptual Layout of SSC-1

Problem description: Incision is moving up tributary SC005R005 paralleling W O St north of Rosa Parks Way.

Recommendation: Recommend constructing grade controls along the upper reach at existing knickpoint locations and installing outlet protection below culvert outfalls to maintain the profile grade along this reach and protect the outfall structures.

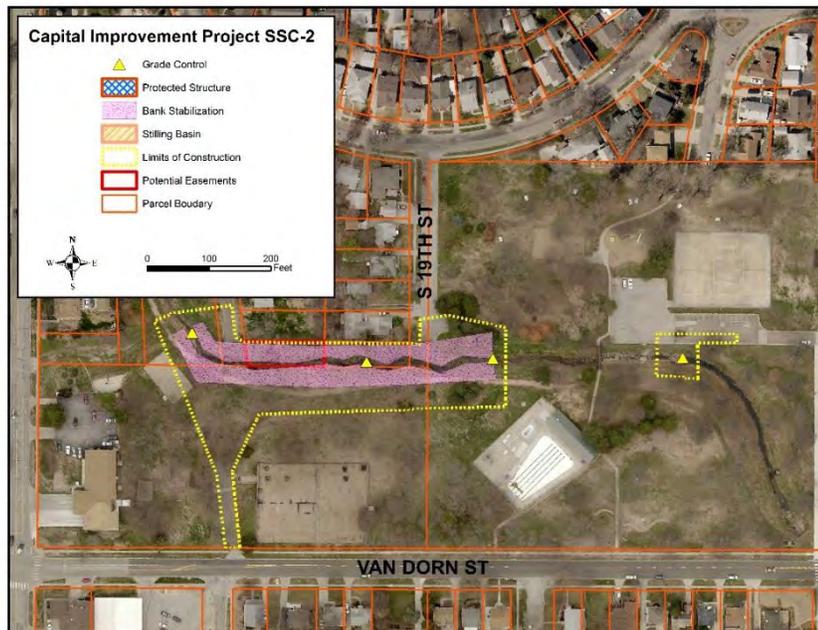
Figure 7-9: Conceptual Layout of SSC-2

Problem description: Stream incising and plan form adjustment on tributary SC015R015 is threatening Irvingdale Park infrastructure and one residential parcel. An existing rock grade control is failing upstream of the park pedestrian bridge over the tributary and bank erosion is threatening the park trail, one resident and a storm water outfall downstream of the pedestrian bridge.

Recommendation: Recommend removing the failed grade control and replacing it with a new rock grade control structure and associated bank stabilization to stop incision and protect the parking lot and the project reach upstream of the pedestrian bridge. Recommend installation of grade controls and bank stabilization measures to protect the residential parcel, park infrastructure and storm water outfall along the project reach downstream of the pedestrian bridge.

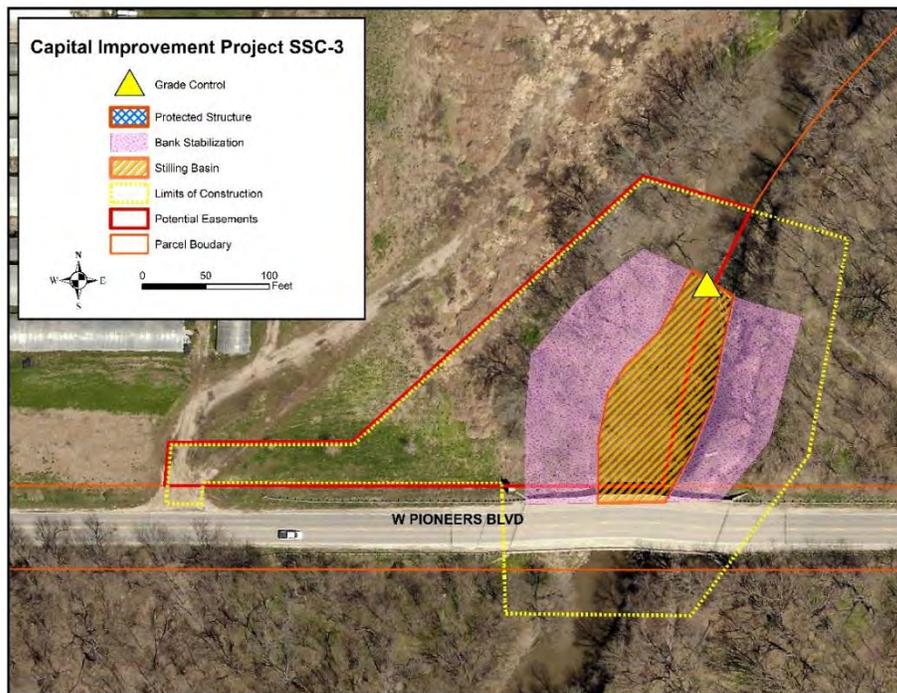
Figure 7-11: Conceptual Layout of SSC-3

Problem description: An existing rock armored knickpoint in the channel main stem SCR010 at W Pioneers Blvd Bridge (County Structure O-175) over the main stem (Located east of W Pioneer Blvd and S 1st St) is failing. Past incision has exposed the bridge pier foundation and the stream banks downstream of the bridge are eroding.

Recommendation: Recommend constructing a rock grade control and stilling basin with associated bank revetment to protect the bridge piers and channel by preventing the knickpoint from propagating upstream. A USGS stream gauge is installed on the bridge at this location. The designed revetment must not interfere with the operation of the gauge. City GIS contour data indicates the channel flowline at elevation immediately upstream of the knickpoint at the W Pioneers Blvd Bridge is 1,136 feet AMSL.

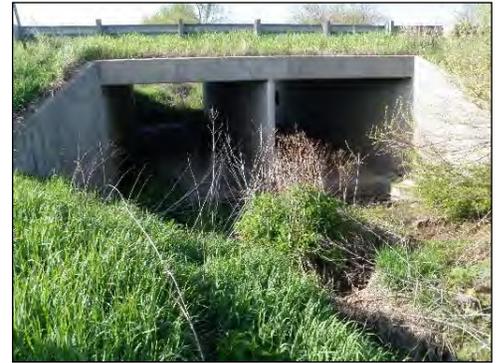
Figure 7-33: Perched Saltillo Rd culvert

Recommendation: Recommend constructing a grade control, stilling basin and associated bank stabilization to protect the culvert.

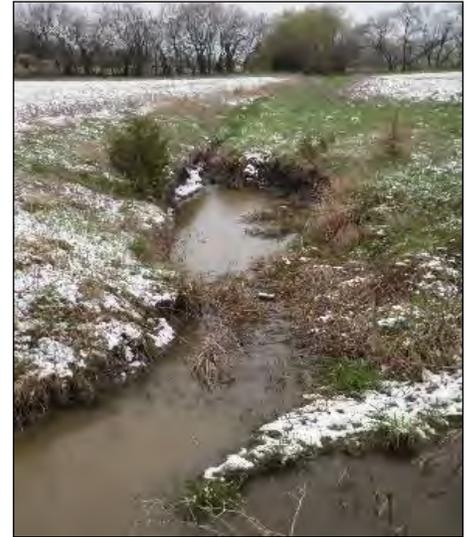
Figure 7-39: Knick at confluence

Recommendation: Recommend installing a grade control to stop the propagation of incision and protect the tributary.

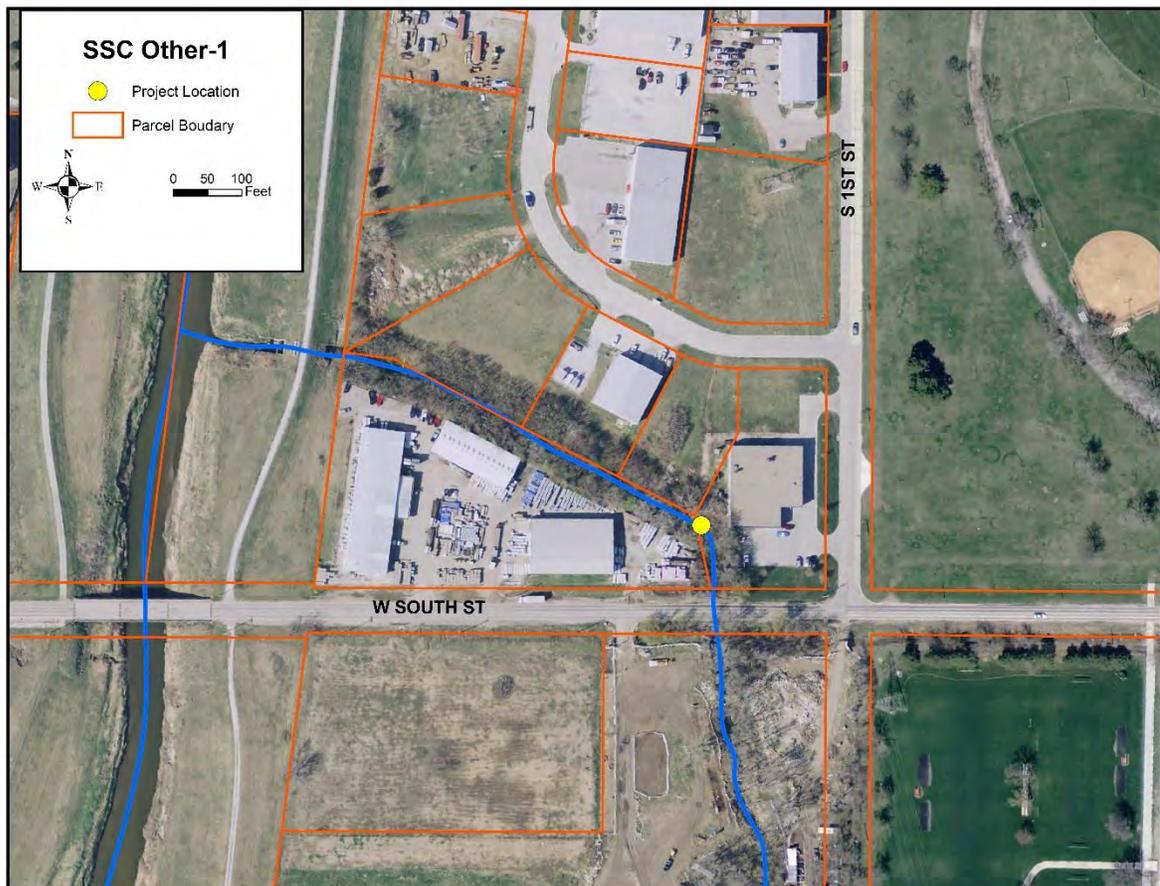
Figure 7-46: SSC Other-1 Project Location

Project Description: Dumped rubble armor has the potential to undercut trees and expose roots on tributary SC015R005 located downstream of W South St and west of S 1st St.

Recommendation: Monitor this location for potential problems to include in future CIP planning.

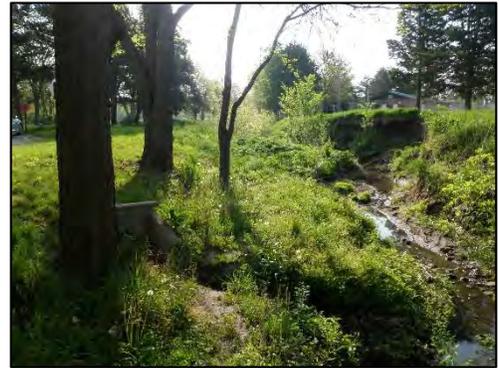
Figure 7-49 – Tributary SC015R015

Recommendation: Consider riparian corridor restoration along the reach through Irvingdale Park, including planting of the next generation of trees.

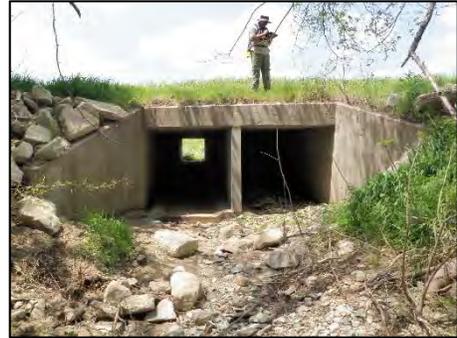
Figure 7-51 – SC015R005 upstream of the dam

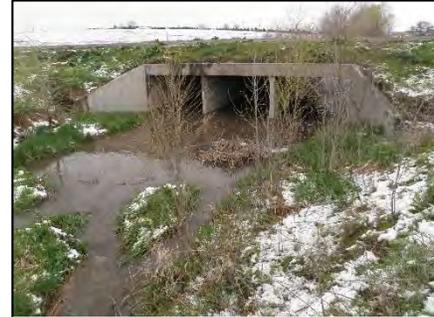
Figure 7-63 – Bennet Rd culvert

Problem description: Hydraulic analysis based on available hydrologic and as-built data, indicates that roadway overtopping will occur at the Bennet Rd culvert (S206) on main stem WTR010 during a 100-year flow event. Roadway overtopping at this location could be eliminated if the culvert capacity is increased. The channel capacity at this locations is sufficient to convey flood flow without overtopping the roadway.

Recommendation: Conduct further evaluation of the culvert crossing to augment prioritization for culvert replacement.

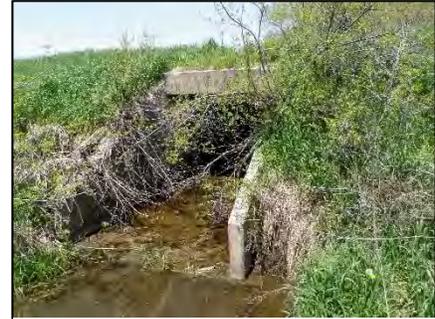
Figure 7-65 – W Rokeby Rd culvert

Problem description: Hydraulic analysis based on available hydrologic and as-built data, indicates that roadway overtopping will occur at the W Rokeby Rd culvert (O48) on tributary SC155R005 during a 100-year flow event. Roadway overtopping at this location could be eliminated if the culvert capacity is increased. The channel capacity at this locations is sufficient to convey flood flow without overtopping the roadway.

Recommendation: Conduct further evaluation of the culvert crossing to augment prioritization for culvert replacement. If the further evaluation indicates that the culvert should be replaced, consider including its replacement in association with CIP-7.

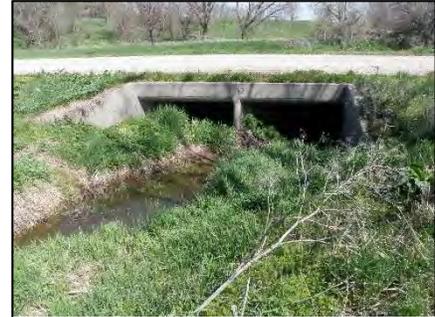
Figure 7-67 – W Rokeby Rd culvert

Problem description: Hydraulic analysis based on available hydrologic and as-built data, indicates that roadway overtopping will occur at the W Rokeby Rd culvert (O192) on tributary SC055R020 during a 100-year flow event. Roadway overtopping at this location could be eliminated if the culvert capacity is increased. The channel capacity at this locations is sufficient to convey flood flow without overtopping the roadway.

Recommendation: Conduct further evaluation of the culvert crossing to augment prioritization for culvert replacment.

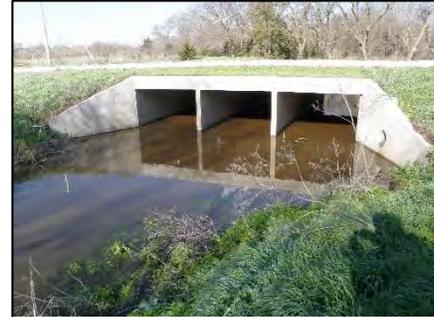
Figure 7-69 – S 1st St culvert

Problem description: Hydraulic analysis based on available hydrologic and as-built data, indicates that roadway overtopping will occur at the S 1st St culvert (O206) on tributary SC055R005 during a 100-year flow event. Roadway overtopping at this location could be eliminated if the culvert capacity is increased. The channel capacity at this locations is sufficient to convey flood flow without overtopping the roadway.

Recommendation: Conduct further evaluation of the culvert crossing to augment prioritization for culvert replacement.

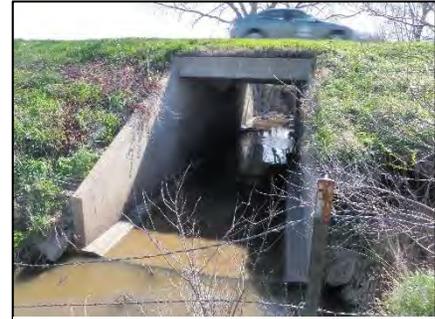
Figure 7-71 – SW 12th St culvert

Problem description: Hydraulic analysis based on available hydrologic and as-built data, indicates that roadway overtopping will occur at the SW 12th St culvert (O153) on tributary SC055R020 during a 100-year flow event. Roadway overtopping at this location could be eliminated if the culvert capacity is increased. The channel capacity at this locations is sufficient to convey flood flow without overtopping the roadway.

Recommendation: Conduct further evaluation of the culvert crossing to augment prioritization for culvert replacment.

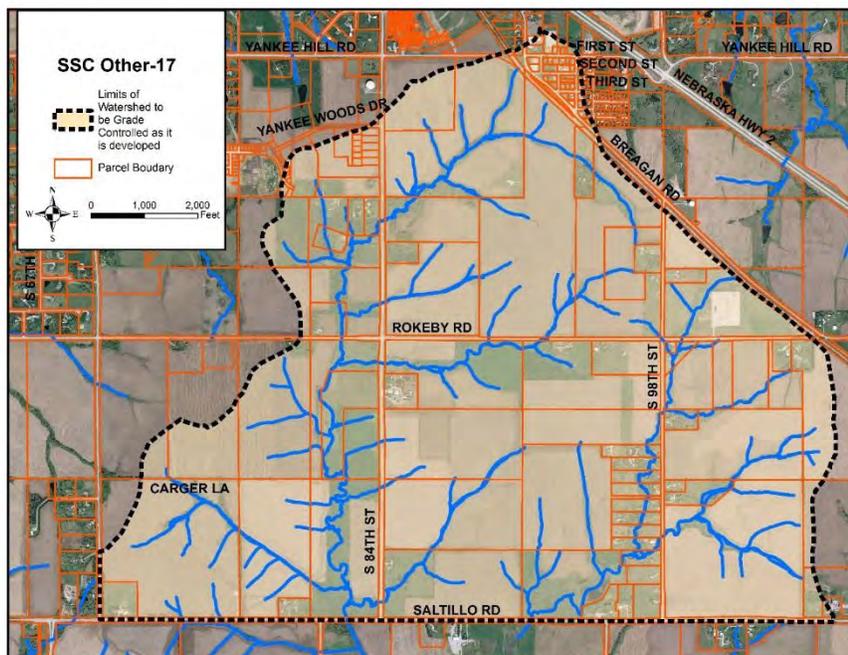
Problem description: The Mainstem and tributaries north of Saltillo Road in the Wagon Train Watershed are generally shallow and stable. This area is identified as possessing high potential for future development. The channels lower in the watershed are incising and this incision will predictably reach these developing areas. The planned new development may contribute to future channel incision similar to that observed elsewhere in the watershed. The cost of repairing channel incision and degradation in a developed area is on the magnitude of 10 times more expensive than the cost of installing protective measures before the degradation occurs. The high channel degradation repair cost is evident by the CIP estimates in this watershed Masterplan. It is less expensive for the citizens of Lincoln to pay for proactive measures when the stream is stable than pay the repair cost after a channel has incised.

Recommendation: The Mainstem and tributaries north of Saltillo Road in the Wagon Train Watershed are generally shallow and stable. This area is identified as possessing high potential for future development. The channels lower in the watershed are incising and this incision will predictably reach these developing areas. The planned new development may contribute to future channel incision similar to that observed elsewhere in the watershed. The cost of repairing channel incision and degradation in a developed area is on the magnitude of 10 times more expensive than the cost of installing protective measures before the degradation occurs. The high channel degradation repair cost is evident by the CIP estimates in this watershed Masterplan. It is less expensive for the citizens of Lincoln to pay for proactive measures when the stream is stable than pay the repair cost after a channel has incised.
