Appendix C - Site Prioritization Ranking Worksheets

ANTELOPE CREEK STRUCTURAL LOCATIONS MAP

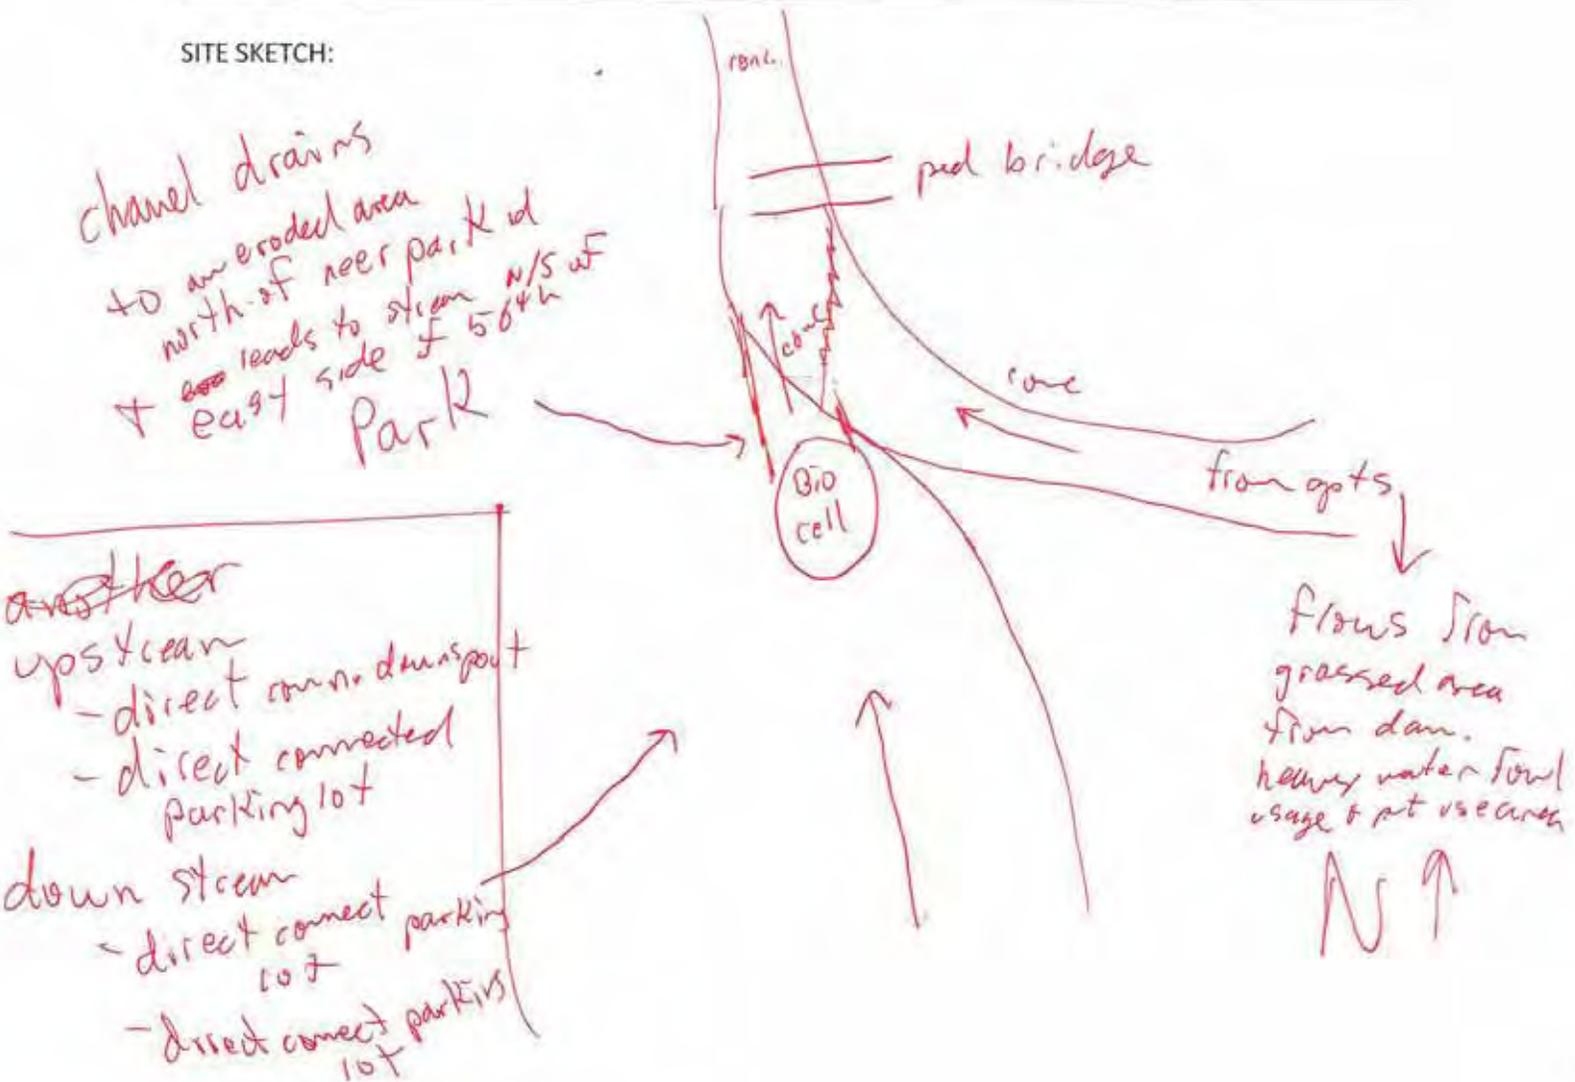
SITE SKETCH:

DATE: 9/22/11
 STAFF: Tom T & Janie S
 LOCATION ID #: Park PIRE
 ADDRESS: 56th + north of pioneers
 PICTURES AND GPS: YES NO #9 - ~~no~~ pict-
 PUBLIC or PRIVATE PROERTY #11-19
 LAND USE: park
 POLLUTANT SOURCES NEARBY: urban wildlife, possible nutrients
 TOPOGRAPHY: slopes to concrete channel
 MAINTENANCE ACCESS: not ideal, no streets butt up to it, park on street
 LOCATION DESCRIPTION: 1 block away park east of 56th concrete channel between houses. sediment w/ in channel but probably can't hydraulically connect
 LAND AVAILABILITY: LOW / MEDIUM / HIGH
 POTENTIAL PROJECT TYPE: Bio cell, maybe a small hydro sep. but would be impossible to access to remove sediment.

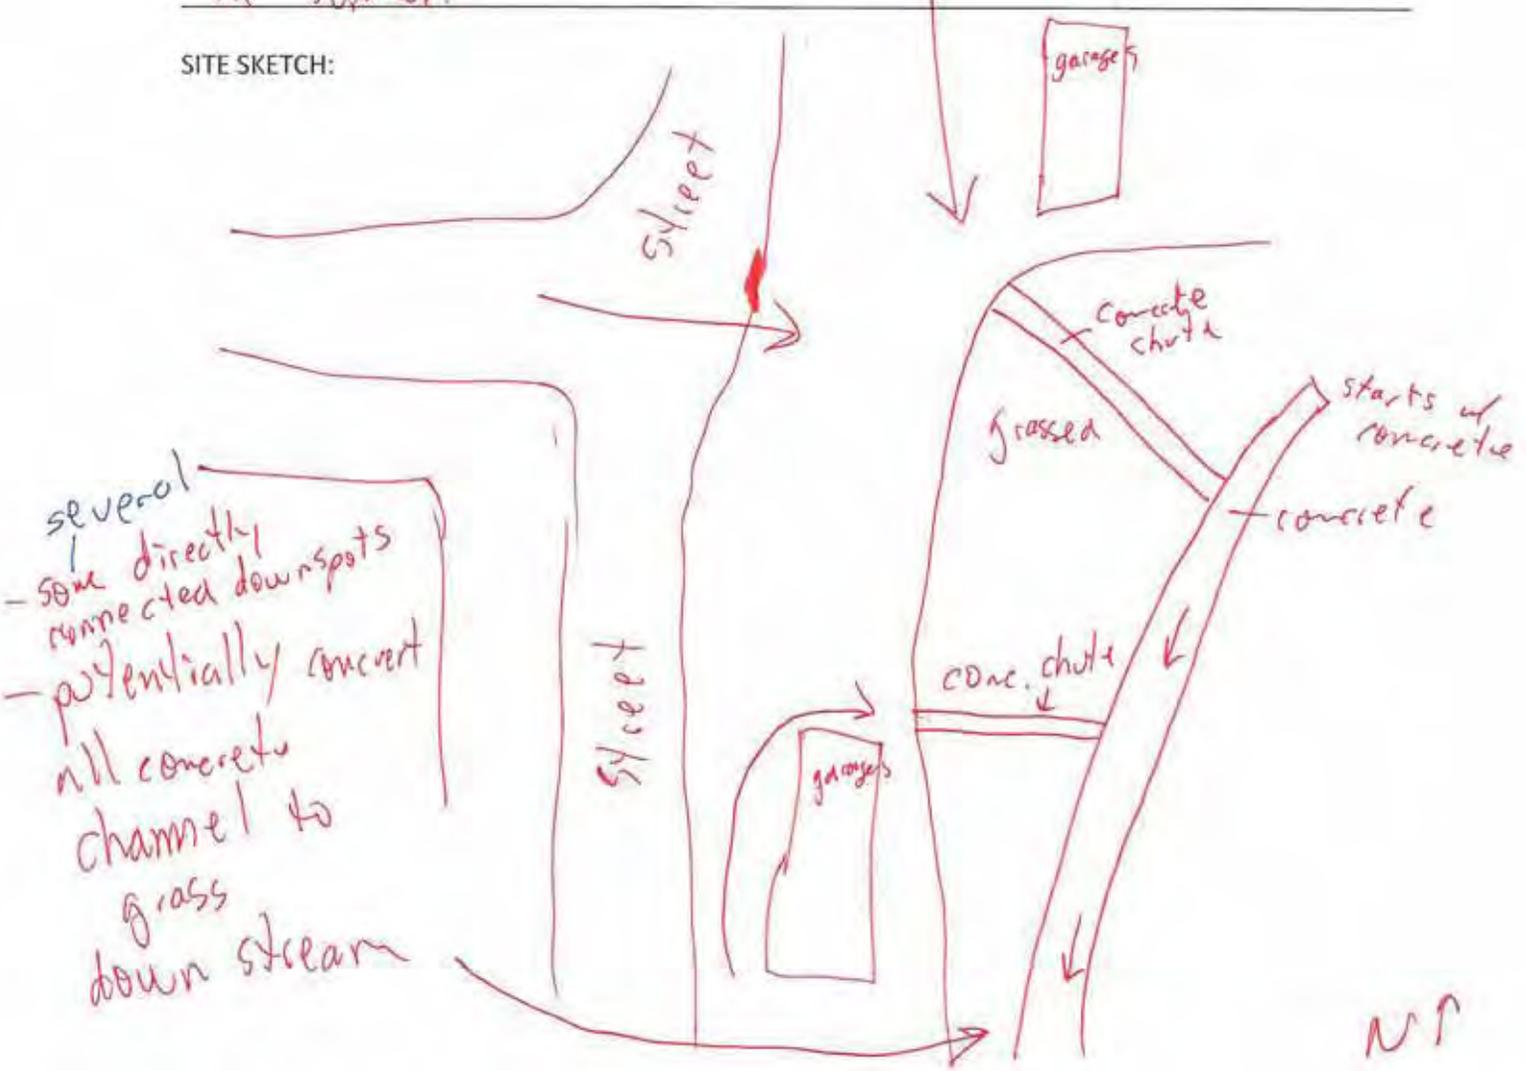
SITE SKETCH:

DATE: 9/22/11
 STAFF: Jon M & Jamie
 LOCATION ID #: R1
 ADDRESS: 60th & Van Dorn Apts
 PICTURES AND GPS: YES NO 20-25
 PUBLIC or PRIVATE PROPERTY
 LAND USE: parking lot for Apts
 POLLUTANT SOURCES NEARBY: sediment, nutrients
 TOPOGRAPHY: all slopes to 1 area to concrete chute & channel
 MAINTENANCE ACCESS: on private property but other than that very ideal

LOCATION DESCRIPTION: parking drains to 2 conc chutes & then to concrete channel which leads to AC.

several
 - some directly connected downspots
 - potentially concrete
 all concrete channel to grass down stream

POTENTIAL PROJECT TYPE: Bio-cell or hydro separator. Lot is probably heavily sanded in winter, grass probably fertilized in summer.

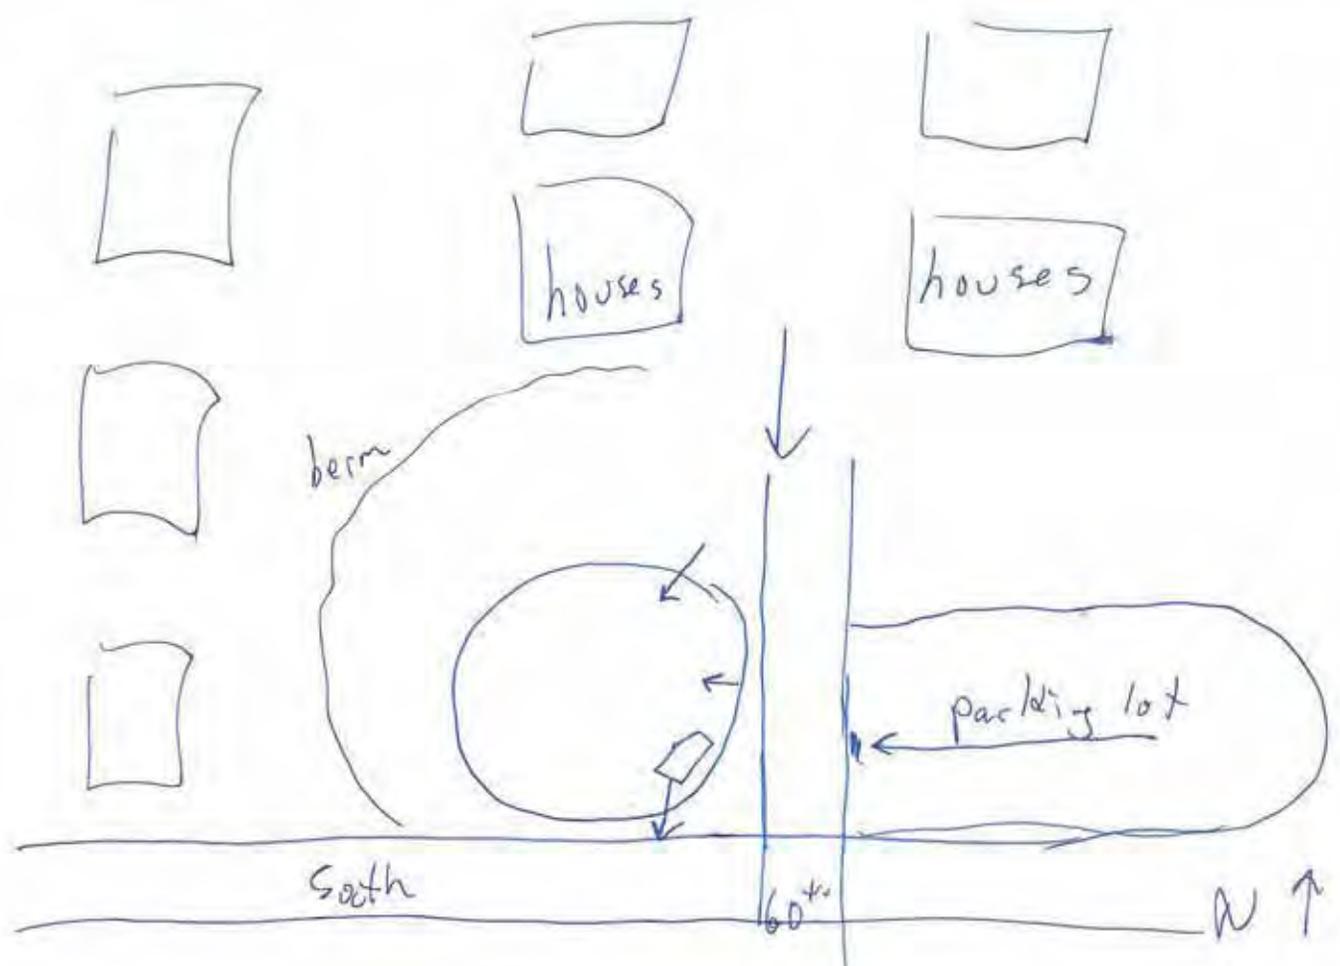
SITE SKETCH:

DATE: 9/22/11
 STAFF: Jon M.
 LOCATION ID #: R2
 ADDRESS: 60th & South
 PICTURES AND GPS: (YES) NO 26 → 308
 PUBLIC or PRIVATE PROPERTY: don't know (utility easement)
 LAND USE: Parking lot runoff
 POLLUTANT SOURCES NEARBY: sediment, nutrients
 TOPOGRAPHY: slopes to dry pond
 MAINTENANCE ACCESS: ideal

LOCATION DESCRIPTION: dry pond NW of 60th & South
parking lots drain to pond. pond has inlet/outlet @ same elevation &
short cutting most treatment

POTENTIAL PROJECT TYPE: Make infiltration higher / retrofit

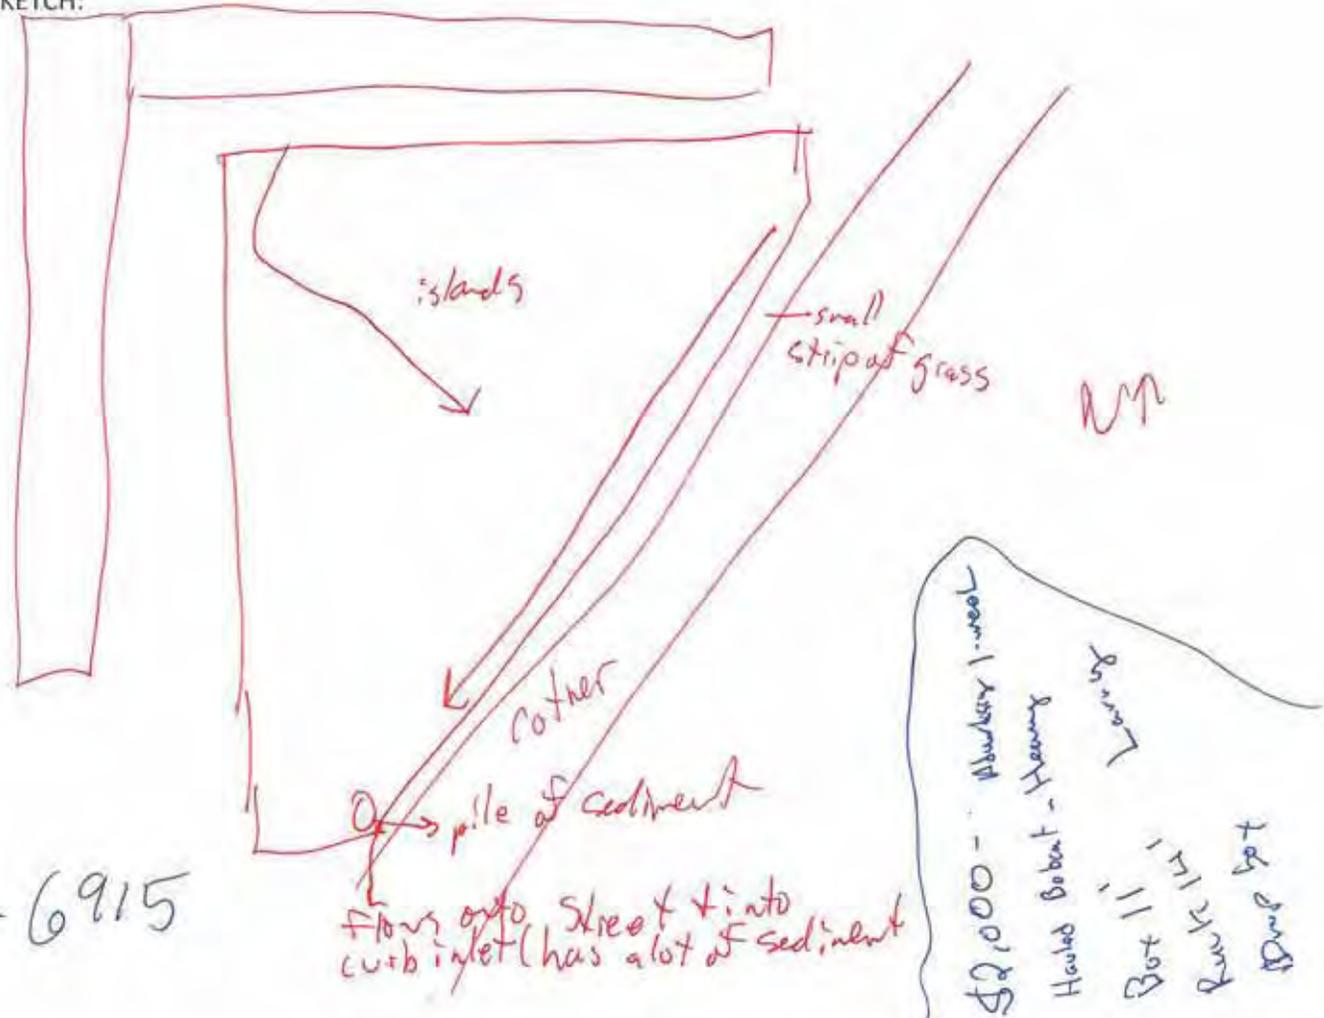
SITE SKETCH:

DATE: 9/22/11
 STAFF: Jon M. & Jan
 LOCATION ID #: C1
 ADDRESS: Cotner & Aldrich (Piedmont Shopping area)
 PICTURES AND GPS: YES NO 39-495
 PUBLIC or PRIVATE PROERTY
 LAND USE: parking lot
 POLLUTANT SOURCES NEARBY: lots of sediment, PDLs,
 TOPOGRAPHY: All slopes to south east
 MAINTENANCE ACCESS: ideal

LOCATION DESCRIPTION: Piedmont Mall/shopping parking lot

POTENTIAL PROJECT TYPE: island bio swales, curb cut bio swales
hydro separator for trash & sediment

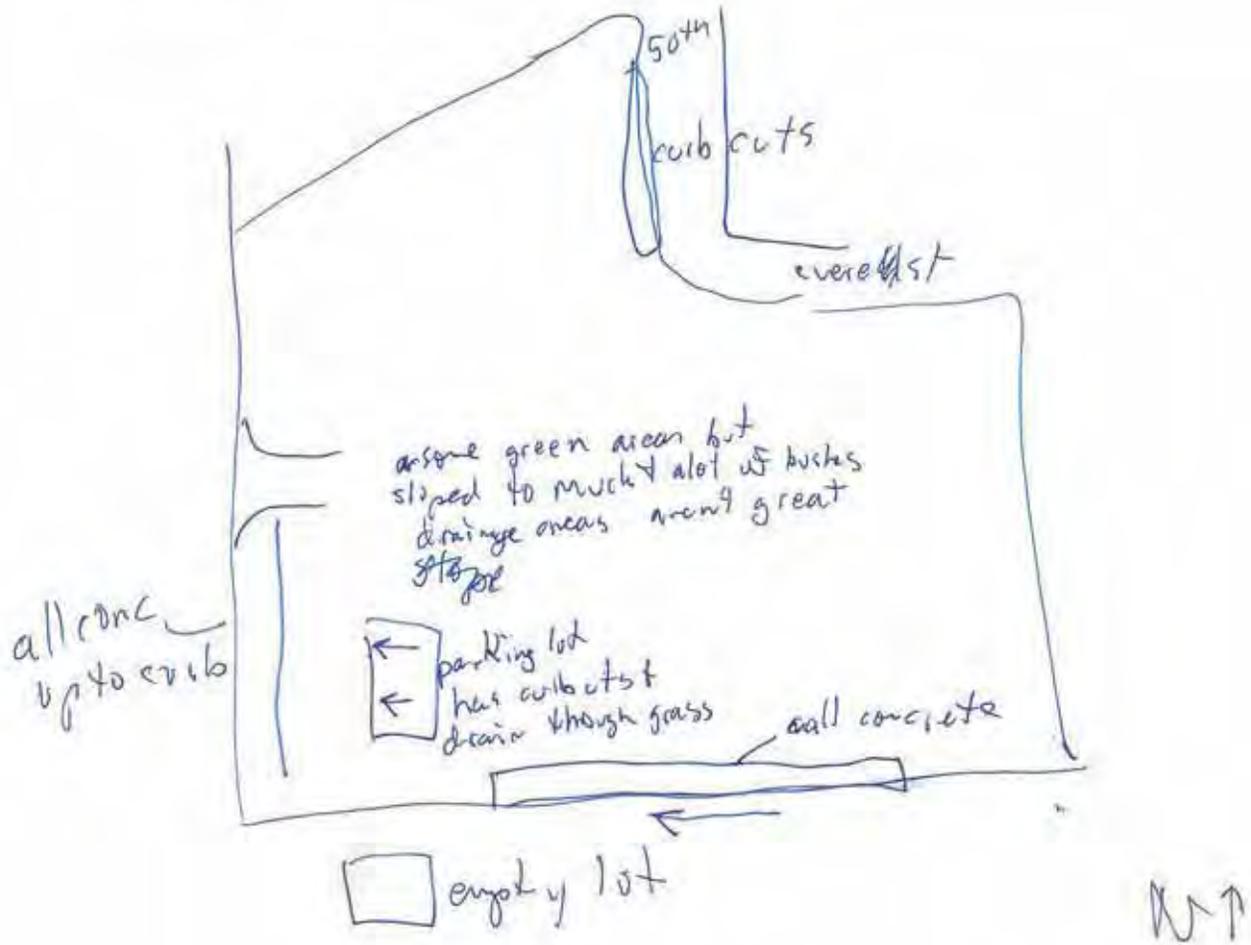
SITE SKETCH:

DATE: 9/22/11
 STAFF: Jon M. Y
 LOCATION ID #: I I
 ADDRESS: Brian LGH East
 PICTURES AND GPS: (YES) NO 46497
 PUBLIC or PRIVATE PROERTY
 LAND USE: Institutional
 POLLUTANT SOURCES NEARBY: PDLs, nutrients, sediment
 TOPOGRAPHY: Changes
 MAINTENANCE ACCESS: easy

LOCATION DESCRIPTION: Brian LGH

POTENTIAL PROJECT TYPE: curb cuts, inlet traps

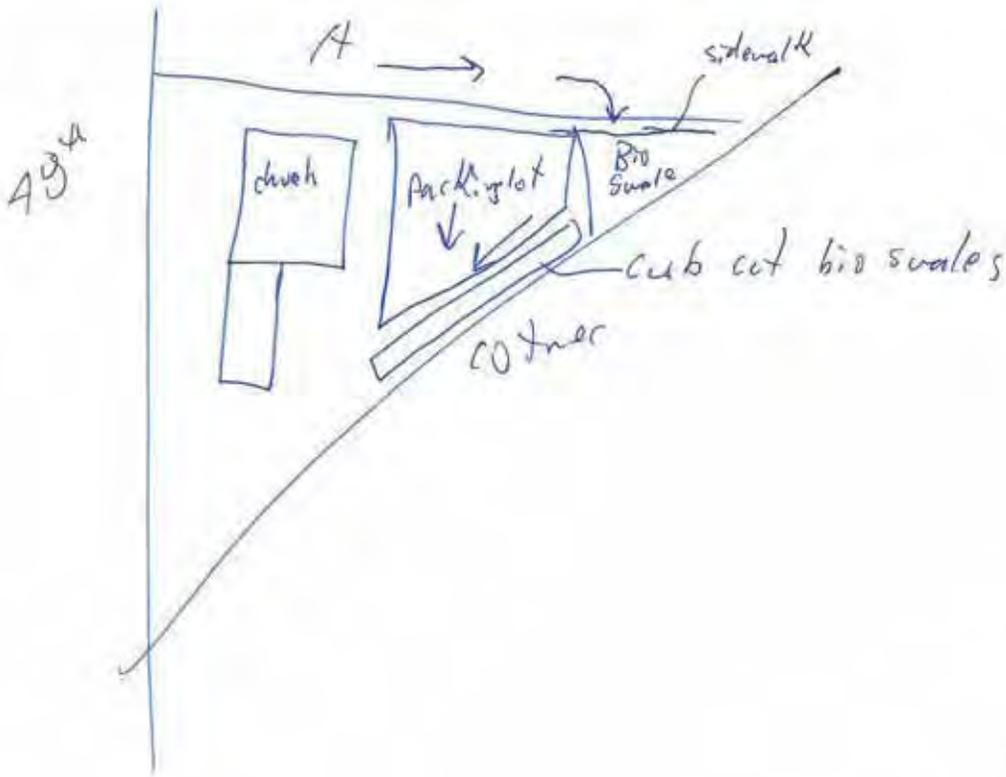
SITE SKETCH:

DATE: 9/22/11
 STAFF: Jon M. Jarvis
 LOCATION ID #: I2
 ADDRESS: 50th & A
 PICTURES AND GPS: (YES) NO
 PUBLIC or PRIVATE PROPERTY: 48-53
 LAND USE: parking lot & street drainage
 POLLUTANT SOURCES NEARBY: sediment piles
 TOPOGRAPHY: Slopes to inlets on street
 MAINTENANCE ACCESS: easy

LOCATION DESCRIPTION: church on ~~50th~~ 48th & A

LAND AVAILABILITY: (LOW) / MEDIUM / HIGH
 POTENTIAL PROJECT TYPE: bio swale & curb cuts

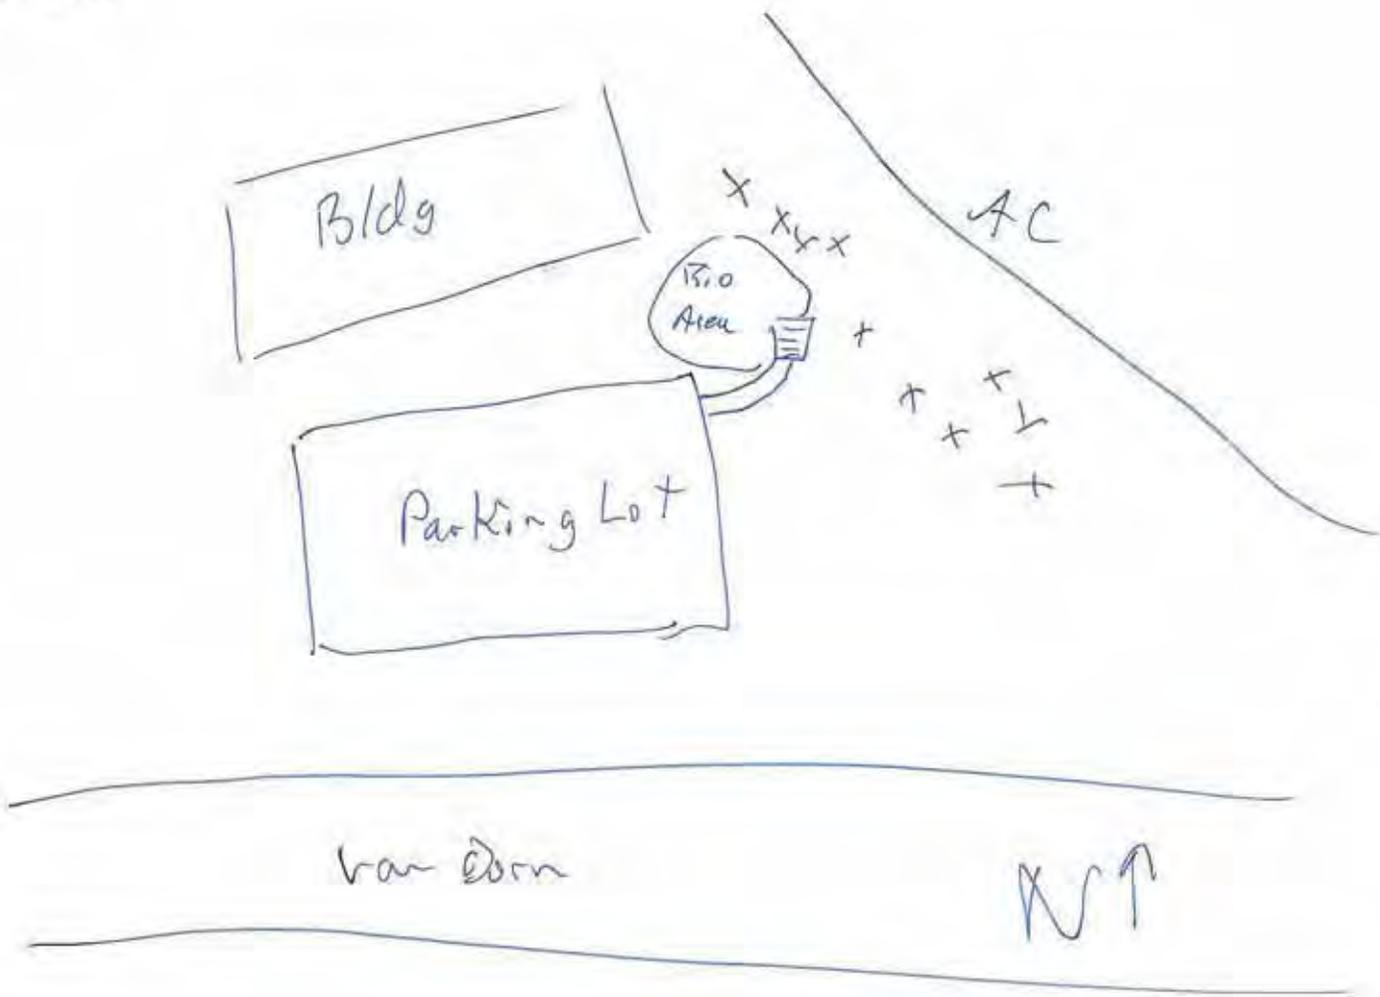
SITE SKETCH:

DATE: 9/22/11
 STAFF: Jon M & Jamie
 LOCATION ID #: C3
 ADDRESS: Post Office on Van Dorn
 PICTURES AND GPS: (YES) NO 59-62
 PUBLIC or PRIVATE PROERTY - Post office
 LAND USE: Parking lot
 POLLUTANT SOURCES NEARBY: Lots of sediment
 TOPOGRAPHY: Parking Lot drains to grate inlet
 MAINTENANCE ACCESS: easy

LOCATION DESCRIPTION: Post office on Van Dorn

LAND AVAILABILTY: (LOW) MEDIUM / HIGH
 POTENTIAL PROJECT TYPE: Bio snare prior to inlet

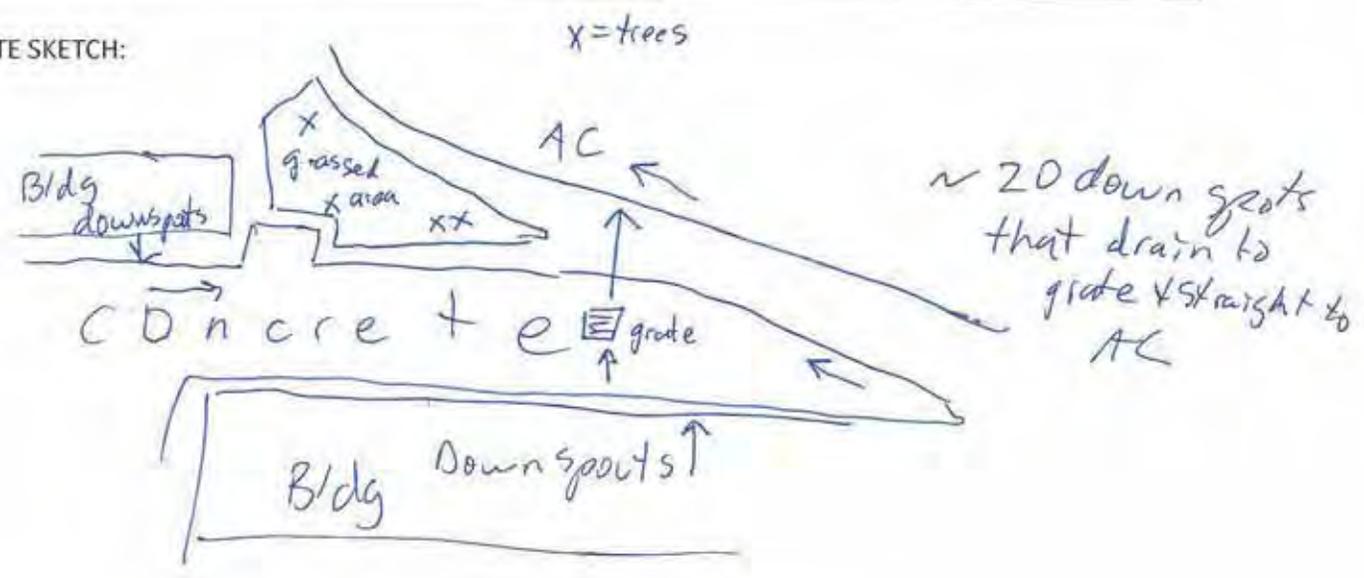
SITE SKETCH:

DATE: 9/22/11
 STAFF: Jon M. & Jamie S.
 LOCATION ID #: C2
 ADDRESS: _____
 PICTURES AND GPS: (YES) NO 54-
 PUBLIC or PRIVATE PROPERTY: _____
 LAND USE: parking lot & roof
 POLLUTANT SOURCES NEARBY: metals, sediment, POLs
 TOPOGRAPHY: flat & drains to inlet straight to AC
 MAINTENANCE ACCESS: easy

LOCATION DESCRIPTION: Northside of Vardorn Plaza

parking lot on southside very little area

LAND AVAILABILITY: LOW / MEDIUM / HIGH
 POTENTIAL PROJECT TYPE: hire swale to infiltrate roof on vardorn plaza

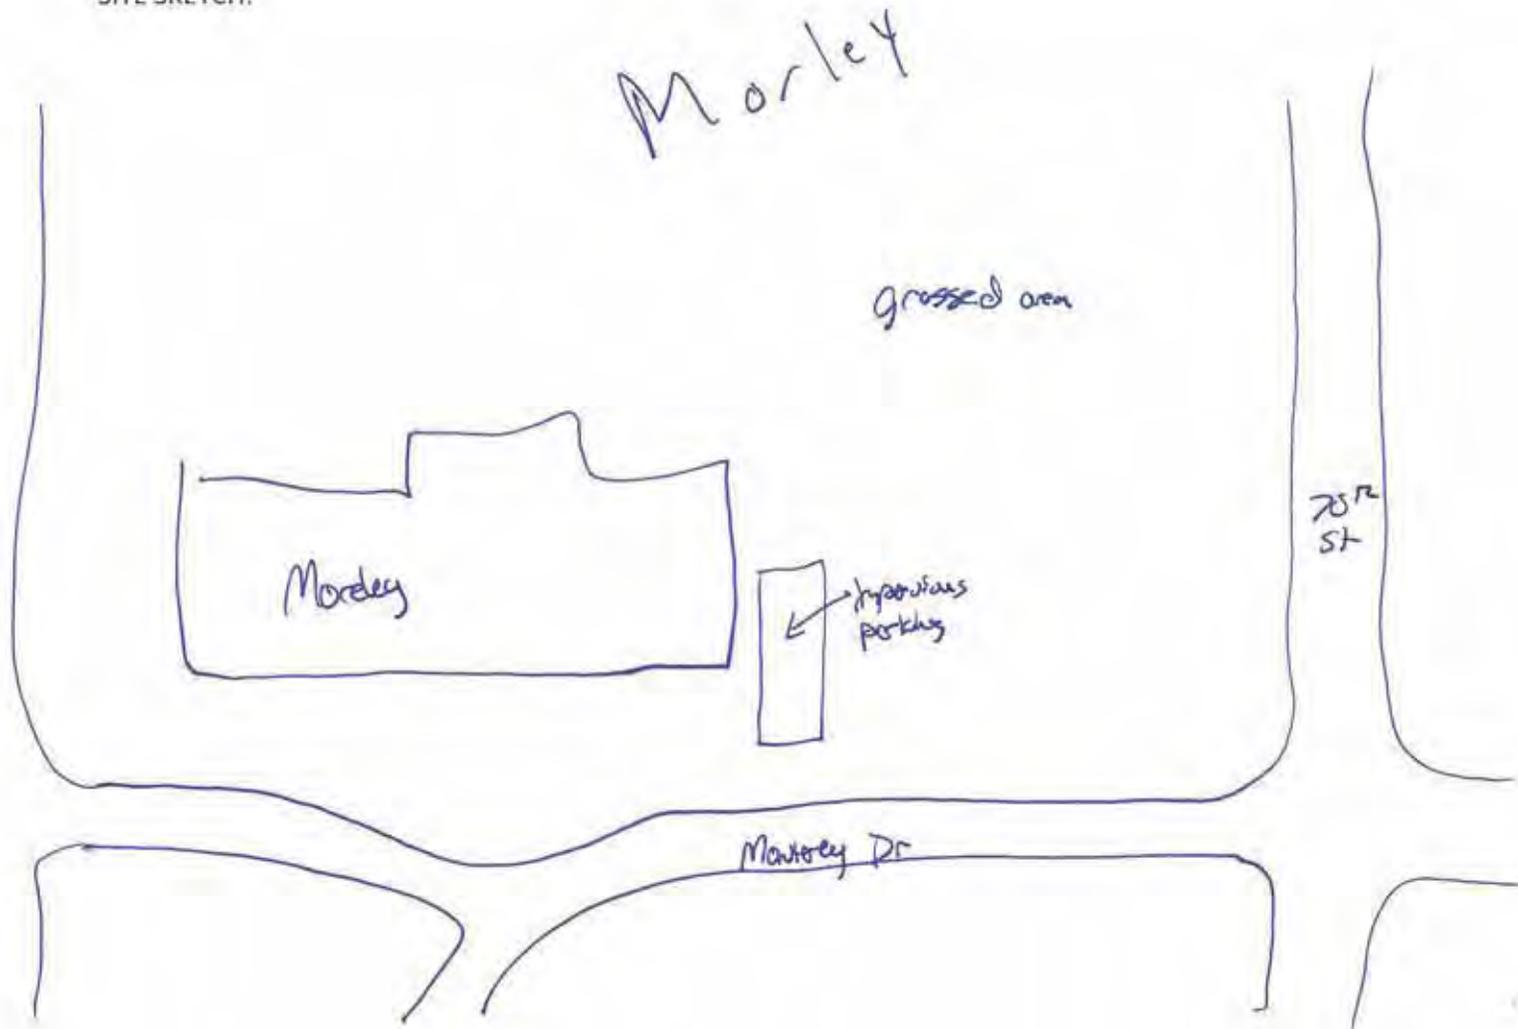
SITE SKETCH:

TOPOGRAPHY: Slopes east to west and west to east school in

LOCATION DESCRIPTION: Truss roadway, open Astell road
Small parking

POTENTIAL PROJECT TYPE: Perimeter parking

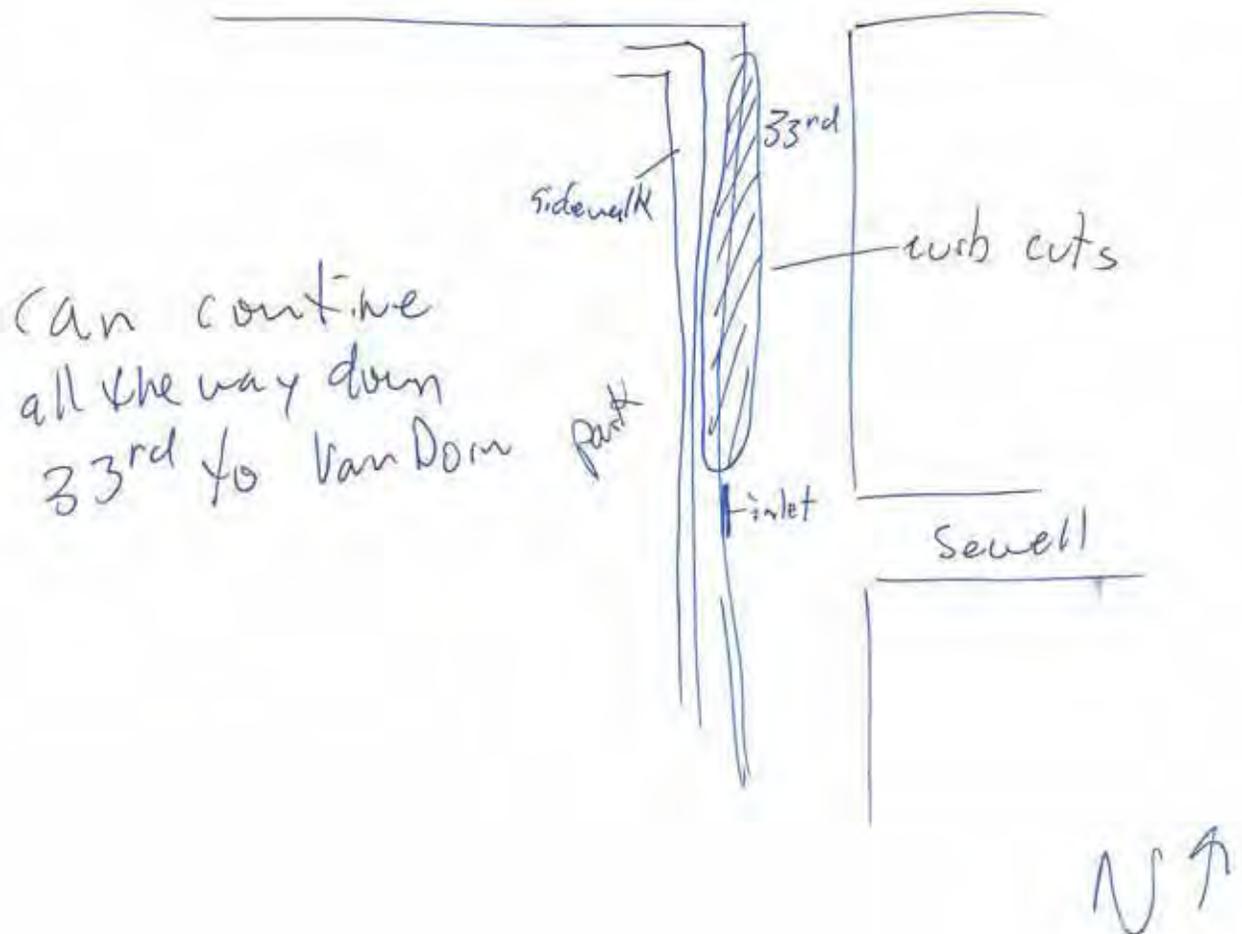
SITE SKETCH: South

DATE: 9/22/11
 STAFF: _____
 LOCATION ID #: PIR 2
 ADDRESS: ~~33rd~~ 33 & Sewell
 PICTURES AND GPS: (YES) NO
 PUBLIC or PRIVATE PROPERTY
 LAND USE: ROW
 POLLUTANT SOURCES NEARBY: sediment
 TOPOGRAPHY: flat
 MAINTENANCE ACCESS: easy

LAND AVAILABILITY: (LOW) MEDIUM / HIGH
 POTENTIAL PROJECT TYPE: curb cut bio swale

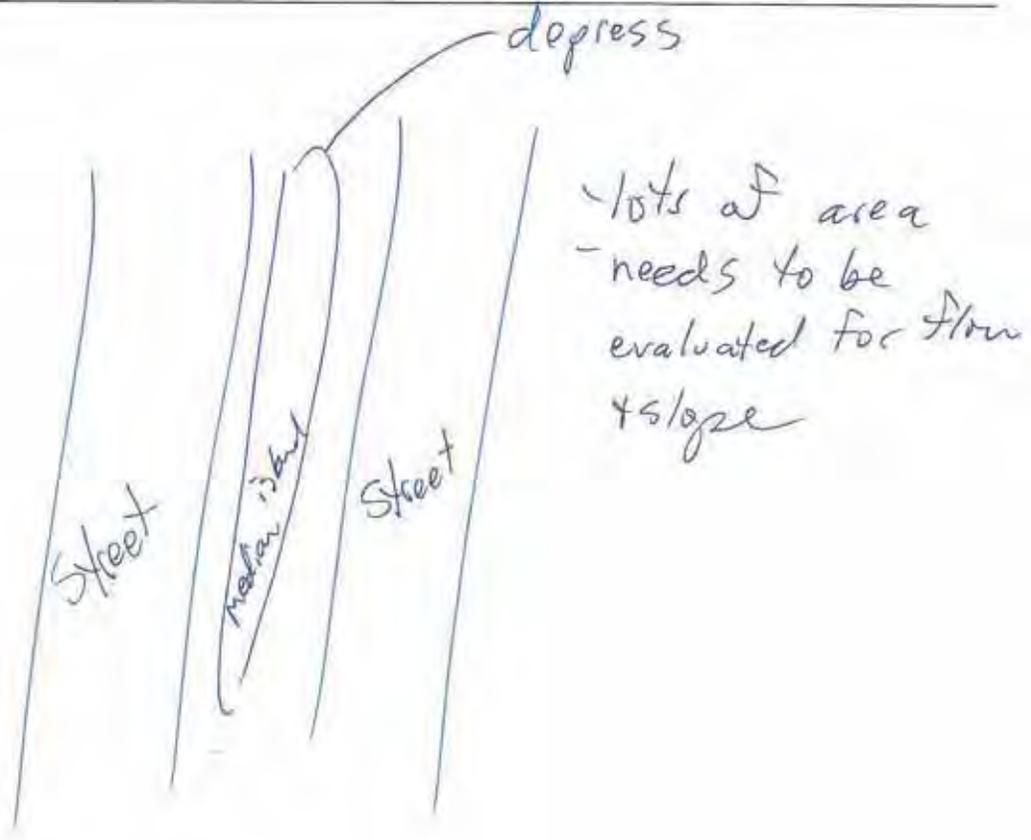
SITE SKETCH:

DATE: 9/22/11
 STAFF: Jamie S. Tomlin
 LOCATION ID #: ~~33~~ Steindan Street median R3
 ADDRESS: Steindan Bradford & Stratford
 PICTURES AND GPS: YES NO 68-71
 PUBLIC or PRIVATE PROPERTY
 LAND USE: ROW
 POLLUTANT SOURCES NEARBY: POL, nutrients, gravel
 TOPOGRAPHY: sloped
 MAINTENANCE ACCESS: east west stratford
 LOCATION DESCRIPTION: median along Bradford & Steindan Drives

POTENTIAL PROJECT TYPE: Bio swales in medians or depressed grass areas & curb cuts

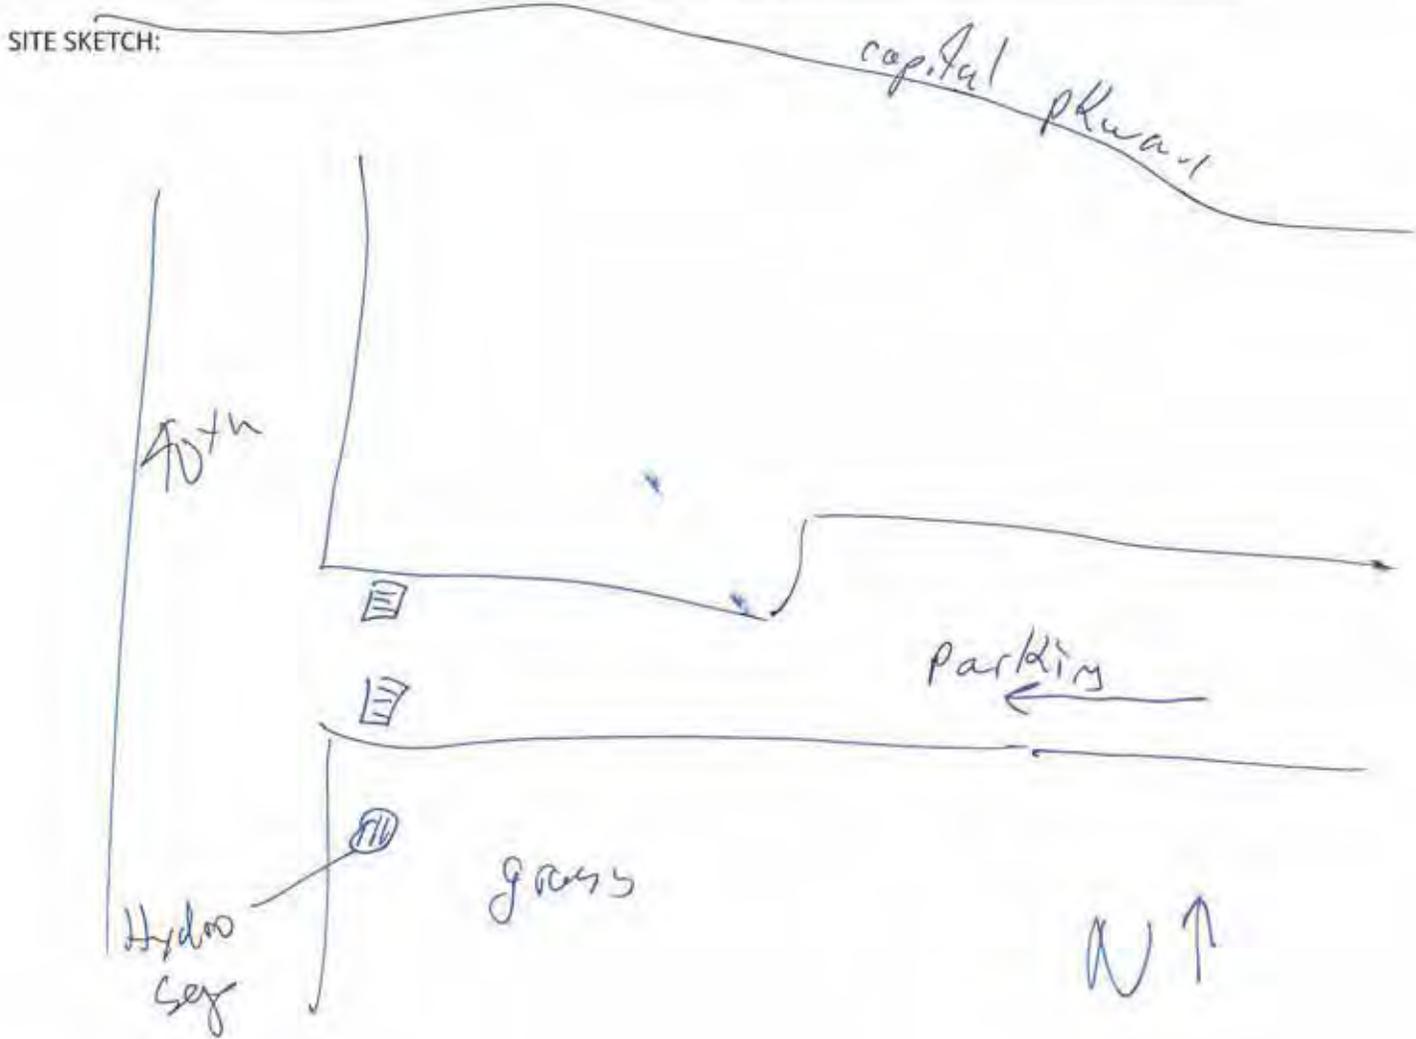
DATE: 7/22/11
 STAFF: _____
 LOCATION ID #: R5
 ADDRESS: 10th & south capital Pkwy
 PICTURES AND GPS: YES NO 75-78
 PUBLIC or PRIVATE PROPERTY
 LAND USE: Parking
 POLLUTANT SOURCES NEARBY: gravel (lots of gravel)
 TOPOGRAPHY: Sloped
 MAINTENANCE ACCESS: _____

LOCATION DESCRIPTION: parking lot by apts

POTENTIAL PROJECT TYPE: Hydro sep

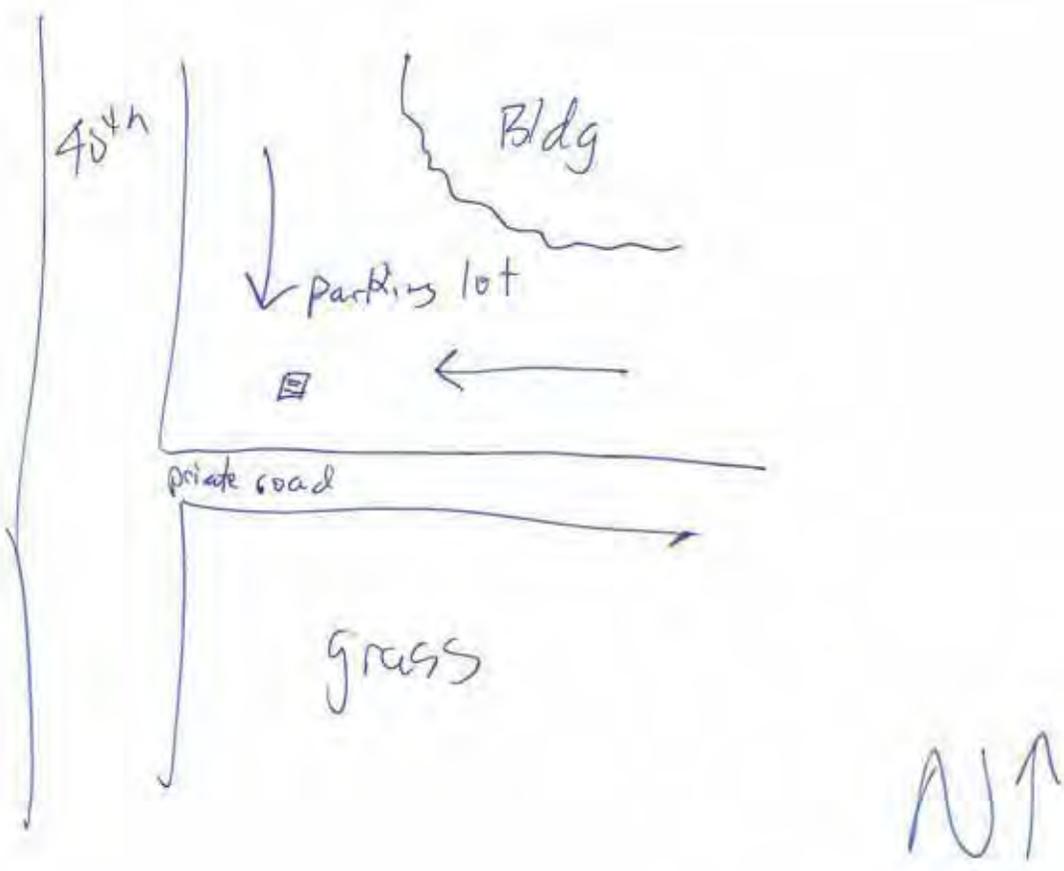
SITE SKETCH:

DATE: 9/22/11
 STAFF: Jan M. & Janie S.
 LOCATION ID #: R4
 ADDRESS: 40th & Capital Pkwy
 PICTURES AND GPS: YES NO 72-79
 PUBLIC or PRIVATE PROPERTY: both
 LAND USE: ROW + private parking lot
 POLLUTANT SOURCES NEARBY: Sediment & PCLs
 TOPOGRAPHY: the little slope
 MAINTENANCE ACCESS: easy

LOCATION DESCRIPTION: parking lot draining to storm grate

POTENTIAL PROJECT TYPE: Bio swale

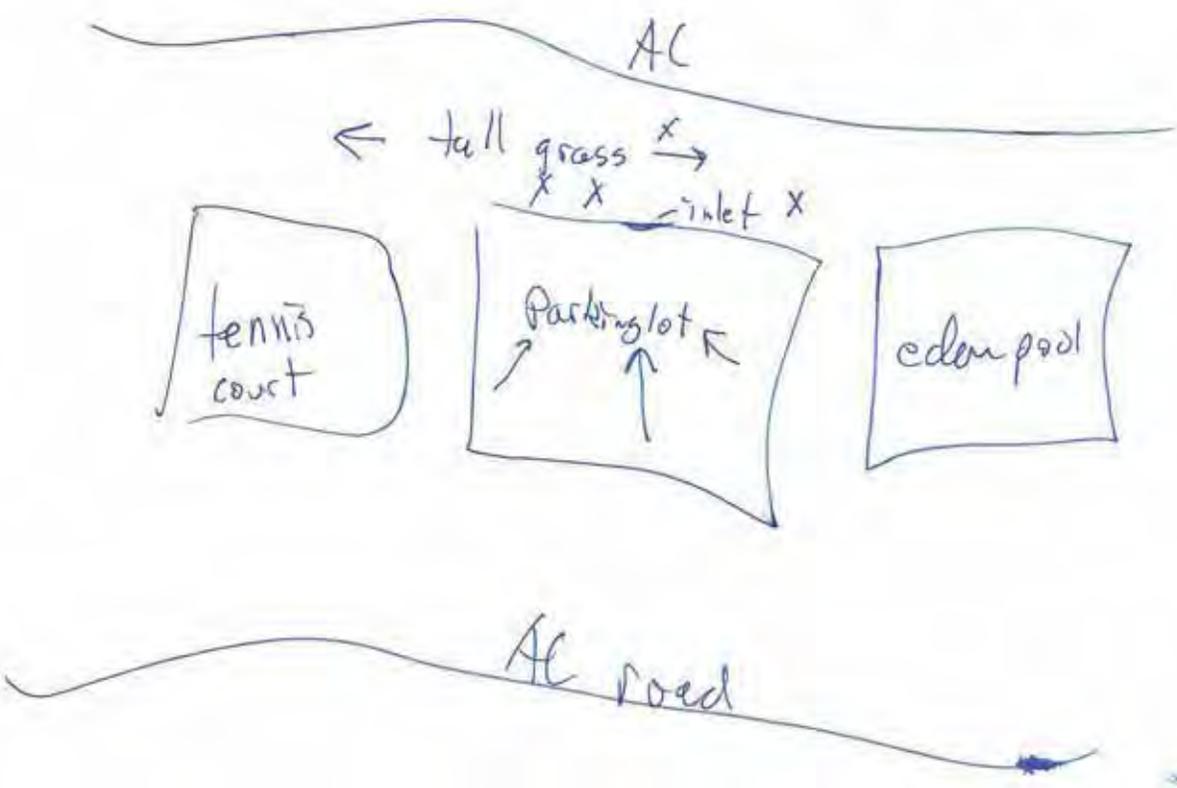
SITE SKETCH:

DATE: 7/22/11
 STAFF: _____
 LOCATION ID #: P/R 3
 ADDRESS: Antelope Creek Rd & west of 18th
 PICTURES AND GPS: (YES) NO -83
 PUBLIC or PRIVATE PROPERTY
 LAND USE: Parking lot
 POLLUTANT SOURCES NEARBY: gravel & P.O.L.S
 TOPOGRAPHY: flat
 MAINTENANCE ACCESS: easy

LOCATION DESCRIPTION: Parking lot next to pool

POTENTIAL PROJECT TYPE: Bio swale on north side

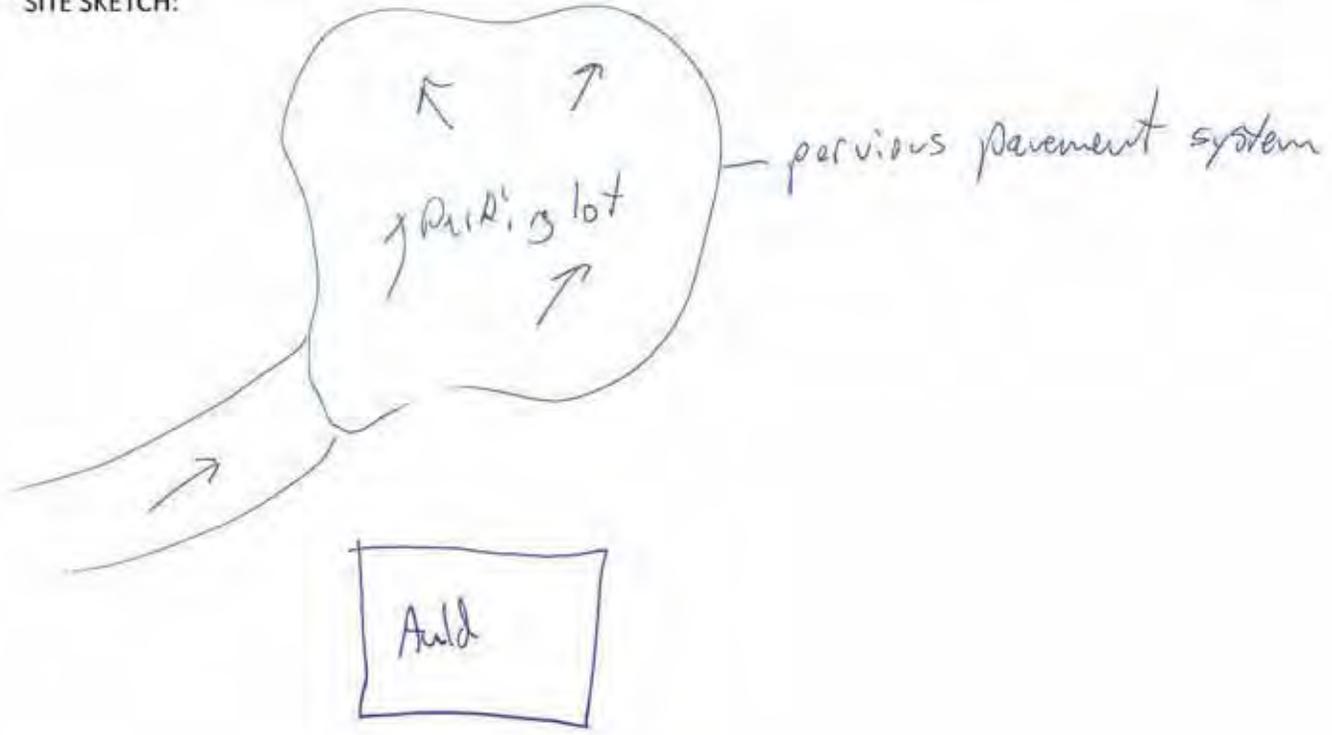
SITE SKETCH:

DATE: 9/26/11
STAFF: Jamie S.
LOCATION ID #: Auld Pavilion North
ADDRESS: Antelope Park
PICTURES AND GPS: YES NO
PUBLIC or PRIVATE PROPERTY: PUBLIC
LAND USE: Parking Lot
POLLUTANT SOURCES NEARBY: gravel, e. coli,
TOPOGRAPHY: gently slope
MAINTENANCE ACCESS: easy

LOCATION DESCRIPTION: large open parking lot N. of Auld Pavilion

POTENTIAL PROJECT TYPE: reduce runoff by impervious pavement system (or draining to nearby greenspace?)

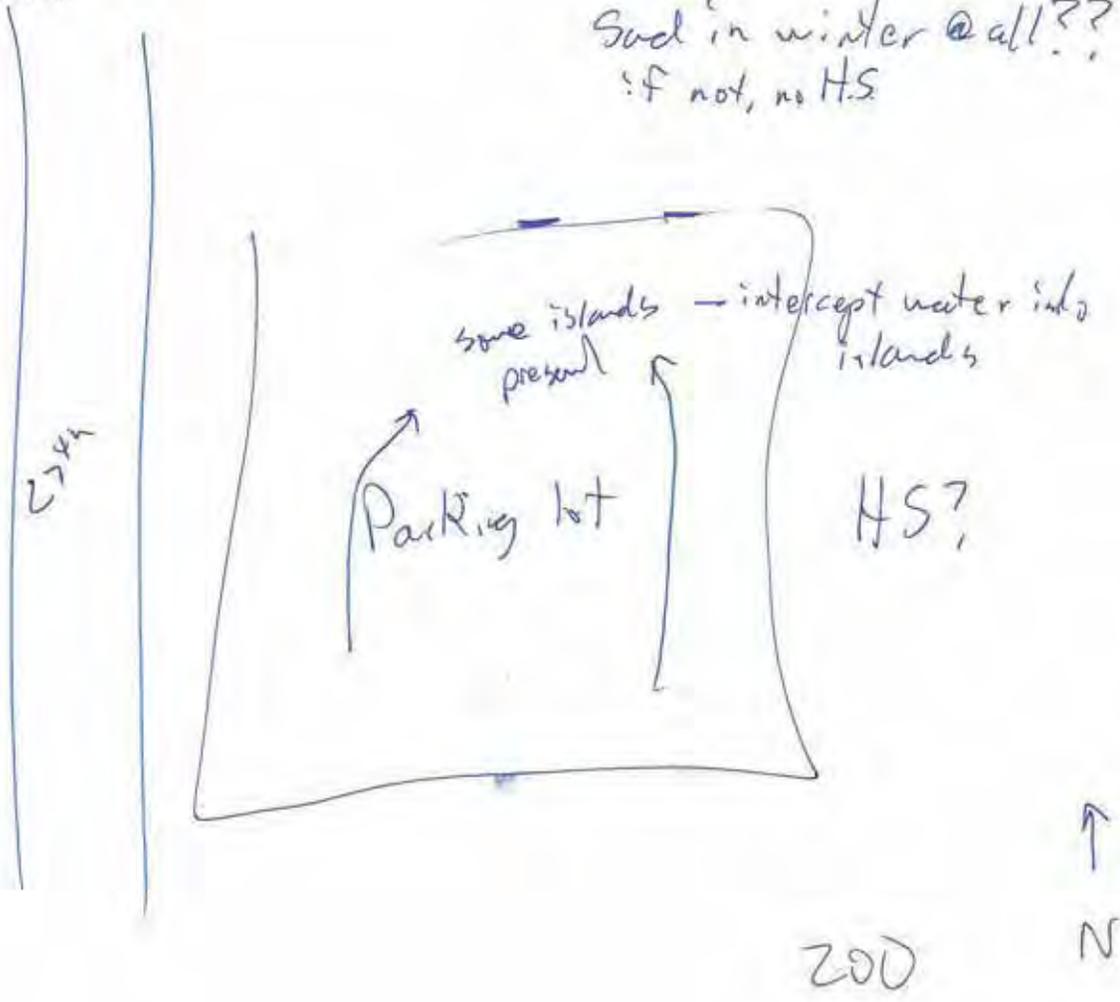
SITE SKETCH:

DATE: 9/22/11
STAFF: _____
LOCATION ID #: PR 6
ADDRESS: _____
PICTURES AND GPS: YES NO
PUBLIC or PRIVATE PROPERTY
LAND USE: Parking
POLLUTANT SOURCES NEARBY: gravel, PDLs
TOPOGRAPHY: Sloped to storm inlet (culb + gutter)
MAINTENANCE ACCESS: easy

- very public
- very easy to install/design

LOCATION DESCRIPTION: Lincoln Children's zoo

POTENTIAL PROJECT TYPE: Rain gardens, hydroseparator

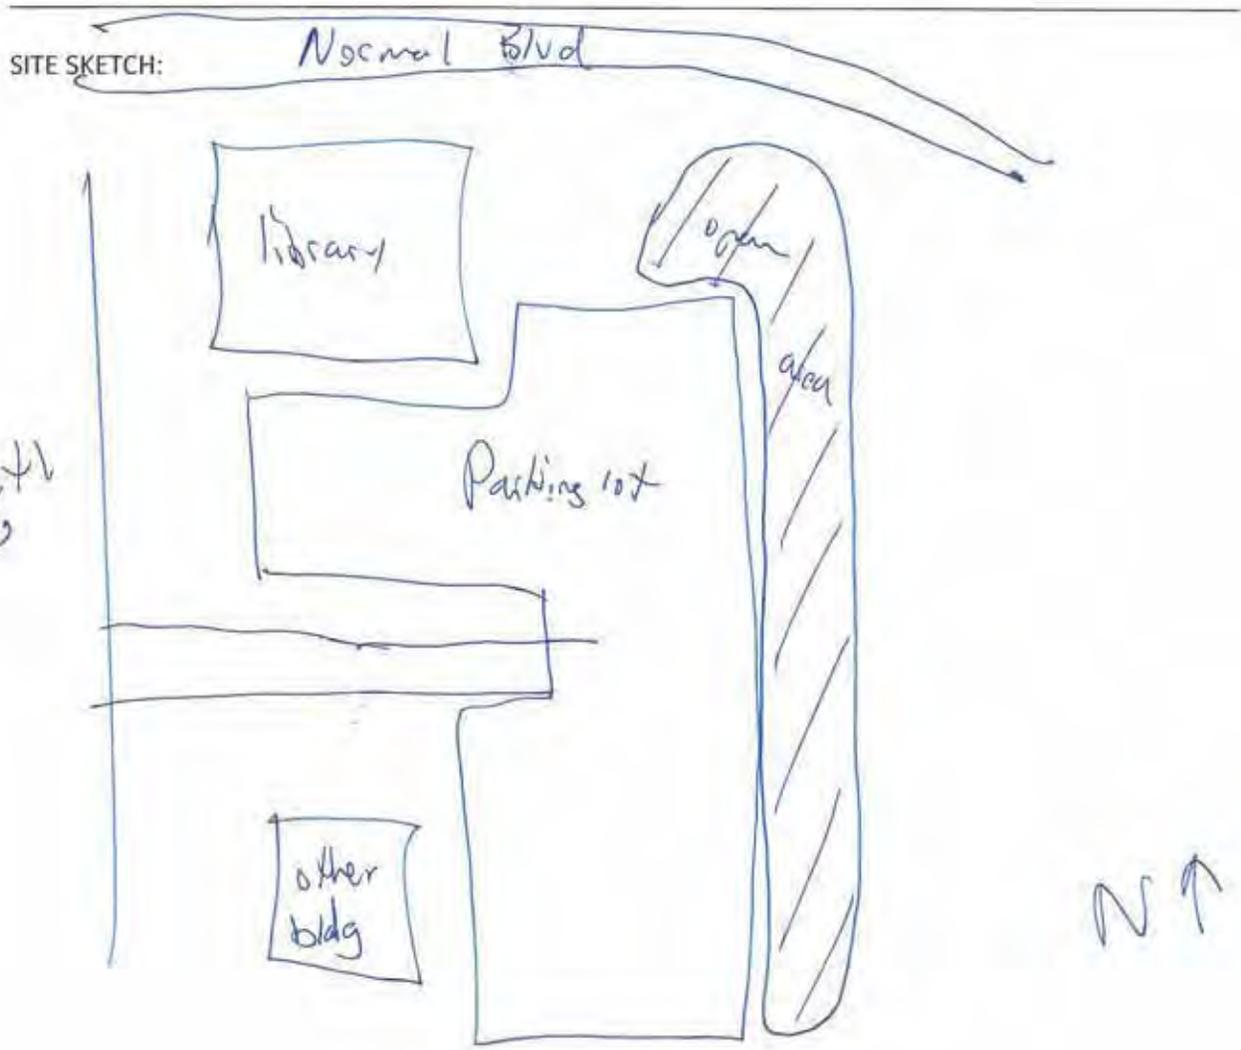
DATE: 9/26/11
STAFF: Jamie S.
LOCATION ID #: 65
ADDRESS: 56th & Normal Blvd
PICTURES AND GPS: (YES) NO
PUBLIC or PRIVATE PROPERTY: (PUBLIC)
LAND USE: Parking lot
POLLUTANT SOURCES NEARBY: PULs, sediment
TOPOGRAPHY: Flat - drains to storm inlets to far NW by 56th
MAINTENANCE ACCESS: easy
LOCATION DESCRIPTION: Public library & other Public Bldg adjacent to 56th street

- excellent
- very public
- easy implementation

LAND AVAILABILITY: LOW / (MEDIUM) / HIGH
POTENTIAL PROJECT TYPE: rain gardens, bio swale, pervious pavement
