Appendix C - Site Prioritization Ranking Worksheets

ANTELOPE CREEK STRUCTURAL LOCATIONS MAP

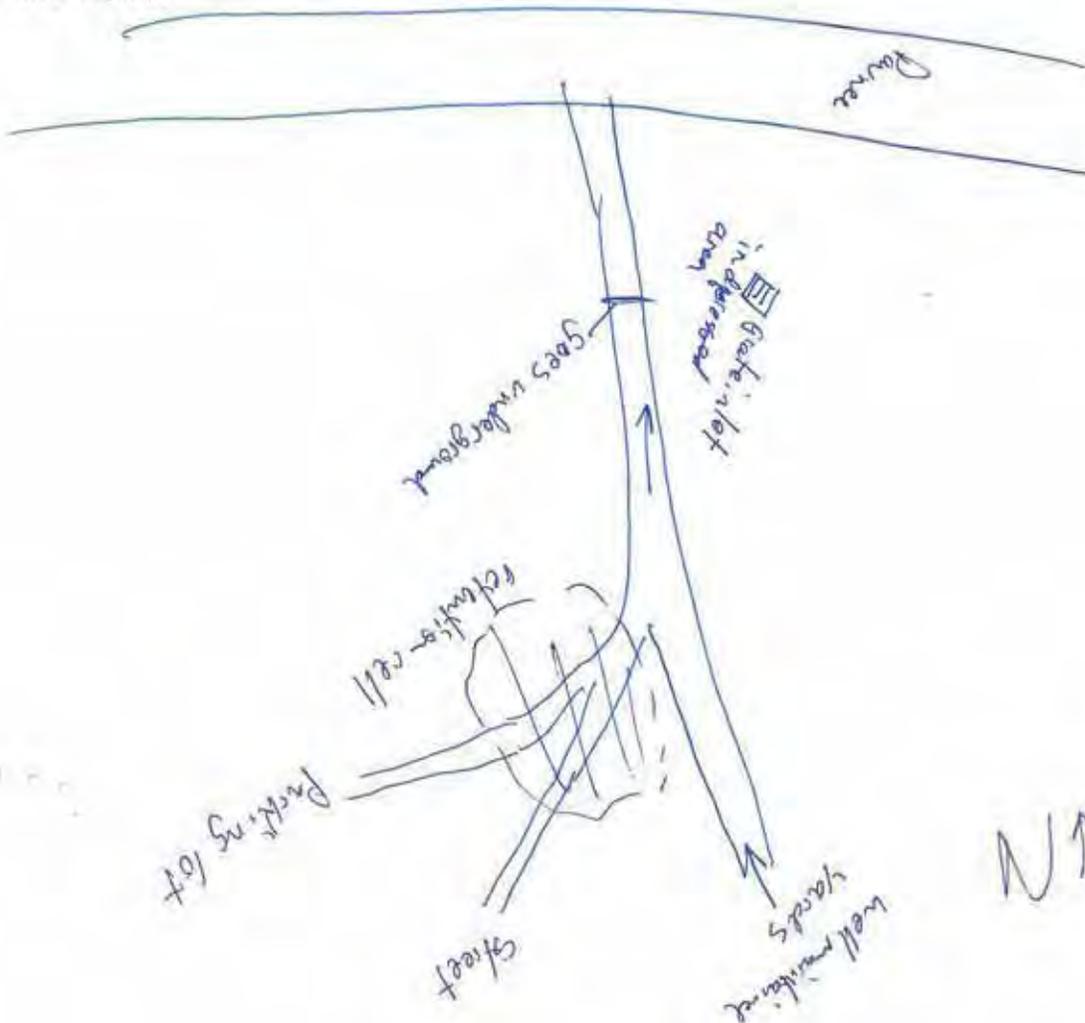
SITE SKETCH:

DATE: 9/26/11
STAFF: Jamie
LOCATION ID #: PIR 7
ADDRESS: 52nd & Pawnee
PICTURES AND GPS: YES NO
PUBLIC or PRIVATE PROPERTY
LAND USE: Drainage, parking area
POLLUTANT SOURCES NEARBY: PDLs, sediment, nutrients
TOPOGRAPHY: gentle slope
MAINTENANCE ACCESS: slightly difficult

LOCATION DESCRIPTION: concrete drainage ditch which captures street & parking lots

LAND AVAILABILITY: LOW MEDIUM / HIGH
POTENTIAL PROJECT TYPE: Bioswale, convert concrete channel to grass?

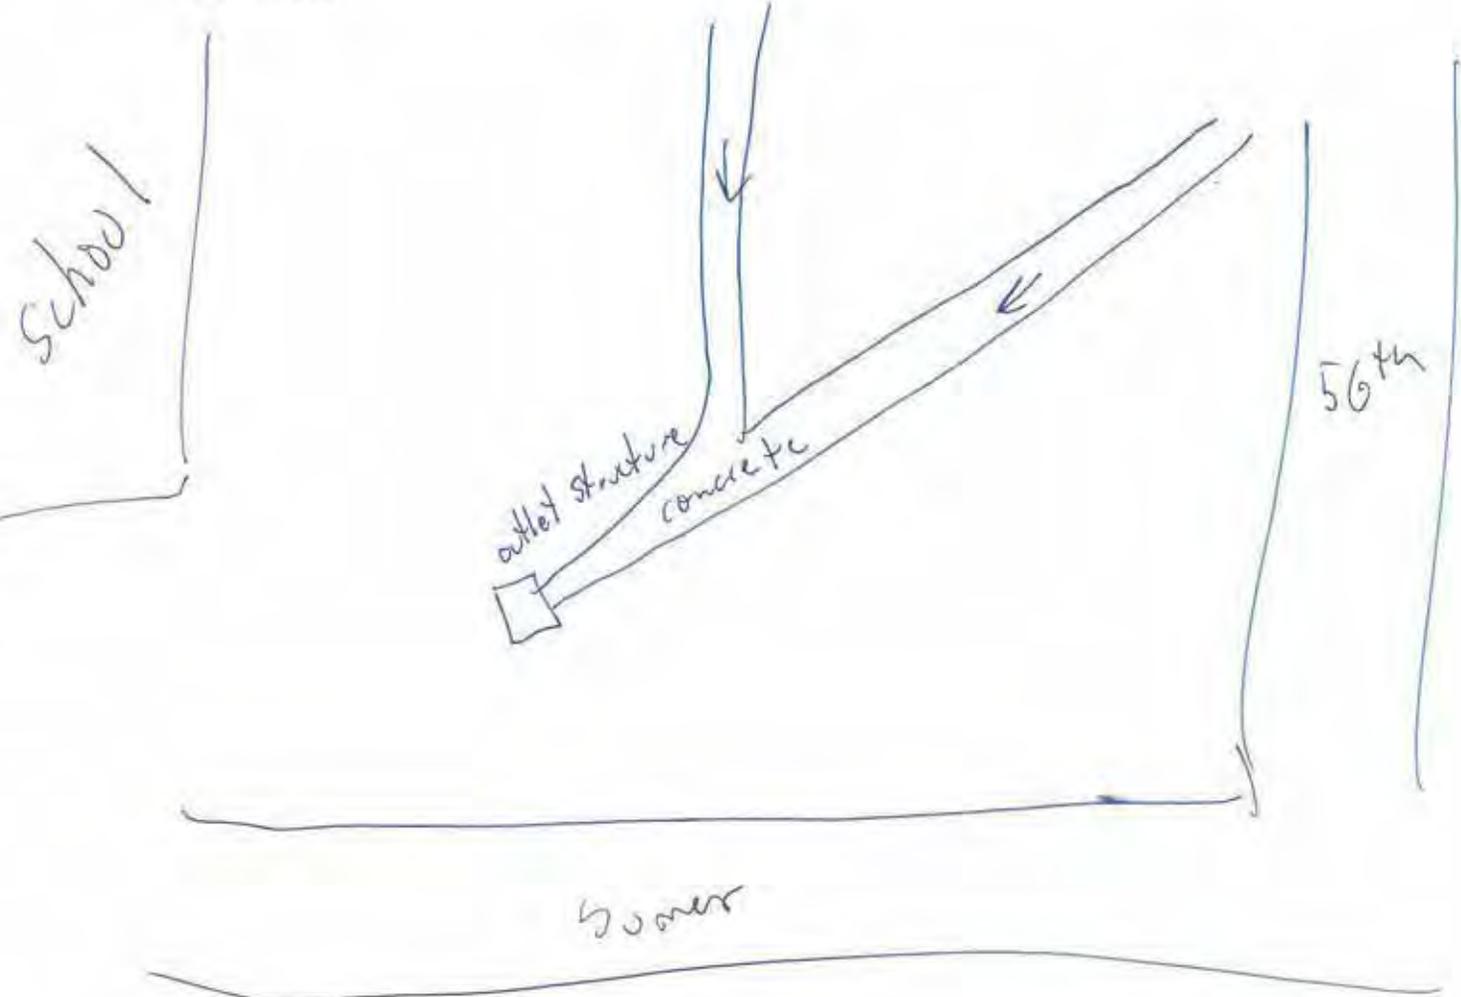
SITE SKETCH:

DATE: 4/26/11
STAFF: Jarvis
LOCATION ID #: PRB
ADDRESS: 56th & North of Sumner
PICTURES AND GPS: YES NO
 PUBLIC or PRIVATE PROPERTY
LAND USE: park/drainage
POLLUTANT SOURCES NEARBY: nutrients
TOPOGRAPHY: Sloped & bermed
MAINTENANCE ACCESS: ~~not clear~~ park @ substation nearby
LOCATION DESCRIPTION: Park west of 56th & north of Sumner

LAND AVAILABILITY: LOW / MEDIUM / HIGH
POTENTIAL PROJECT TYPE: dry detention basin

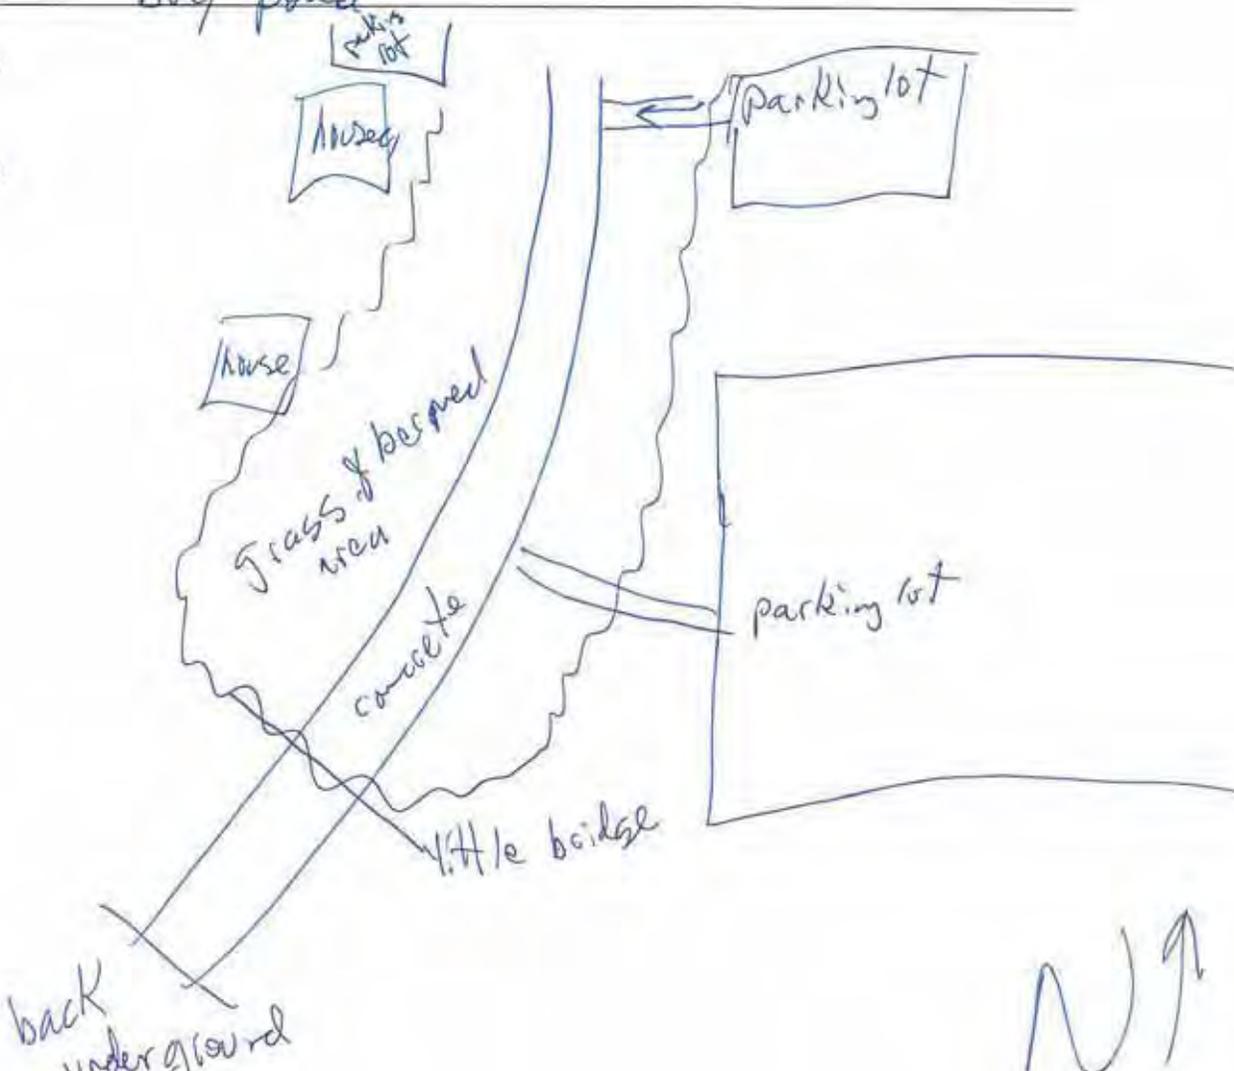
SITE SKETCH:

DATE: 9/26/11
STAFF: Jamie S.
LOCATION ID #: PR 9852
ADDRESS: 44th St
PICTURES AND GPS: YES NO
PUBLIC or PRIVATE PROPERTY
LAND USE: Drainage/ Park
POLLUTANT SOURCES NEARBY: POBs, nutrients, sediment
TOPOGRAPHY: sloped
MAINTENANCE ACCESS: easy

LOCATION DESCRIPTION: drainage channel west of Providence Health career center

- could infiltrate a lot

LAND AVAILABILITY: LOW / MEDIUM / HIGH
POTENTIAL PROJECT TYPE: Parking lots to impervious, ~~the~~ disconnected directly connected pavement areas
Day pond?

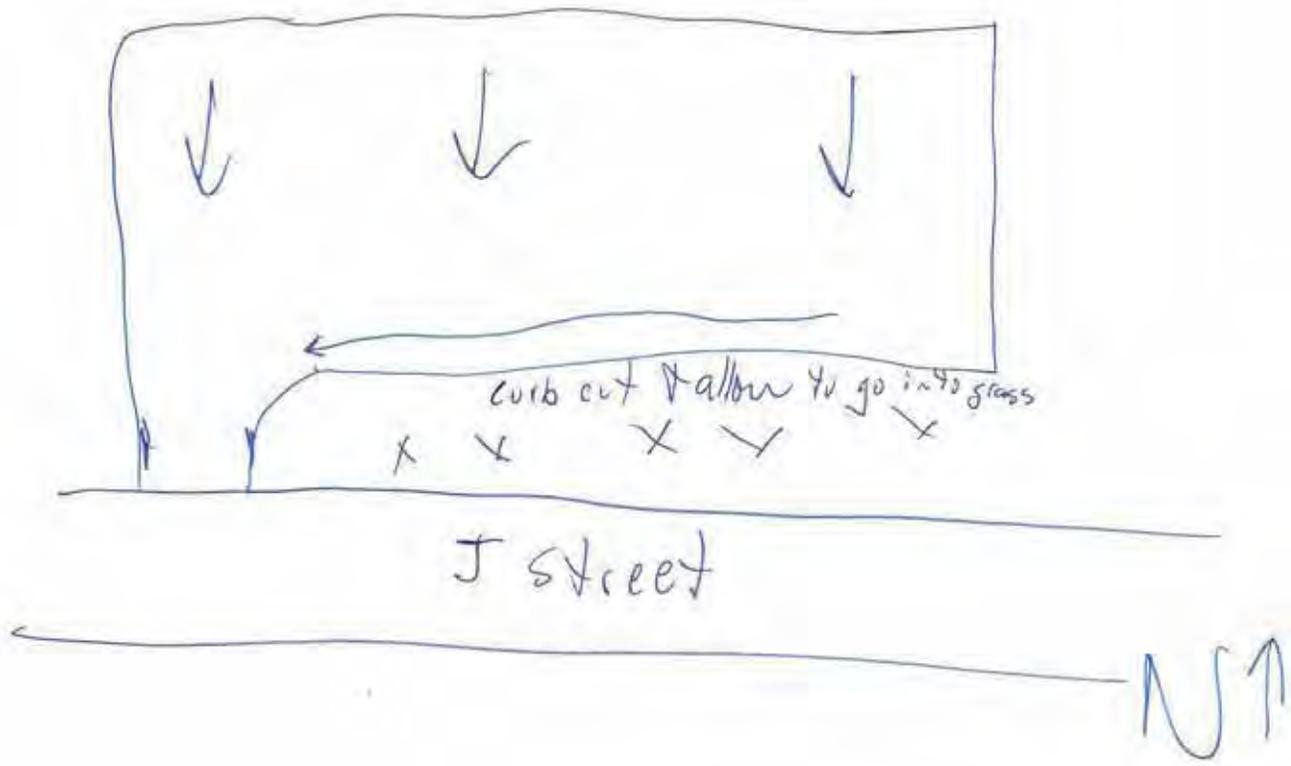
SITE SKETCH:

DATE: 9/26/11
STAFF: Janie S
LOCATION ID #: on 33rd St P/R ID
ADDRESS: _____
PICTURES AND GPS: YES NO
PUBLIC or PRIVATE PROPERTY
LAND USE: Parking lot
POLLUTANT SOURCES NEARBY: POLs sediment
TOPOGRAPHY: slight
MAINTENANCE ACCESS: easy
LOCATION DESCRIPTION: Parking lot next to ball fields

LAND AVAILABILITY: LOW / MEDIUM / HIGH
POTENTIAL PROJECT TYPE: Bio swats

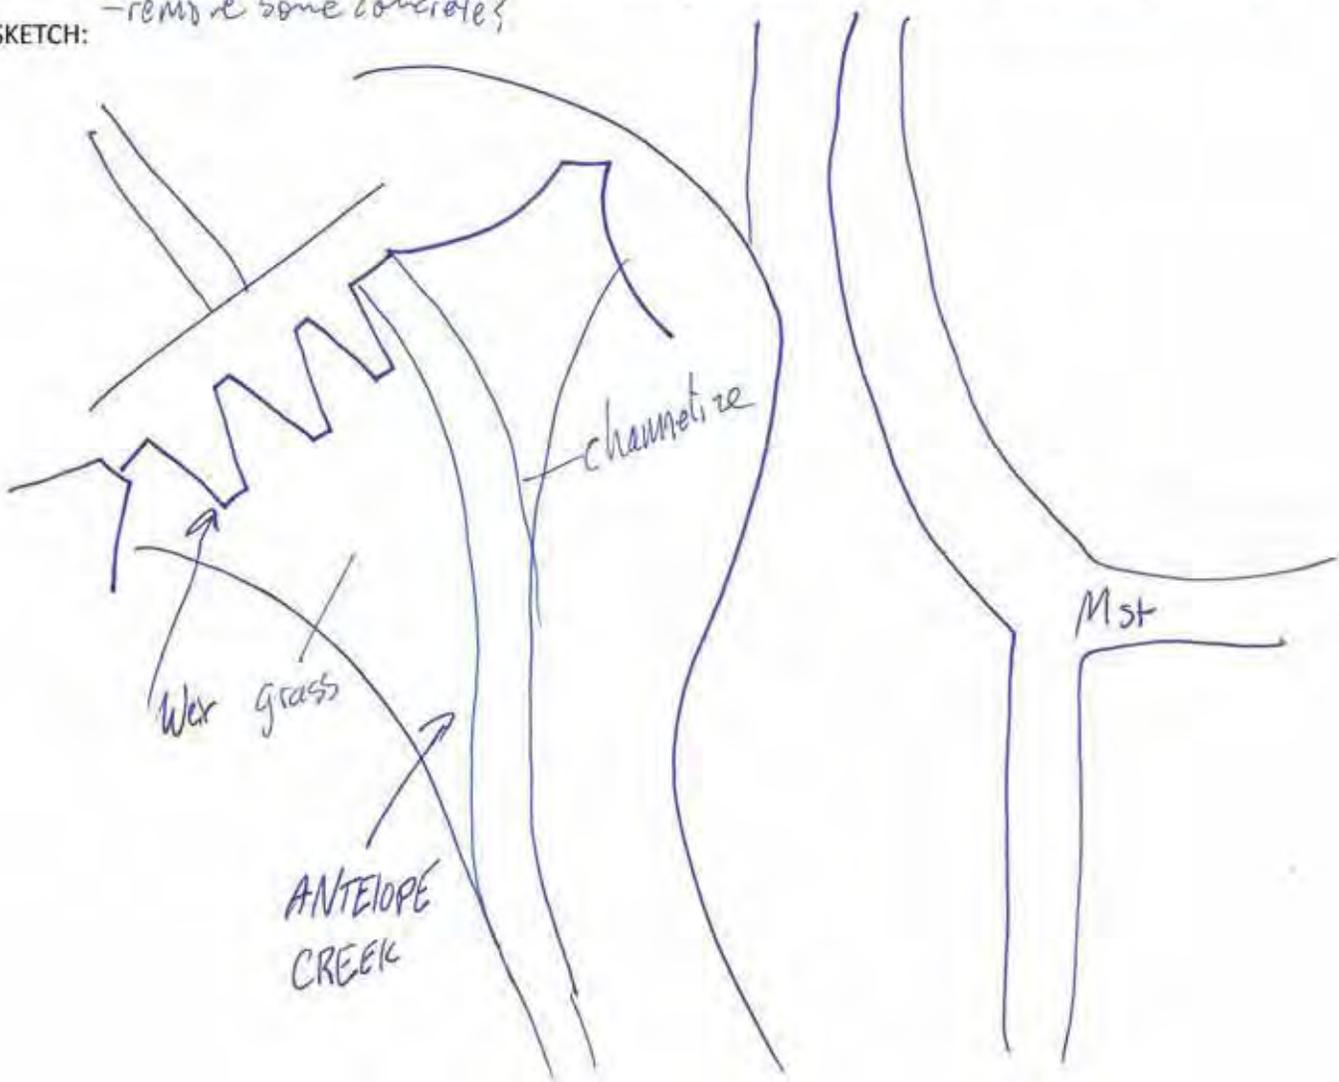
SITE SKETCH:

DATE: 9/26/11
 STAFF: Jamie S & Jon T.
 LOCATION ID #: Antelope Weir
 ADDRESS: Labyrinth Weir
 PICTURES AND GPS: (YES) NO
 PUBLIC or PRIVATE PROPERTY
 LAND USE: Public (USACE/Parks)
 POLLUTANT SOURCES NEARBY: POL, Sediment, Nutrients, E. coli
 TOPOGRAPHY: creek bottom
 MAINTENANCE ACCESS: Difficult

LOCATION DESCRIPTION: upstream of Labyrinth Weir on AC

POTENTIAL PROJECT TYPE: remove standing water, create area for sedimentation & maintenance
 - potential weir to increase sunlight to reduce E. coli concentrations
 - remove some concrete?

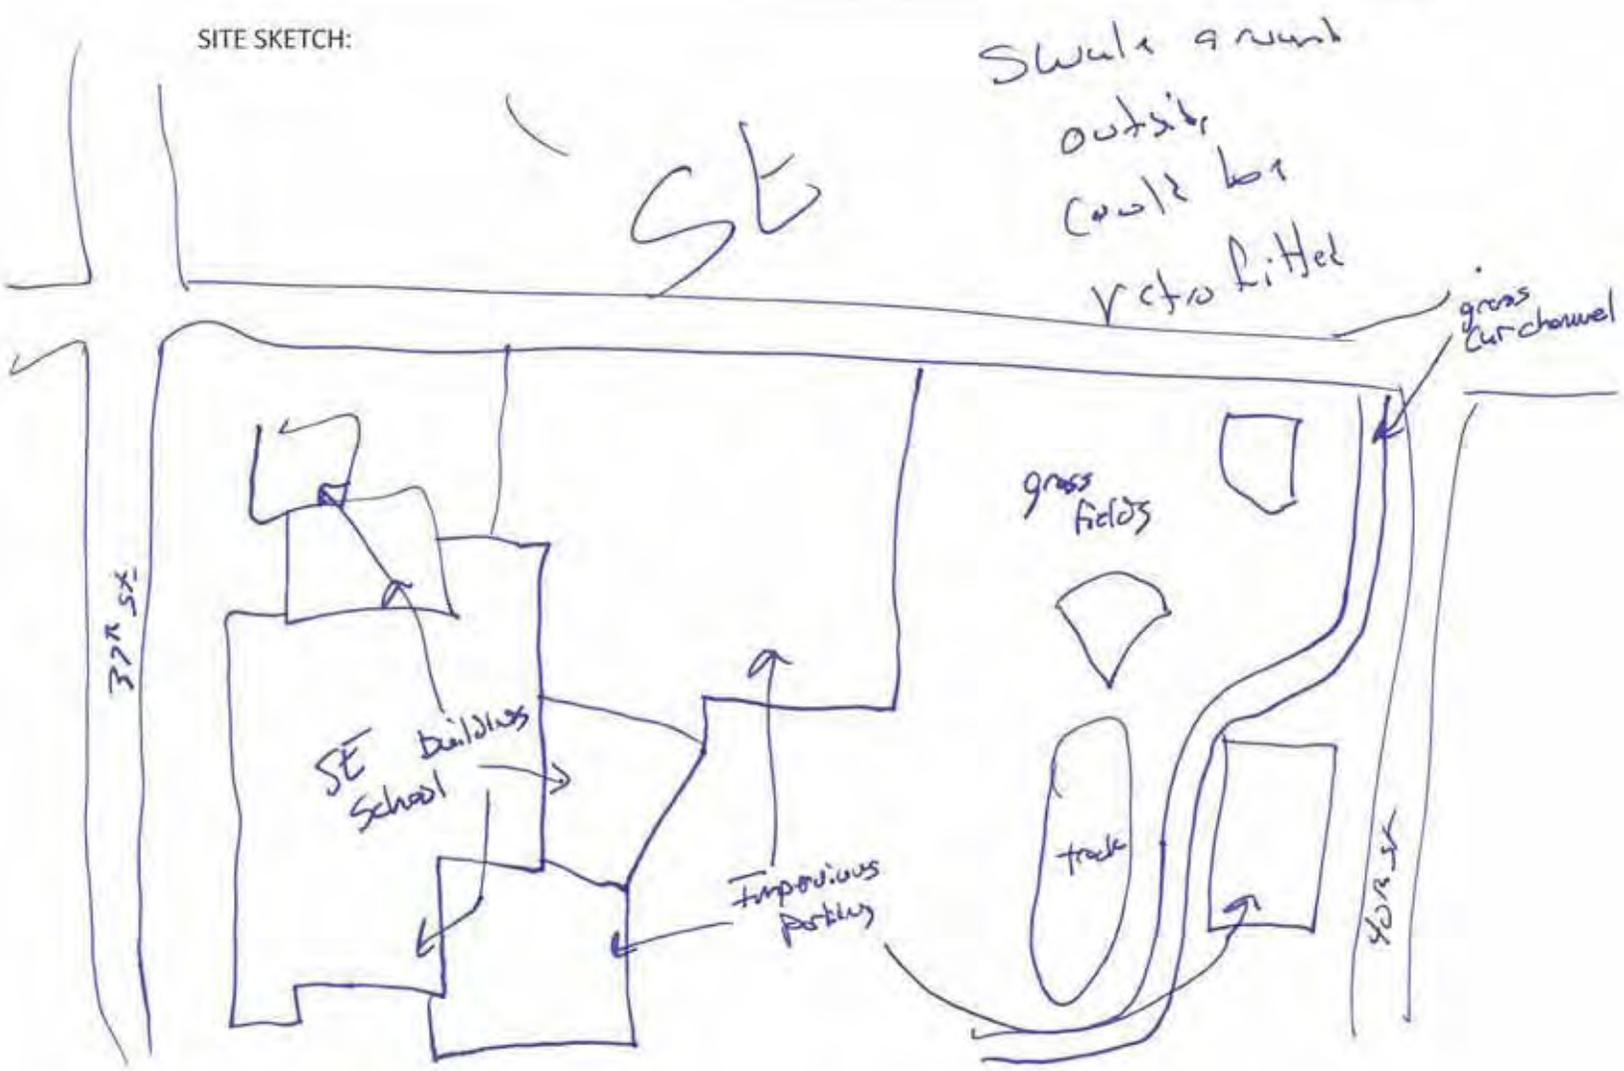
SITE SKETCH:

DATE: 11/9/4
 STAFF: Jaw T & Ben C
 LOCATION ID #: _____
 ADDRESS: 37th + Van Dorn
 PICTURES AND GPS: YES NO
 PUBLIC or PRIVATE PROERTY
 LAND USE: School
 POLLUTANT SOURCES NEARBY: 7.
 TOPOGRAPHY: etc Sloping
 MAINTENANCE ACCESS: Oil

LOCATION DESCRIPTION: Large lot, drain to SS instead of ^{grass} sewer
road by goes underground, low cut out of hillside
lot of pervious not much will hit

POTENTIAL PROJECT TYPE: Hydro, sewer
Swale

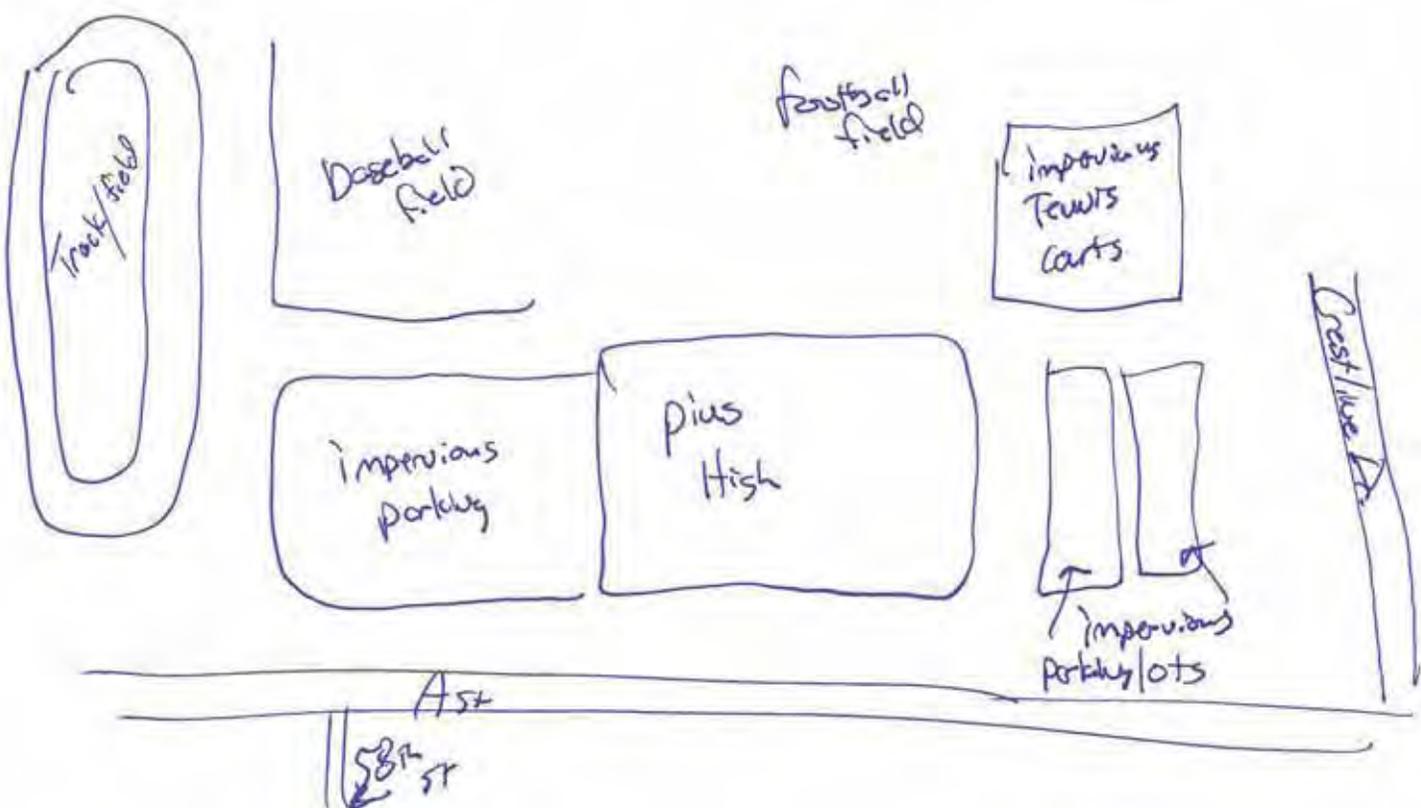
SITE SKETCH:

POLLUTANT SOURCES NEARBY: Sediment, PCL's, ~~Other~~ Nutrients

LOCATION DESCRIPTION: Down Spout to parking, large parking & back

POTENTIAL PROJECT TYPE: Loss Parking lot previous, swaling hydro sept.

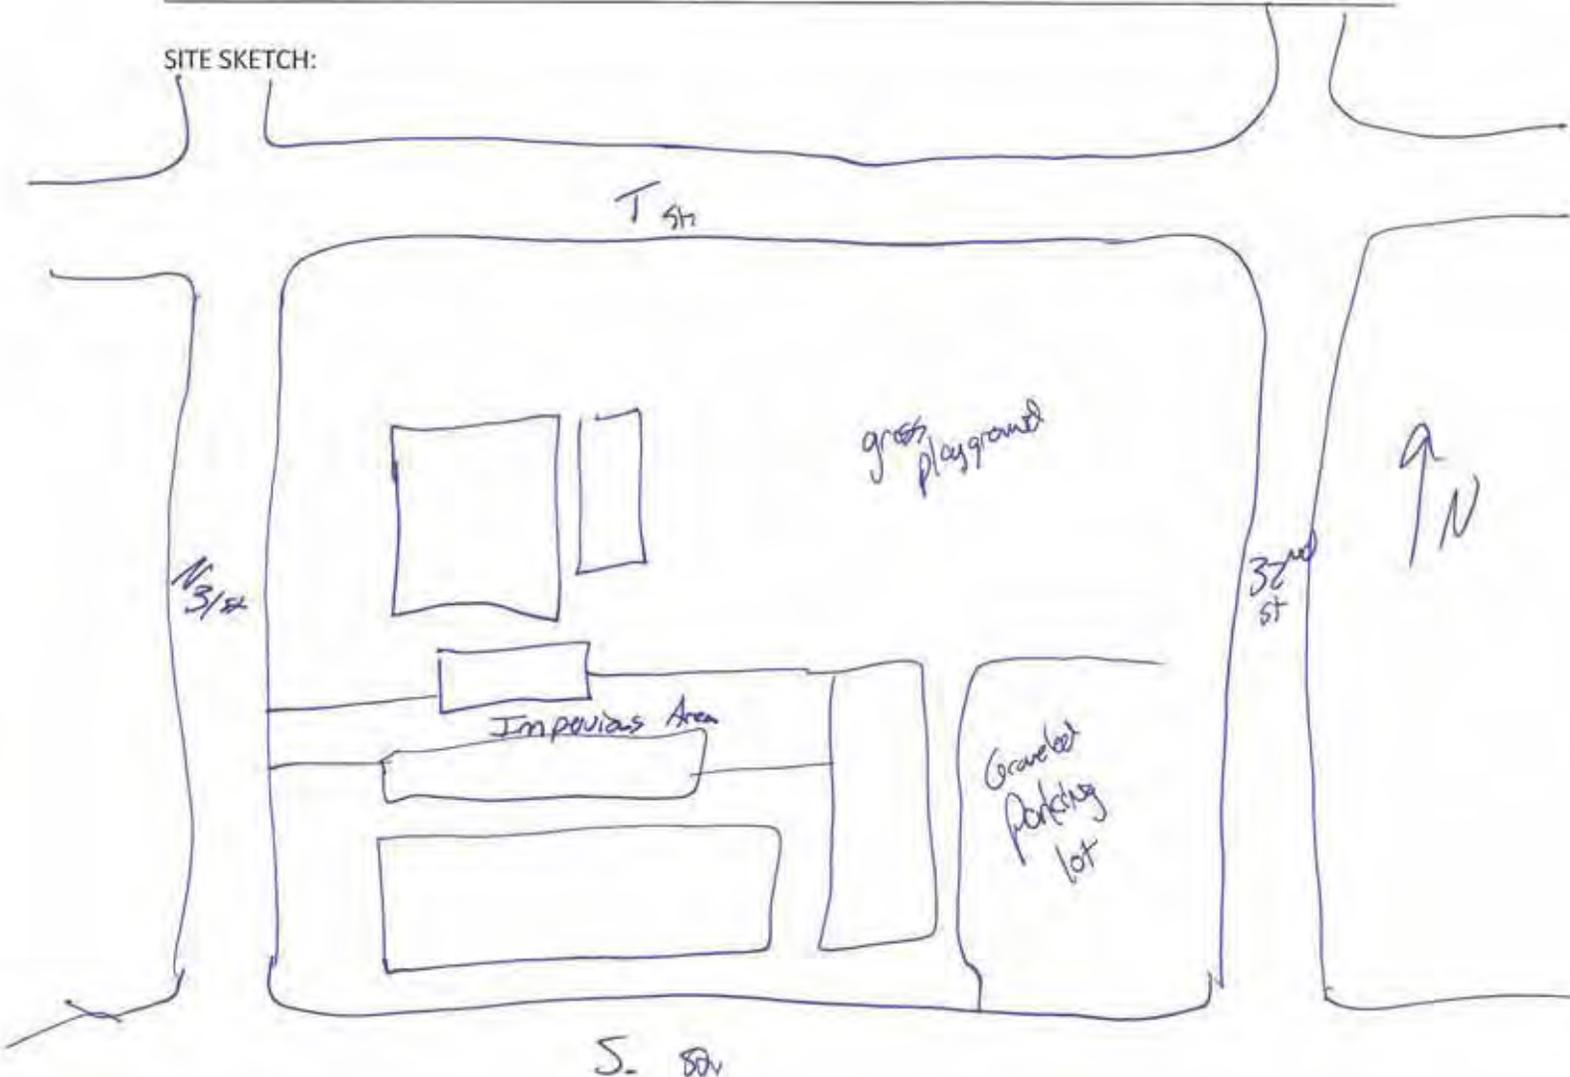
SITE SKETCH:

DATE: 11/9/11
 STAFF: ST OBL
 LOCATION ID #: 2008 Sth Sacred Heart School
 ADDRESS: 31st + S st.
 PICTURES AND GPS: YES NO
 PUBLIC or PRIVATE PROERTY
 LAND USE: school
 POLLUTANT SOURCES NEARBY: Septic tank,
 TOPOGRAPHY: flat
 MAINTENANCE ACCESS: none

LOCATION DESCRIPTION: Sacred Heart School, One large parking lot, 50% impervious total, down spouts hold basins & hold & over land good grass cover

POTENTIAL PROJECT TYPE: bio swale, permeable paver system, downspout disconnection.

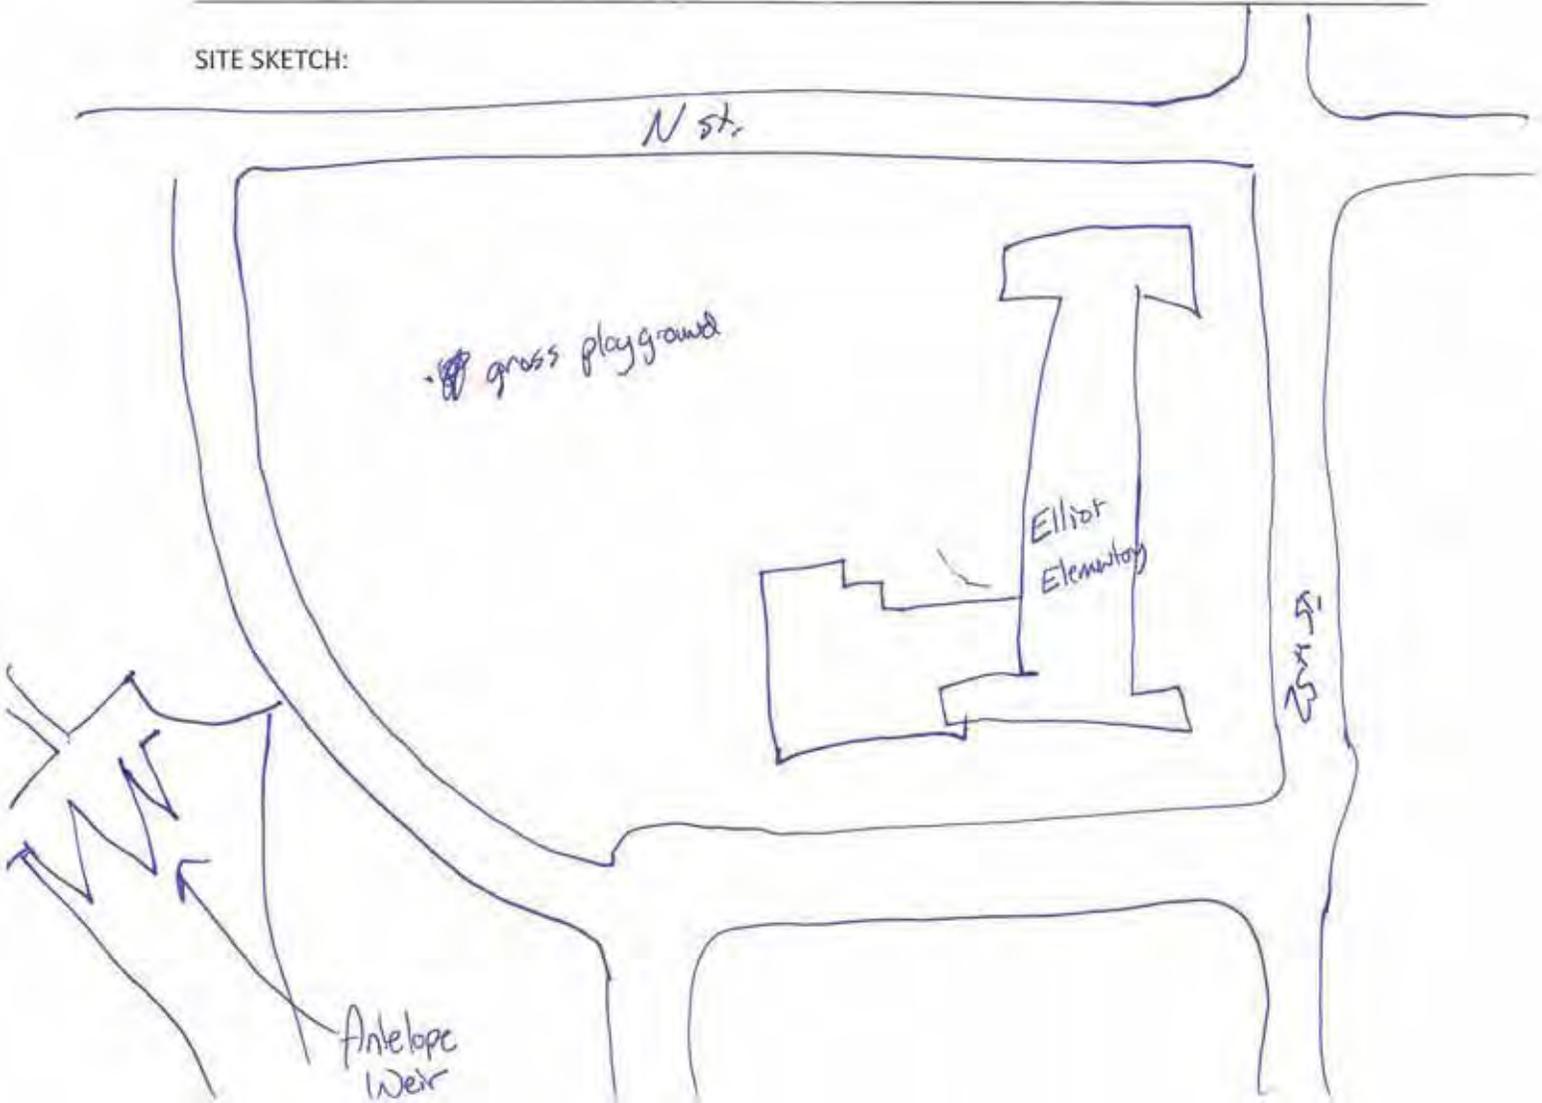
SITE SKETCH:

DATE: 11/9/11
 STAFF: Jan T. + BC
 LOCATION ID #: Ellist Elementary
 ADDRESS: 25th + N
 PICTURES AND GPS: YES NO
 PUBLIC or PRIVATE PROPERTY
 LAND USE: School
 POLLUTANT SOURCES NEARBY: TSS, Nutrients, PCB
 TOPOGRAPHY: gently sloping
 MAINTENANCE ACCESS: none

LOCATION DESCRIPTION: Ellist, grassed area to west, but a lot of impervious area, small parking lot, roof top must drain directly to SS only no downspouts

POTENTIAL PROJECT TYPE: downspout disconnection, permeable paver system

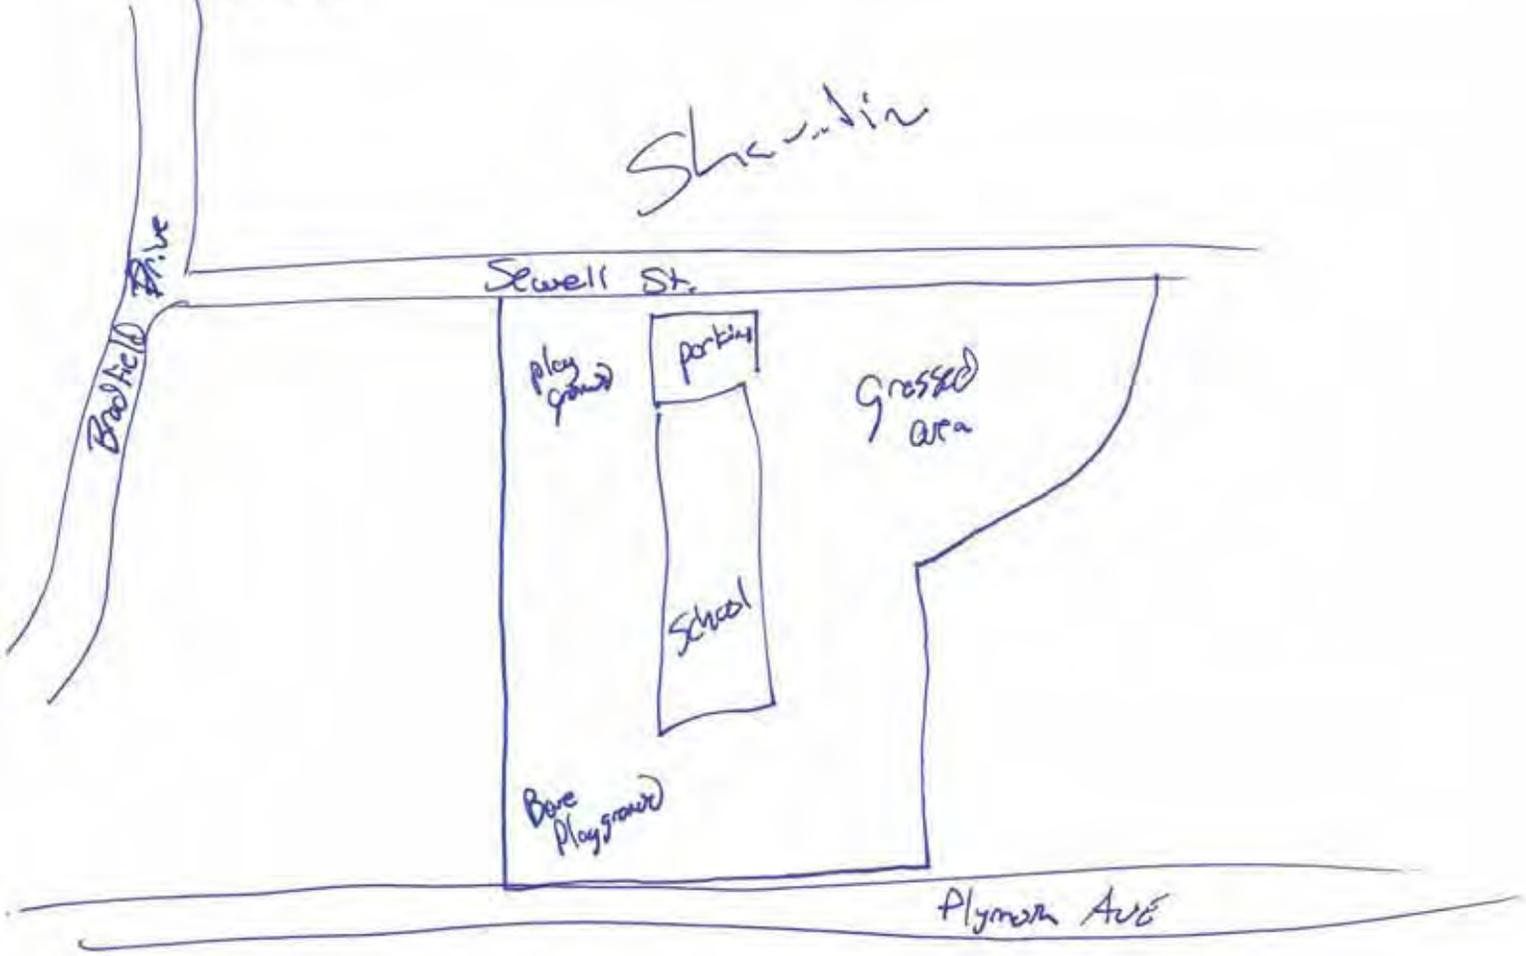
SITE SKETCH:

TOPOGRAPHY: but steep

LOCATION DESCRIPTION: Rolling, small parking

POTENTIAL PROJECT TYPE: None

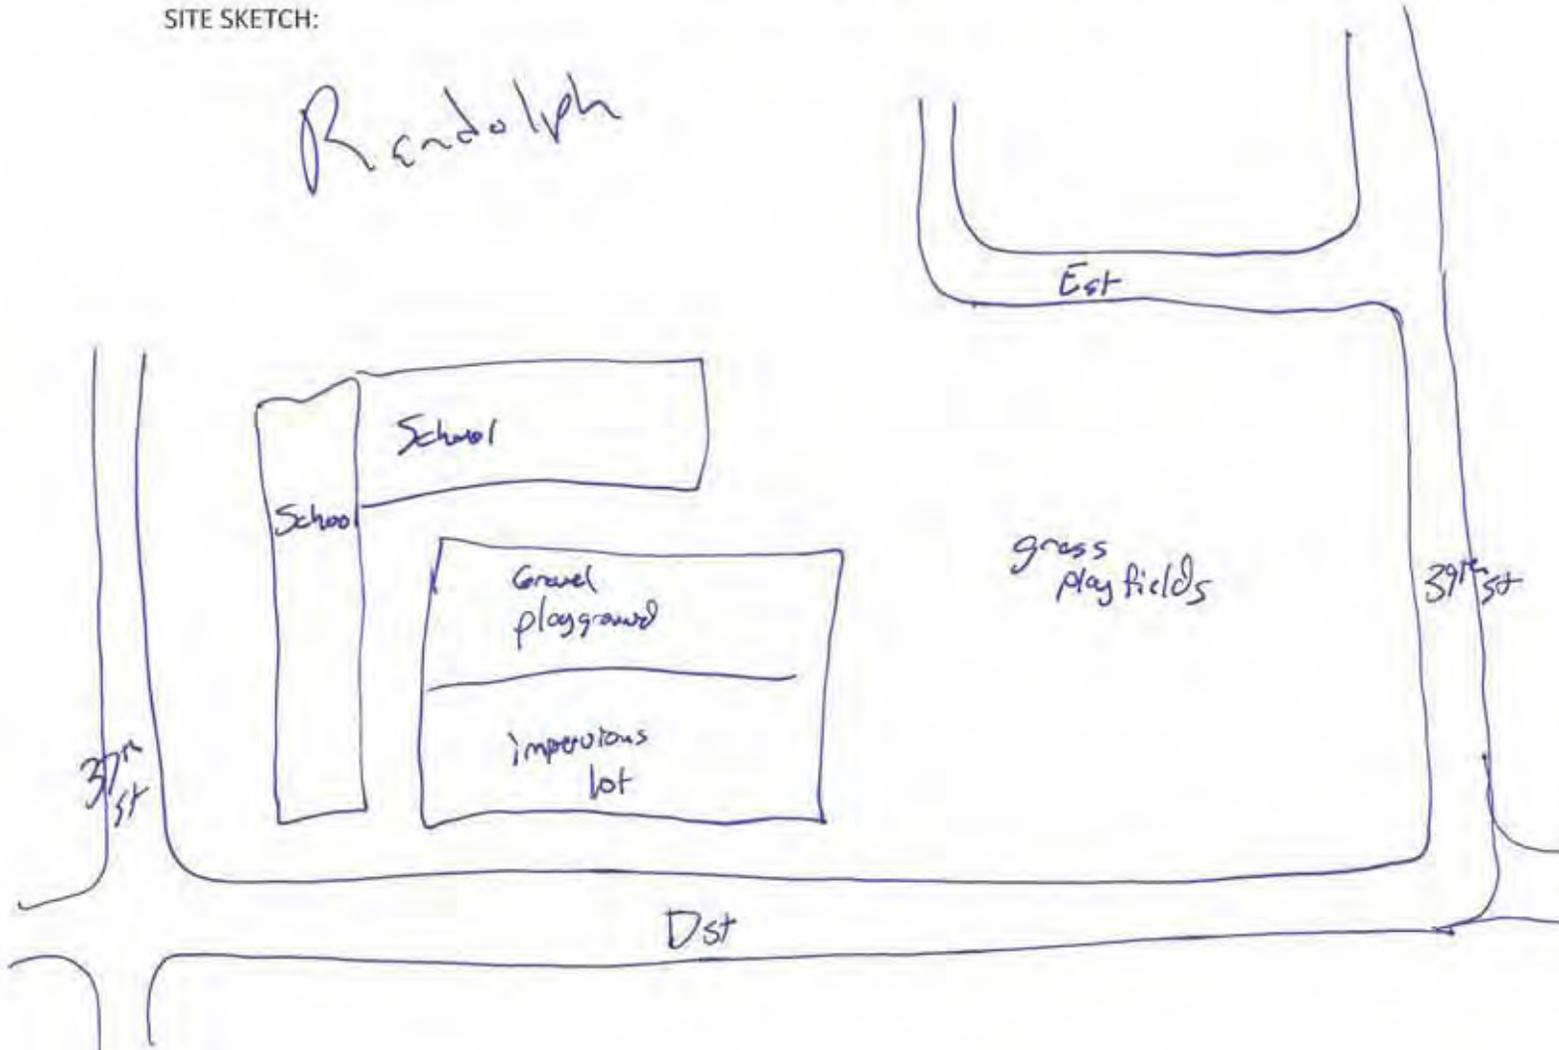
SITE SKETCH:

LOCATION DESCRIPTION: Grass fields east,
Grass in front of large parking lot to the east

POTENTIAL PROJECT TYPE: had topo & open space
parking per views

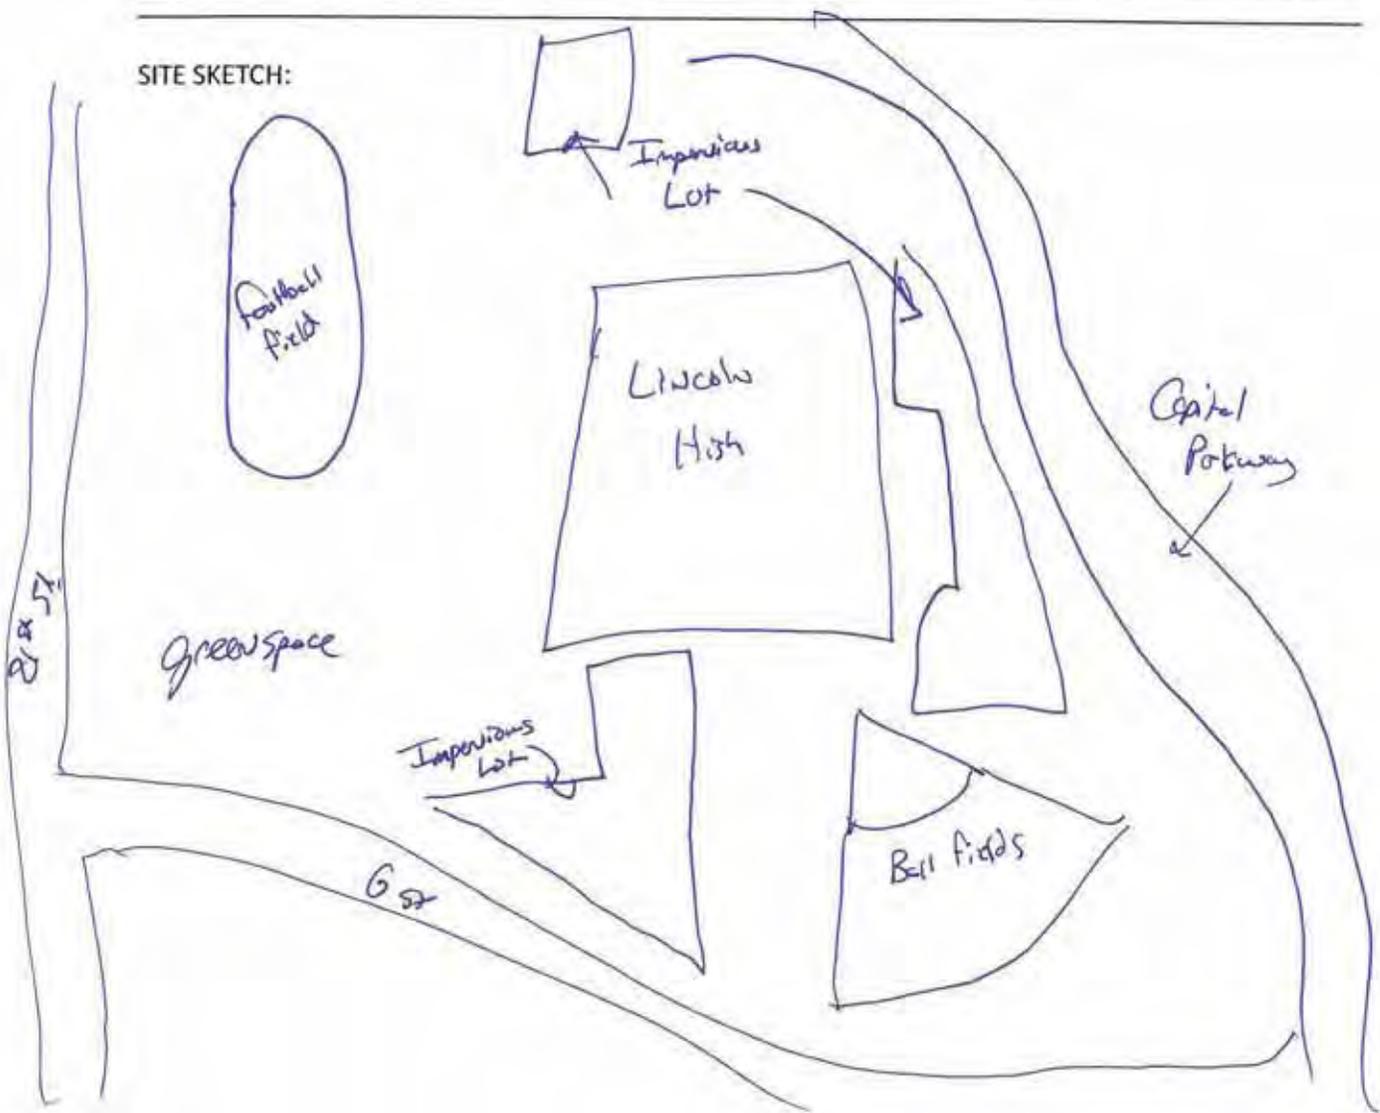
SITE SKETCH:

DATE: 9/26/11
 STAFF: Jamie S.
 LOCATION ID #: Lincoln High
 ADDRESS: 21st St
 PICTURES AND GPS: (YES) NO
 PUBLIC or PRIVATE PROPERTY
 LAND USE: School
 POLLUTANT SOURCES NEARBY: PO's Sediment, Nutrients
 TOPOGRAPHY: Flat
 MAINTENANCE ACCESS: Yes

LOCATION DESCRIPTION: Lincoln High. 3 Parking Lots

POTENTIAL PROJECT TYPE: small bio retention areas

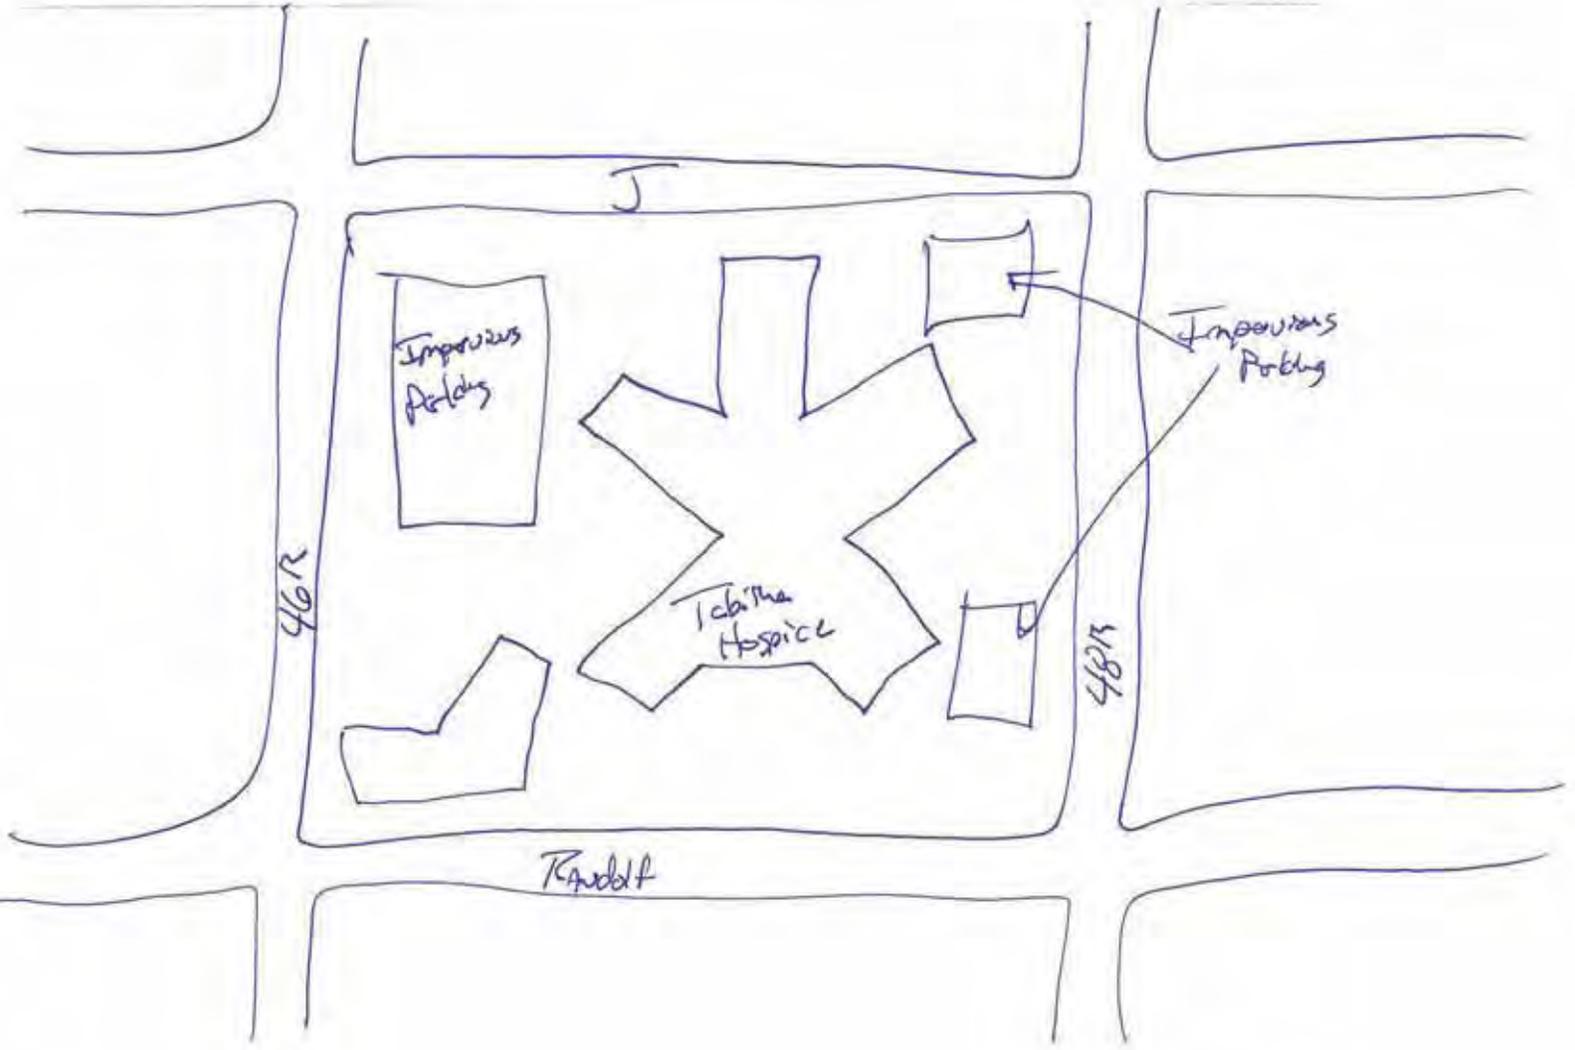
DATE: 11/9/11
 STAFF: Jaw T + Ben C
 LOCATION ID #: 146110
 ADDRESS: 48th + Randall
 PICTURES AND GPS: YES NO
 PUBLIC or PRIVATE PROPERTY
 LAND USE: Hospice
 POLLUTANT SOURCES NEARBY: Sediment Poles Nutrients
 TOPOGRAPHY: Gently sloping
 MAINTENANCE ACCESS: None

LOCATION DESCRIPTION: 1 large + 2 medium parking lots, Impervious lots of open space

POTENTIAL PROJECT TYPE: Impervious pervious pavement, hydrodynamic swales bioswales, rain gardens

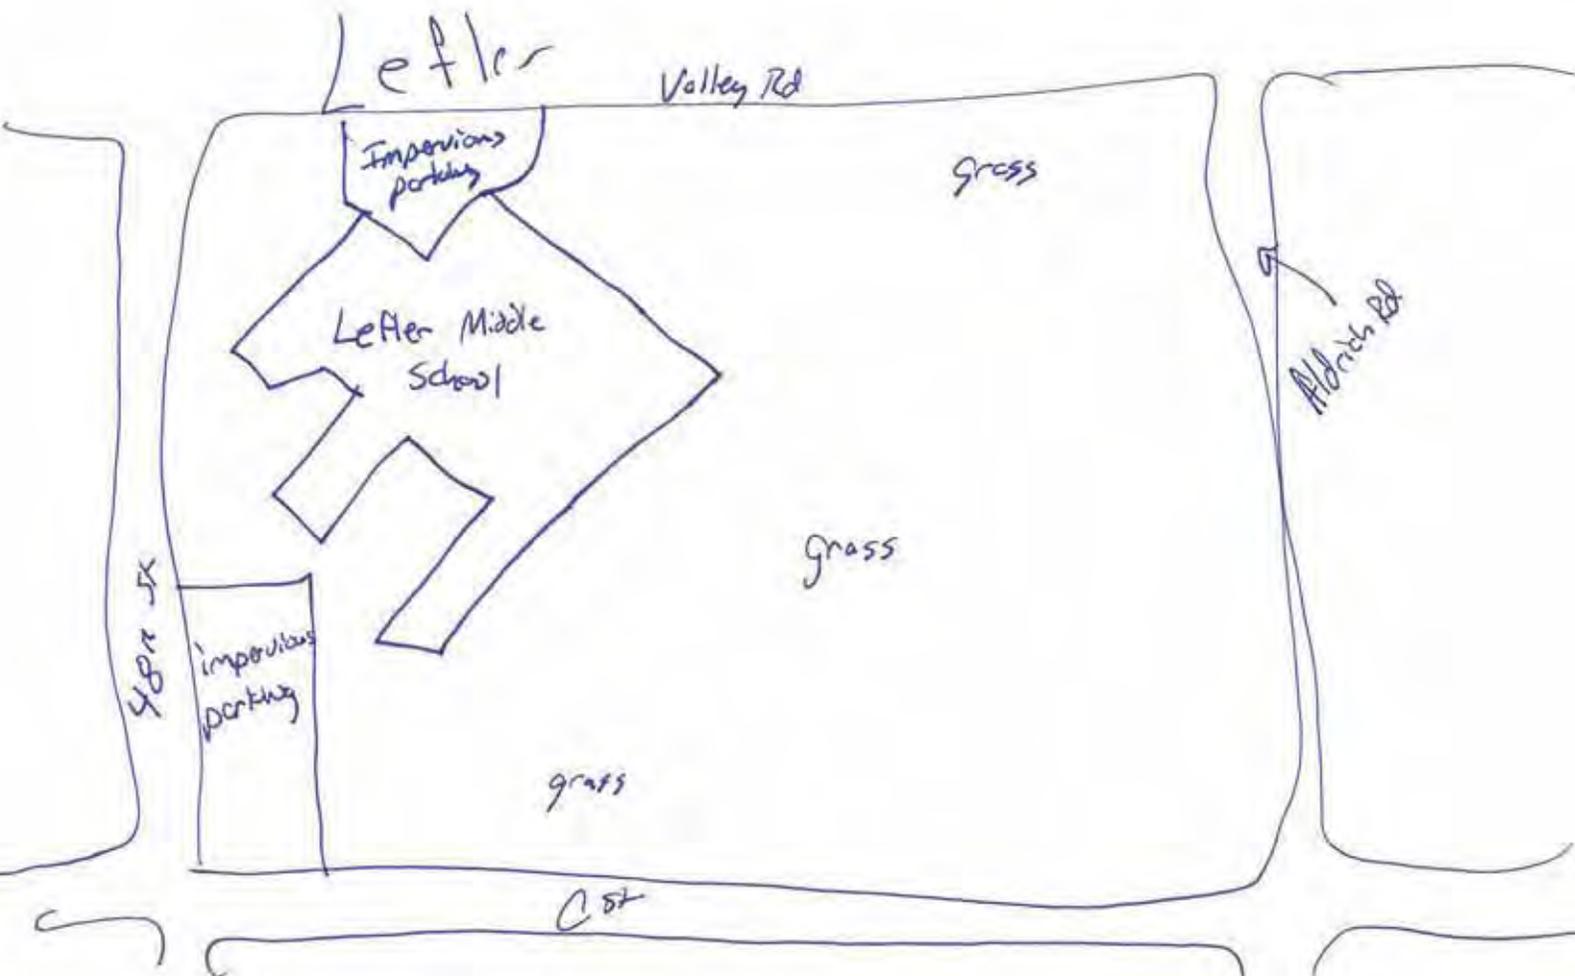
SITE SKETCH:

DATE: 11/9/11
STAFF: BENC & JOE T
LOCATION ID #: _____
ADDRESS: 48th & Valley
PICTURES AND GPS: YES - NO
PUBLIC or PRIVATE PROERTY
LAND USE: School
POLLUTANT SOURCES NEARBY: Not nearby to remove bc cause of low land
TOPOGRAPHY: OK
MAINTENANCE ACCESS: OK

LOCATION DESCRIPTION: School ball field, larger building
relatively small parking lot

POTENTIAL PROJECT TYPE: Small parking lot treatment not much.

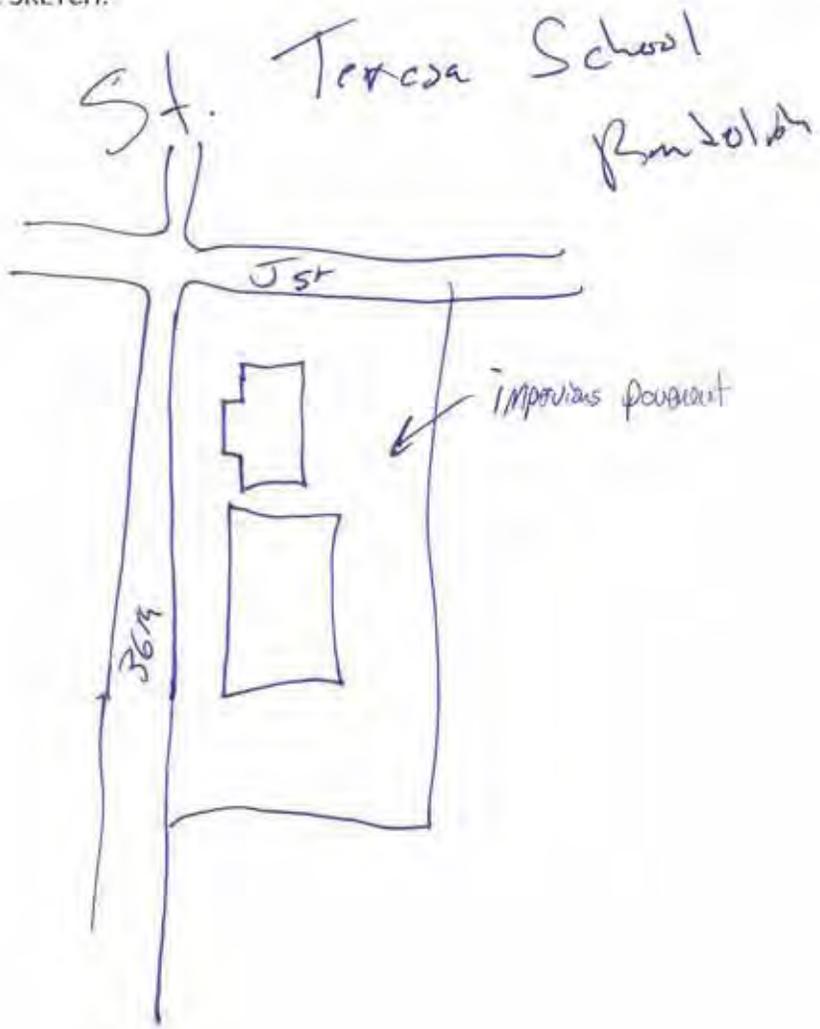
SITE SKETCH:

TOPOGRAPHY: flat / gently sloping

LOCATION DESCRIPTION: No land available
2 large buildings completely surrounded by impervious pavement.

POTENTIAL PROJECT TYPE: impervious pavement
