Appendix C - Site Prioritization Ranking Worksheets

ANTELOPE CREEK STRUCTURAL LOCATIONS MAP

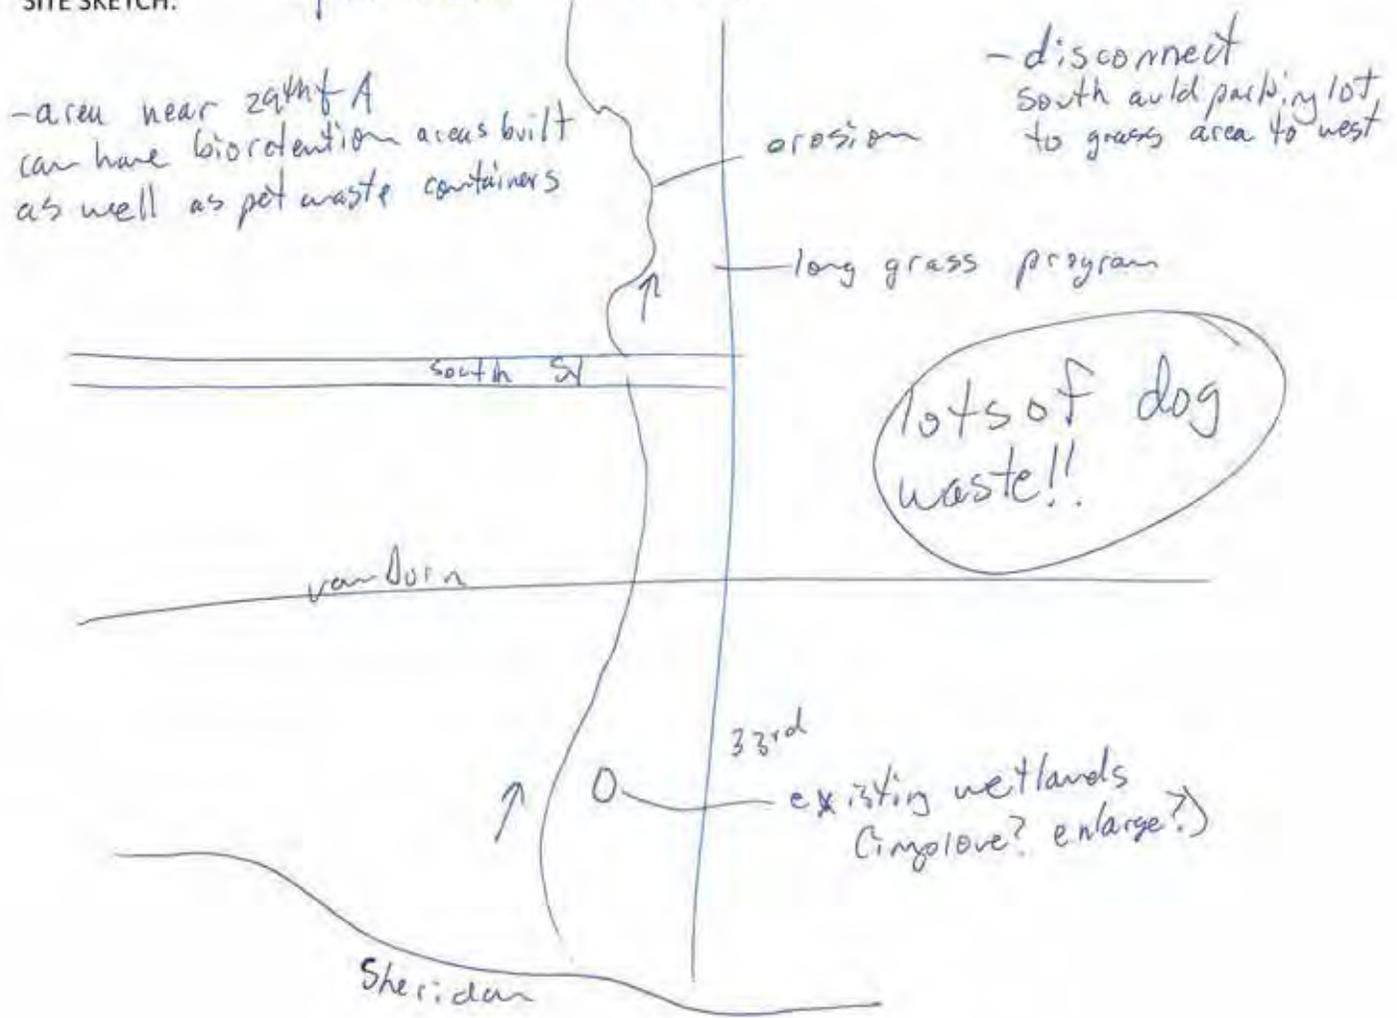
SITE SKETCH: - pet waste containers

DATE: ~~9/26/11~~ 1/10/12
 STAFF: Jamie S & Jon T.
 LOCATION ID #: Antelope Park
 ADDRESS: _____
 PICTURES AND GPS: YES NO
 PUBLIC or PRIVATE PROPERTY
 LAND USE: All Park area
 POLLUTANT SOURCES NEARBY: Nutrients, PO's, sediment
 TOPOGRAPHY: gently sloping
 MAINTENANCE ACCESS: _____

LOCATION DESCRIPTION: Antelope park stretching along 33rd Street between van dorn & A street

POTENTIAL PROJECT TYPE: large bioretention areas, disconnect parking lots, address erosion in meandering channel
 - improve outfalls & wetland areas
